February 2024
SF683A-B

Subject: Detroit Engine Fan HVAC Integration

Models Affected: Specific model years 2023-2024 Freightliner 114SD, and Business Class M2 vehicles, manufactured August 18, 2022, through July 31, 2023.

Updating the Heating, Ventilating, and Air Conditioning (HVAC) Fan Parameter

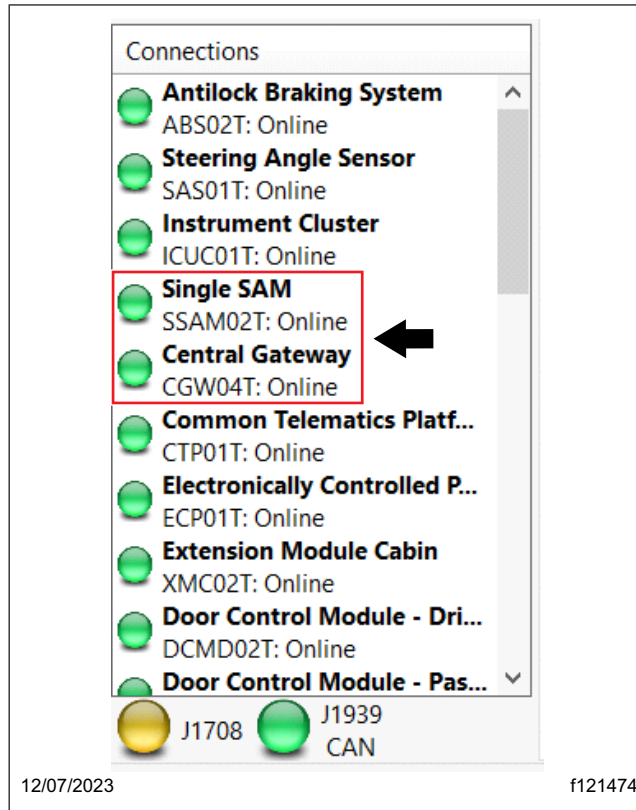
Fig. 1, SSAM02T and CGW04T Connected

6. Ensure the 'Single SAM (SSAM02T)' and 'Central Gateway (CGW04T)' devices rollcall, and are visible in the 'Connections' panel, as shown in [Fig. 1](#).

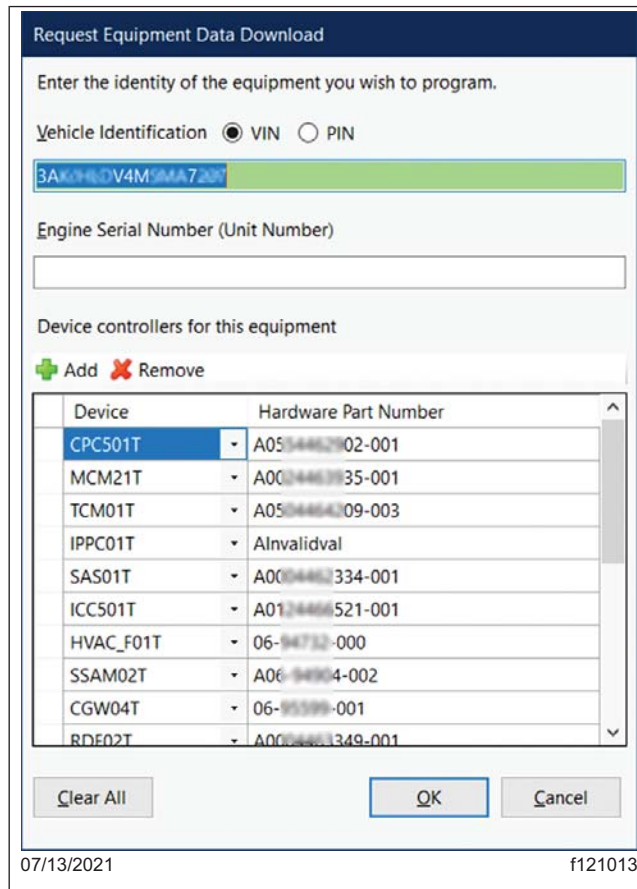
Fig. 4, Manually Connecting to DiagnosticLink

7. Go to the 'Program Device' tab, and make sure that the vehicle identification number (VIN) that appears is correct.
 - If the VIN that appears is incorrect, remove each VIN by selecting the 'Remove' button on the right-hand side of that VIN. To remove all the VINs at once, select the 'Remove All' button at the bottom of the screen. See [Fig. 2](#).
 - If the VIN is not automatically detected, select 'Add request,' then enter the VIN in the designated field. Select the device to be connected, then select 'OK.' See [Fig. 3](#) and [Fig. 4](#).

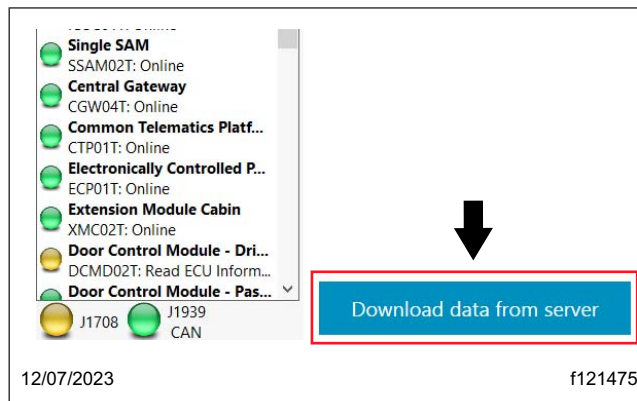
Fig. 5, Downloading the Data from the Server

8. Select the 'Connected unit' panel, and make sure the VIN that now appears is correct.
9. Select 'Download data from server' at the bottom-left of the screen. See Fig. 5.
