HYUNDAI

Technical Service Bulletin

GROUP Campaign	NUMBER 24-01-018H
DATE FEBRUARY 2024	MODEL(S) Accent (HC)

SUBJECT: TCU UPDATE AND IVT REPLACEMENT
(SERVICE CAMPAIGN 9A9)

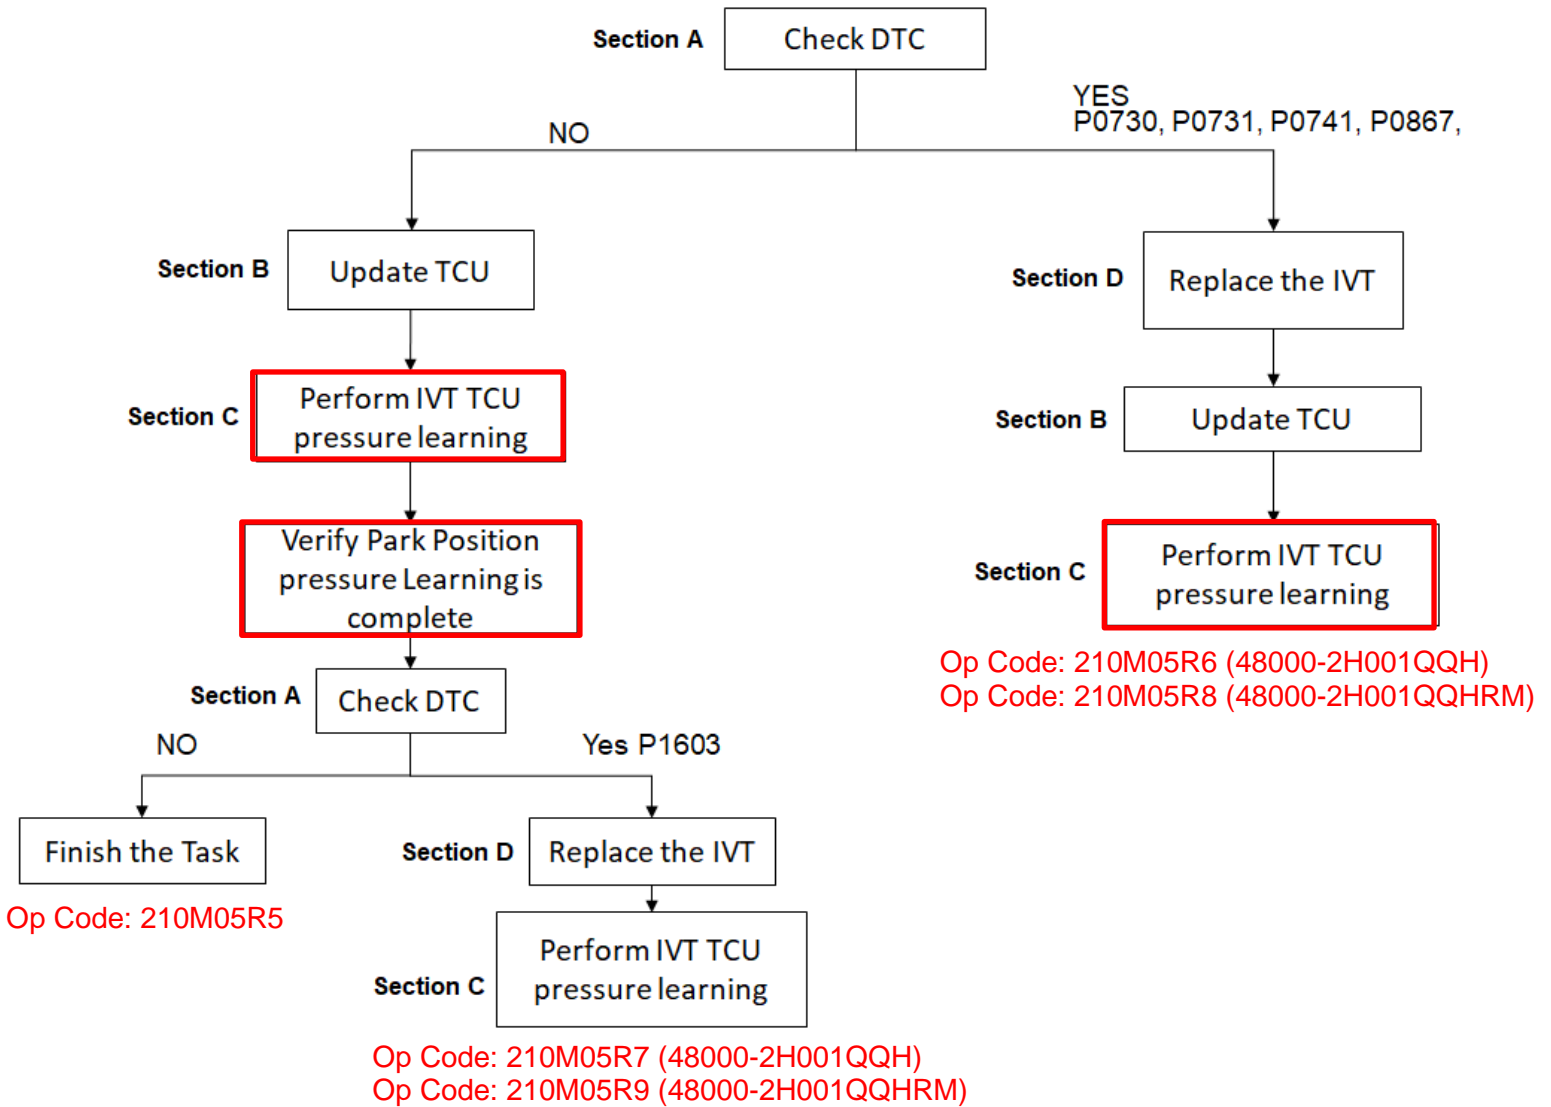
TCU Update Flow (HC with IVT)

1. Refer to the flowchart below to update the procedure.

1. Use the GDS-M to check the TCU DTC.
2. If one of the DTC(s) P0730, P0731, P0741, P0867, P1603 applies (History, Current, or Pending), replace the IVT.
3. Replace the IVT according to the applicable vehicle shop manual.
4. After IVT replacement, perform TCU update first, then perform the IVT resetting auto T/A values, TCU adaptive values learning procedure.

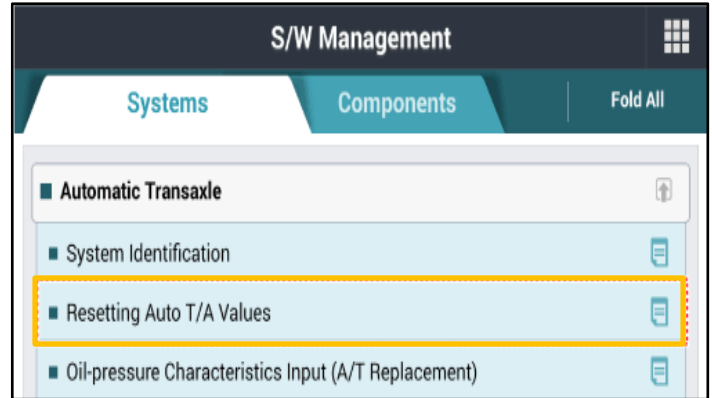
1. Perform IVT Resetting Auto T/A Values using the GDS-M.

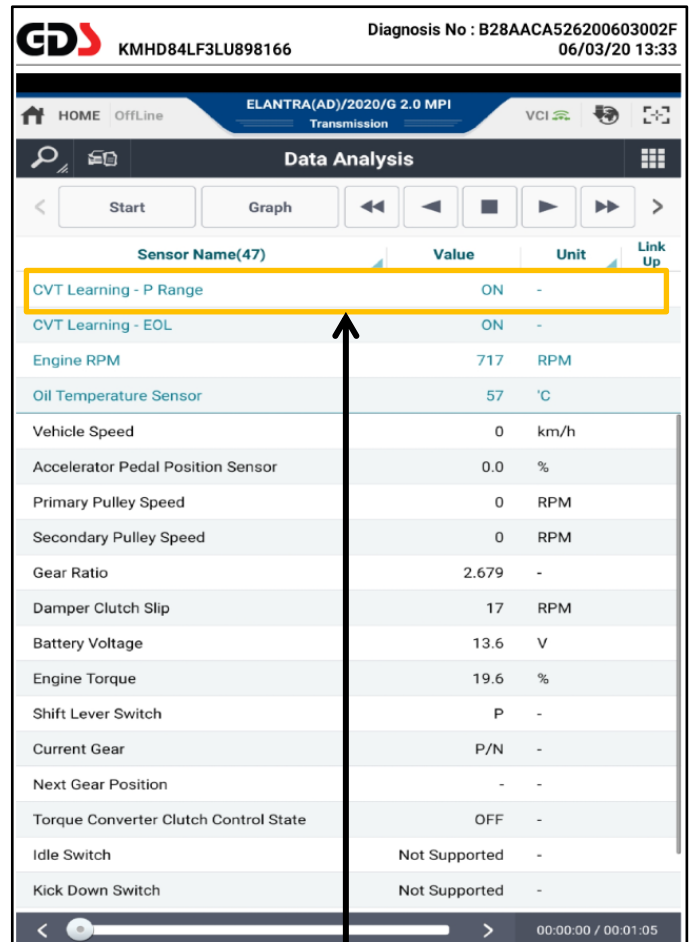
Use the GDS-M to verify the IVT P-Range learning is complete, and check TCU for DTC P1603 (EOL P-Range Pressure Learning Failed).

(1) If IVT- P Range learning is not complete, and P1603 is present, Replace the IVT (Refer to **Section D.**)

(2) If IVT-P Range is not complete, and P1603 is not present, the learning condition has not been met. Re-perform **Section C - IVT, TCU Learning.**

Learning completion can be confirmed by using GDS-M to verify the IVT (“CVT”) P-Range learning value is “ON”. (“OFF” learning has not been completed)

Learning condition Intelligent Variable Transmission Fluid (IVTF) temperature: 86 - 194°F (30 - 90°C)

Start the engine after checking the IVTF temperature with the Ignition ON.

Engine RPM will rise to approximately 1000 rpm after starting the engine.

After 30-120 seconds, the learning is completed when the engine RPM reaches the normal IDLE level.

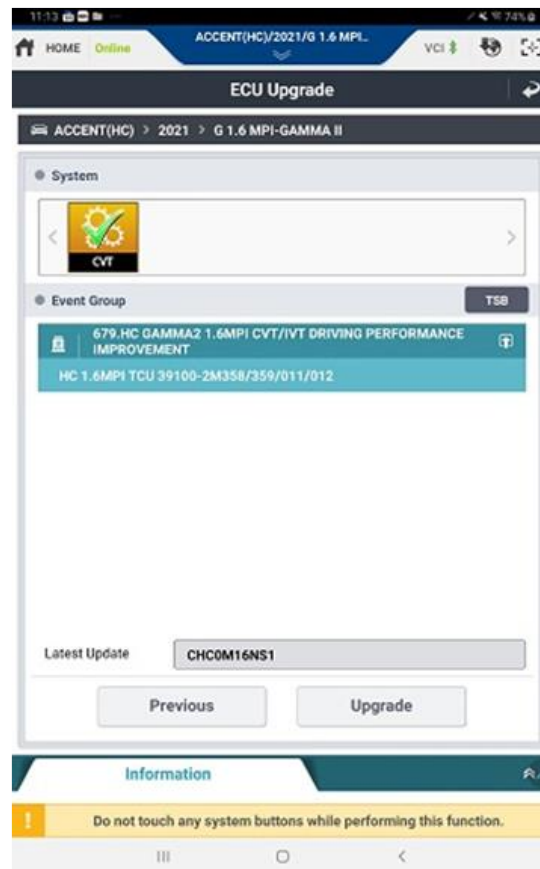
Update Event
679.HC 1.6MPI – IVT Driving Performance Improvement

1. From the GDS-M home screen, select **ECU Upgrade**.
2. From the ECU Upgrade screen, select **Manual Mode**, then select the **Update Event 679**.

3. A password prompt will appear. Enter the password and select **Upgrade**.

MENU	PASSWORD
HC 1.6MPI TCU 39100-2M358/359/011/012	1012
