ECM Reflash Sequence

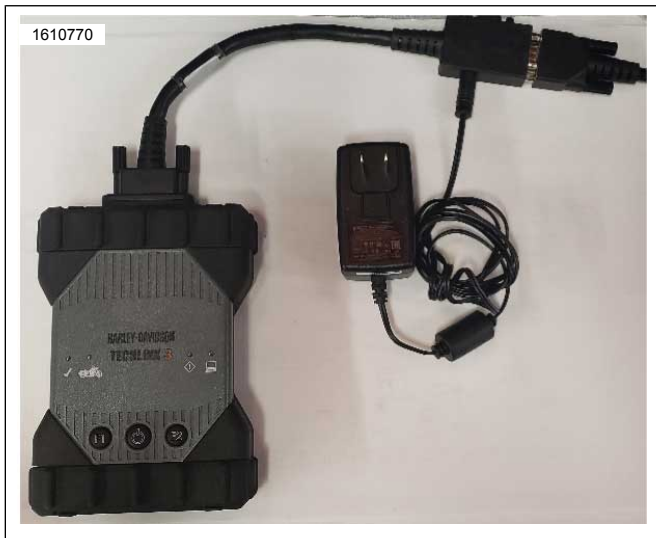
Figure 1. External Power Adapter

- Have a battery tender connected to the battery while performing software update.

1. Connect battery tender directly to vehicle battery (only on 2024 models, the vehicle battery tender lead CAN be used).
 - a. Verify battery is fully charged before proceeding.
2. Connect external power to TL-3 appropriate power supply providing at least:
 - a. 12Voltage (V)
 - b. 1.2Amperes (A)
3. Place vehicle's ignition to ON.
4. Open DT II program and establish communication with vehicle.
5. Proceed to reflash the ECM and follow on-screen directions.
