GLOBAL SAFETY FIELD INVESTIGATIONS
DCS6812
URGENT - DISTRIBUTE IMMEDIATELY

Subject: N232432680 - Special Coverage
Battery Energy Control Module Malfunction

Models: 2016-2018 Chevrolet Volt

N232432680 Battery Energy Control Module Malfunction

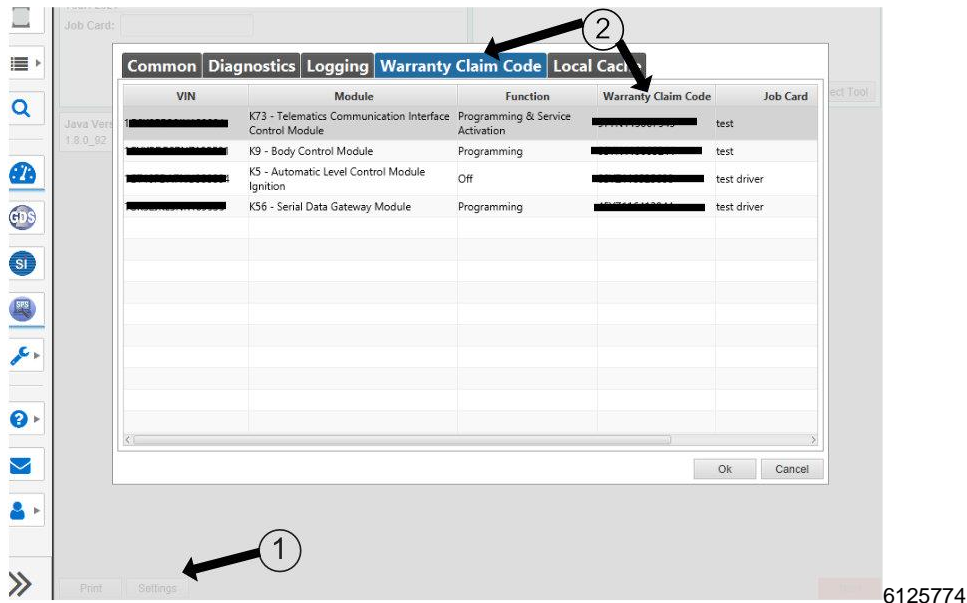
Warranty Claim Code Information Retrieval

If the Warranty Claim Code was not recorded on the Job Card, the code can be retrieved in the SPS2 system as follows:

1. Open TLC on the computer used to program the vehicle.
2. Select and start SPS2.
3. Select Settings (1).
4. Select the Warranty Claim Code tab (2).

The VIN, Warranty Claim Code and Date/Time will be listed on a roster of recent programming events. If the code is retrievable, dealers should resubmit the transaction making sure to include the code in the SPS Warranty Claim Code field.
