Applicability: All Revero GT and GTS and GS-6 (Karma “2.0 vehicles”)

Type: Service Communication

TITLE: Manual Baseline Updating

PURPOSE: This document will be used as a reference guide for technicians to manually update a vehicle to next available baseline software. This involves use of Karma Sync.

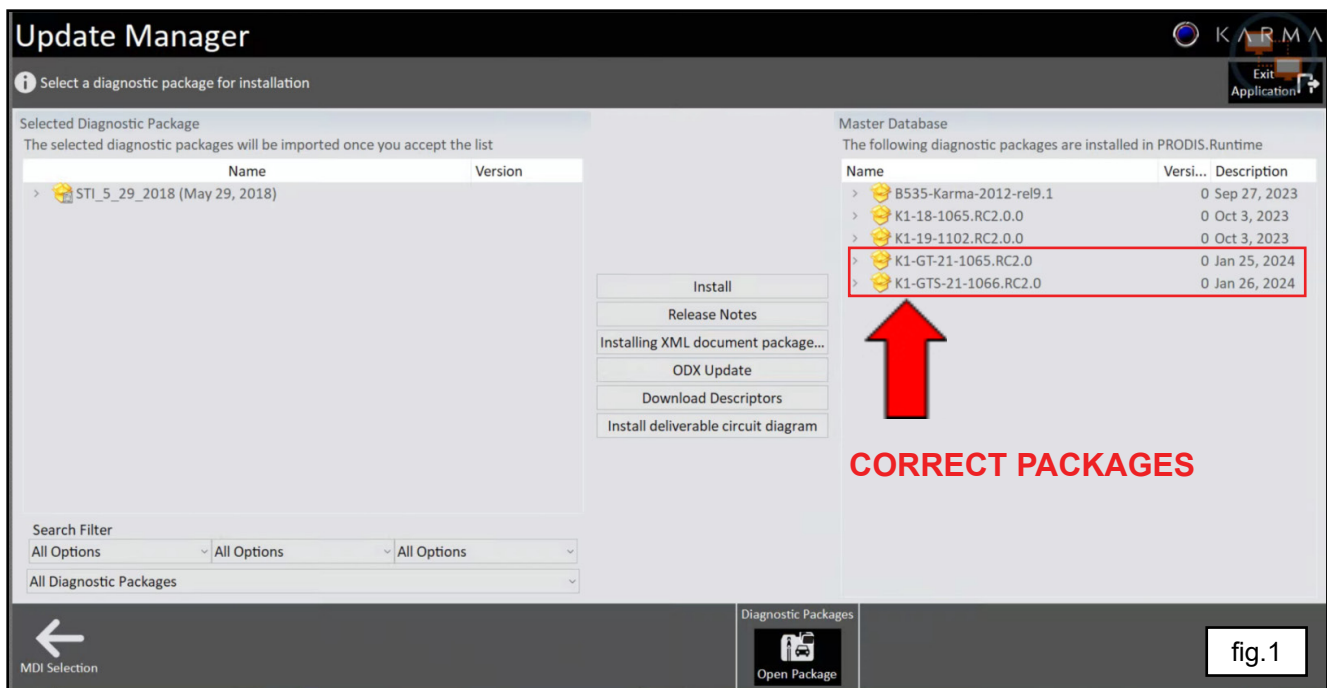
Verify the package is installed successfully into Karma Sync by verifying that “K1-GT-1065.RC2” is displayed in the Update Manager (fig.1).

Recall the GTS or GS-6s , or “Sport” variants will need “K1-GTS-21-1066.RC2” package.

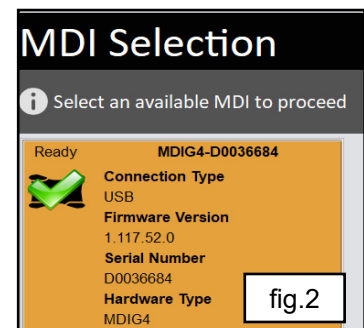
MDI software is at firmware level should display 1.117.52.0 as seen below (fig.2).

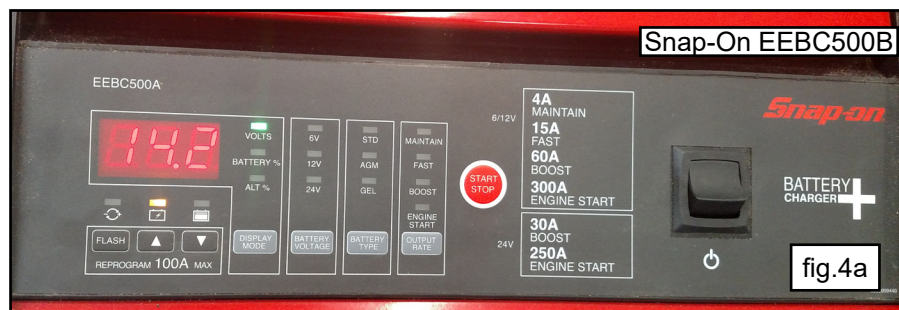
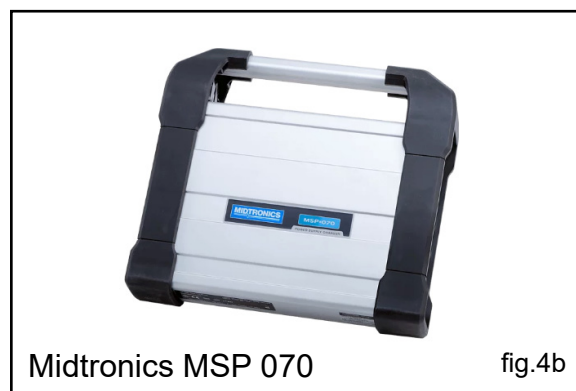
Below are examples of a suitable and recommended power supplies (Snap-on part number EEBC500B in fig.4a and Midtronics MSP 070 fig.4b). Place either at the lowest amperage/ “maintain” setting, for use during baseline updates. This action will maintain the 12V battery at a suitable level for this process.

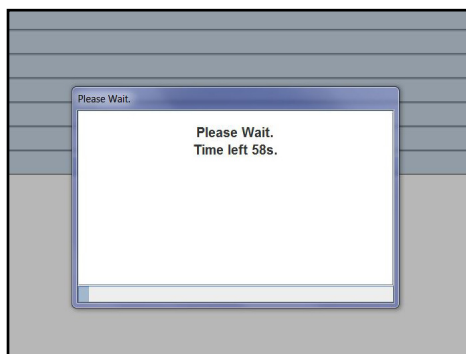
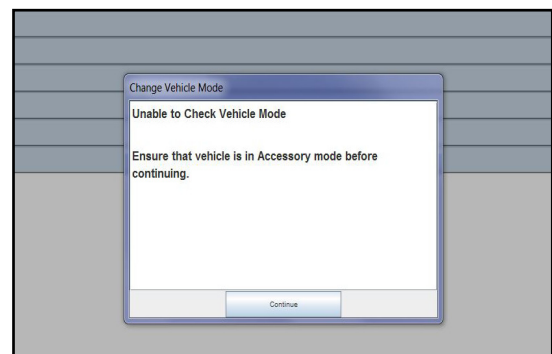
As instructed place vehicle in the requested mode (fig.9a). Do not walk away from the vehicle, as you will be prompted to switch modes.

Follow the prompts and place the vehicle into Accessory or Ready mode (fig.19b). It is normal for the vehicle to appear to be ‘stuck on’ during this step of the programming. Follow the prompts and do as directed (fig 9a,9b,9c,9d).

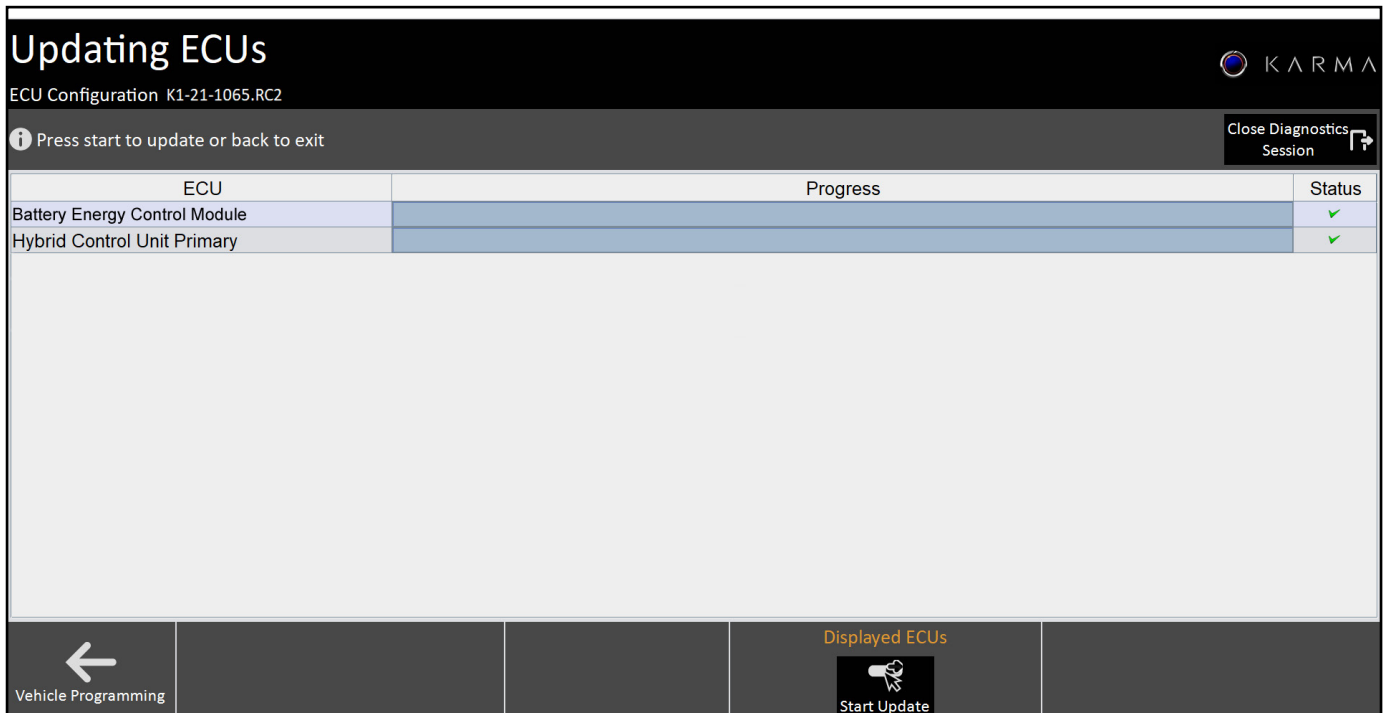
fig.10

When complete the green checks should appear (fig. 10).

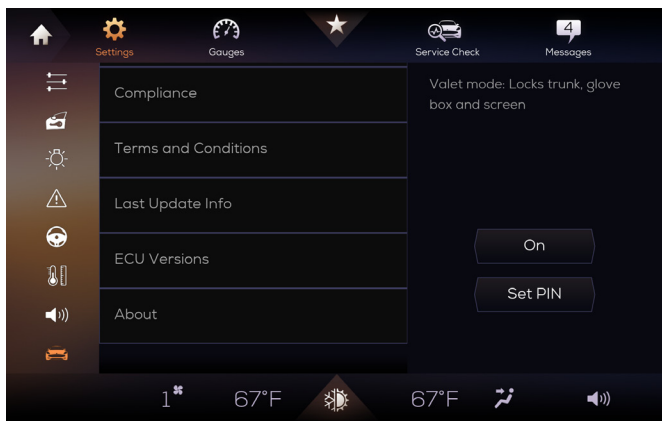
The CIU images below should guide you to view the level the vehicle is currently loaded and installed.

Settings > Vehicle > About	Displayed Version
BL 1050 (and 1051)	21.31.30.2
BL 1060 (and 1061)	21.32.40.2
BL 1065 (and 1066)	21.32.43.2 or 21.32.43.3

If it reads 21.32.43.2 or 21.32.43.3 do not proceed, this vehicle is updated to BL1065/1066.

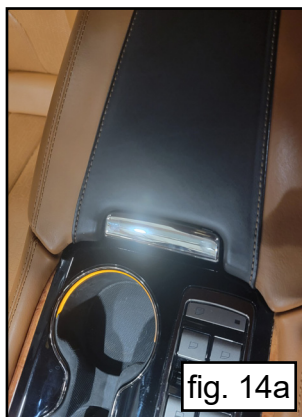
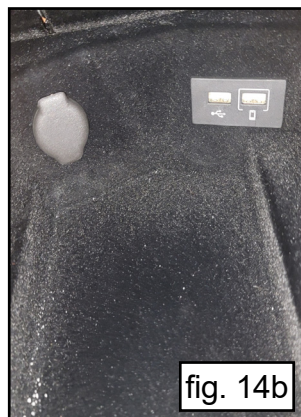
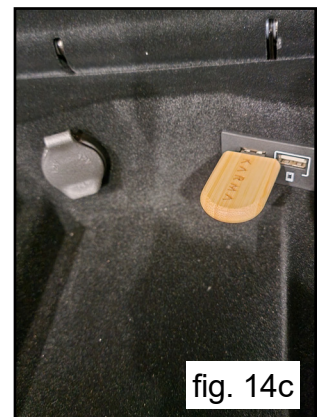
To perform the infotainment update insert the supplied USB drive (fig. 13) into the center console (fig. 14a and fig. 14.b) USB PORT as shown (fig.14c). This will begin the files upload. A message will appear on the TPI: “Please wait while update is extracted.”

Central Infotainment Unit flashing will occur with a USB thumb drive. **TSS is required to be notified prior** to this step. TSS will instruct you to place the vehicle in Ready Mode: the update packet is downloaded to the vehicle – the download requires only the USB to be installed in the center console as shown (below fig 14a). Leave the vehicle in a secure and safe location in your work area for approximately sixty (60) minutes maximum.

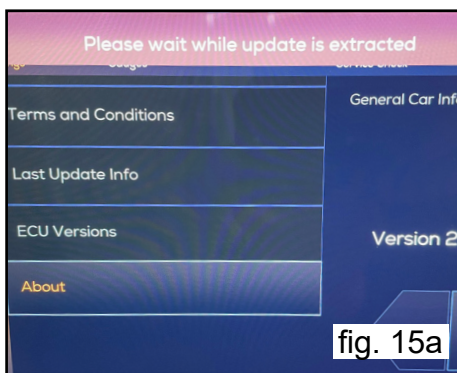
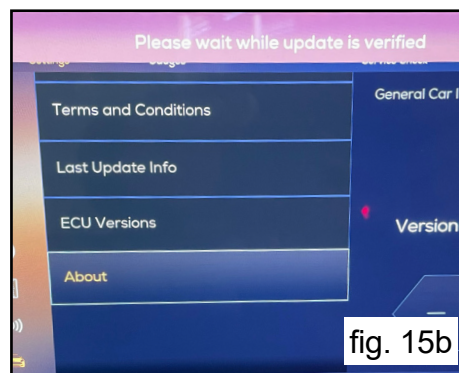
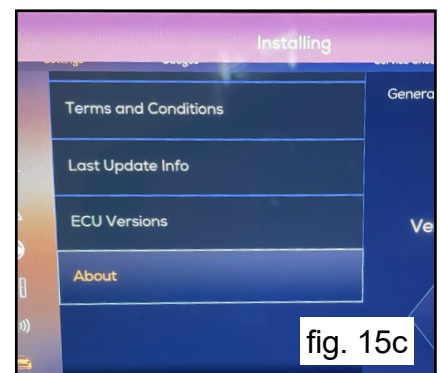
It will then verify and install (fig. 15a,15b,15c). This should take about 10 to 15 minutes.

Remove the USB stick when the TPI displays the “...update is verified” (fig. 15b). Install will follow automatically (fig. 15c).

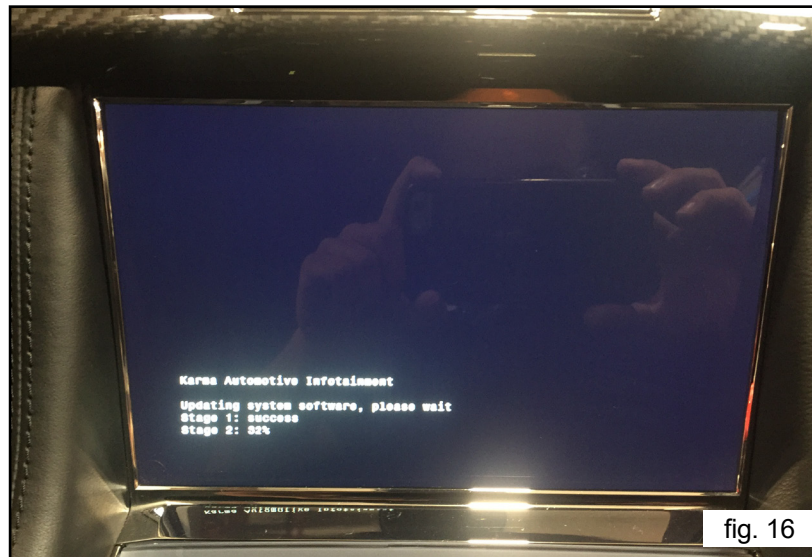
Below are the screens of the TPI read out as the CIU is updating (fig.16) When the update is complete, the screen may go blank or black or cycle on and off, normal function will resume upon cycling the Start/Stop button.
