Subject: Software Update on GM Ultium Vehicles (2024 Blazer EV - Customer Vehicles ONLY)

This EI has been revised to update steps 1-22. Please discard PIE0775A.

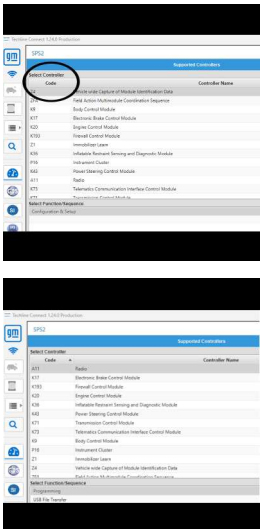
Important: Under “Select Controller” click the “Code” tab to reorder the controller list. A11 Radio should be first. This has to be done after every module is programmed to keep track of the modules being programming.

Important: Techline Connect screens shown above.
