# Service Bulletin

Bulletin No.: 24-NA-044

**Subject: U170 Radio Software Update**

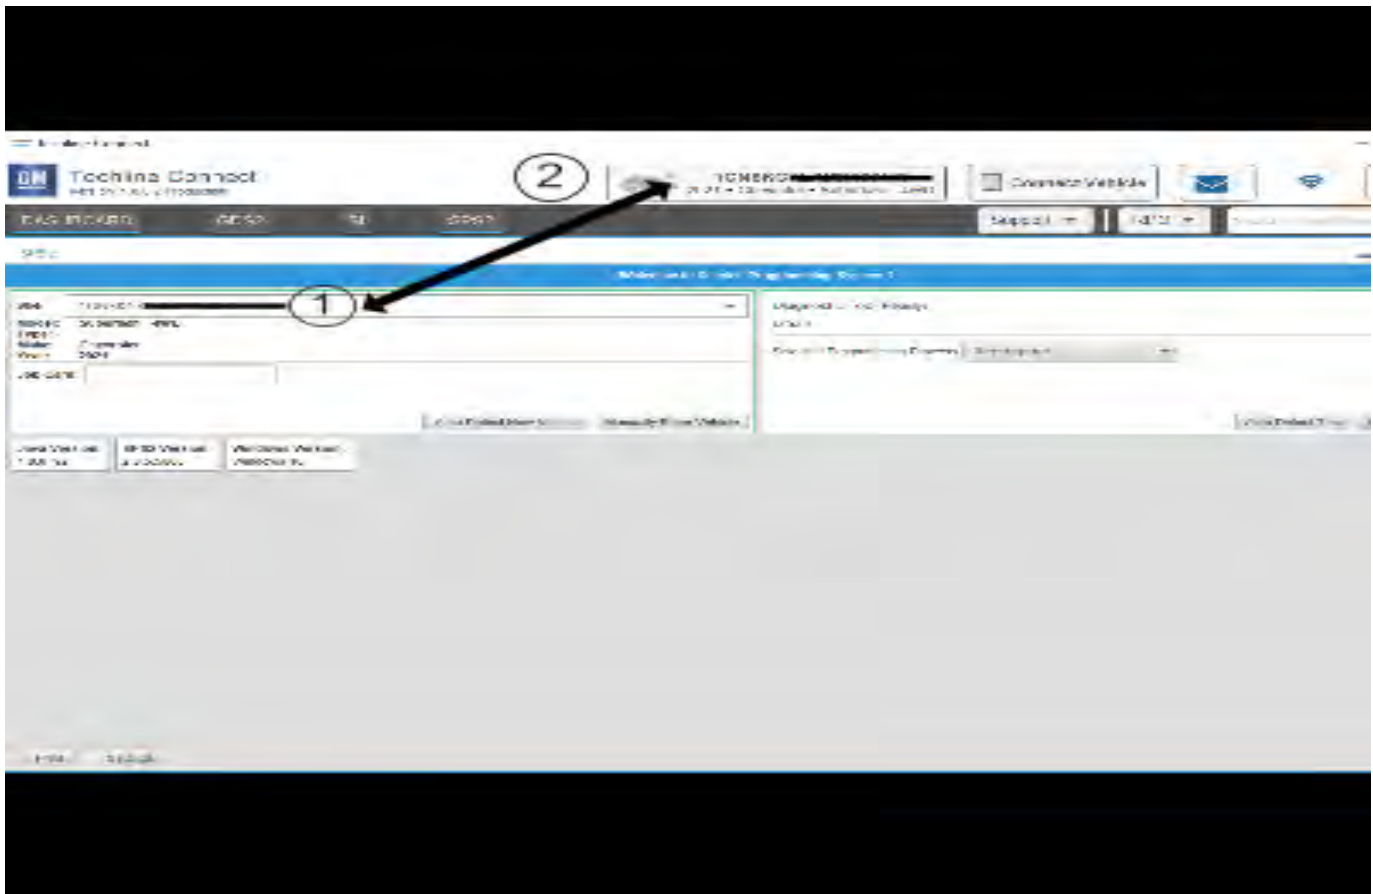
5743643

**Caution:** Be sure the VIN selected in the drop down menu (1) is the same as the vehicle connected (2) before beginning programming.

**Important:** Techline Connect screens shown above.
