Subject: N232432430 - Service Update  
Hybrid/EV Powertrain Control Module 2

Models: 2020 – 2022 Chevrolet Bolt EV  
2022 Chevrolet Bolt EUV

# Service Update

## N232432430 Hybrid/EV Powertrain Control Module 2

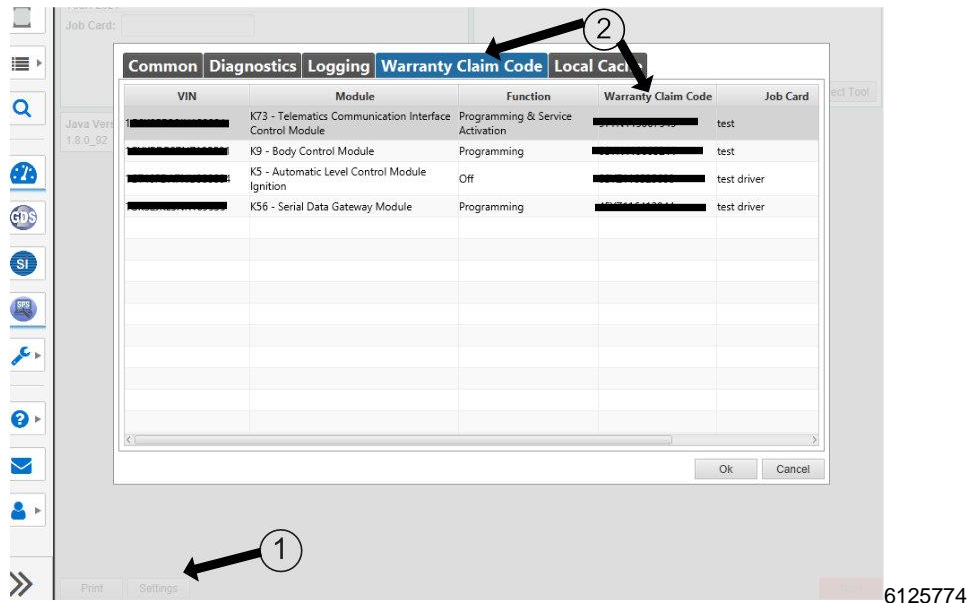
If the Warranty Claim Code was not recorded on the Job Card, the code can be retrieved in the SPS2 system as follows:

1. Open TLC on the computer used to program the vehicle.
2. Select and start SPS2.
3. Select Settings (1).
4. Select the Warranty Claim Code tab (2).

The VIN, Warranty Claim Code and Date/Time will be listed on a roster of recent programming events. If the code is retrievable, dealers should resubmit the transaction making sure to include the code in the SPS Warranty Claim Code field.

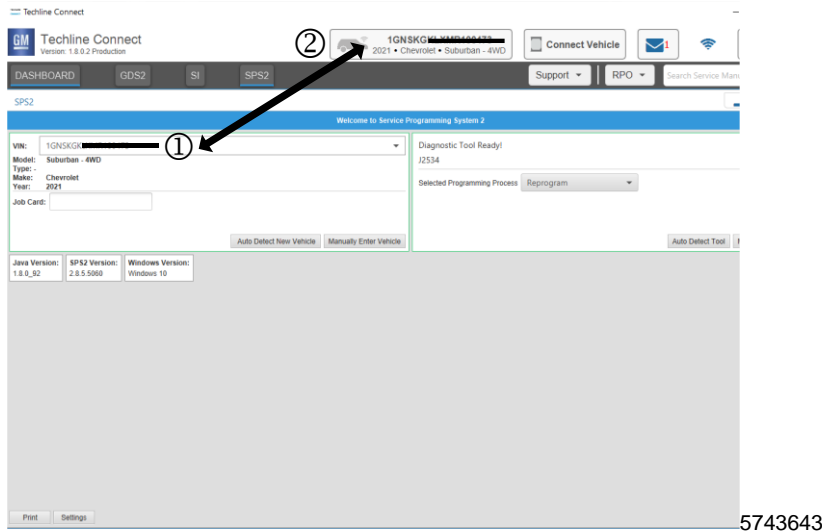
**Caution:** Be sure the VIN selected in the drop down menu (1) is the same as the vehicle connected (2) before beginning programming.

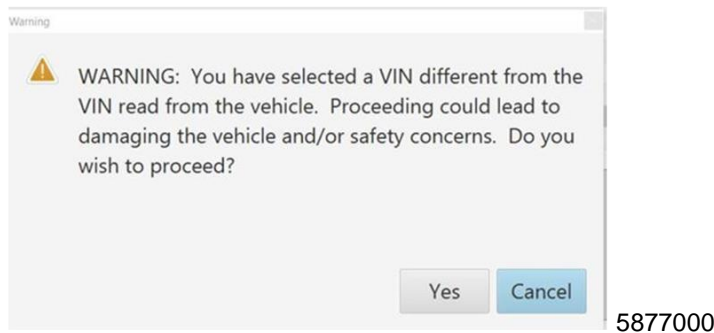
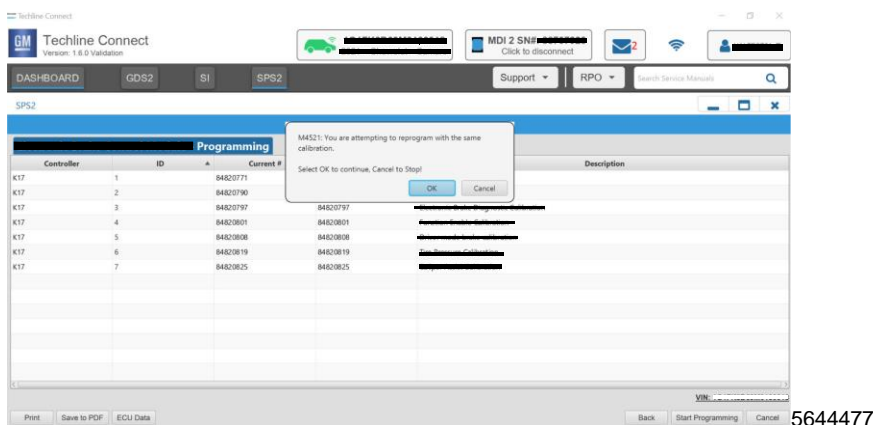
**Important:** If the vehicle VIN DOES NOT match, the message below will be shown.

**Important:** Techline Connect screens shown above.

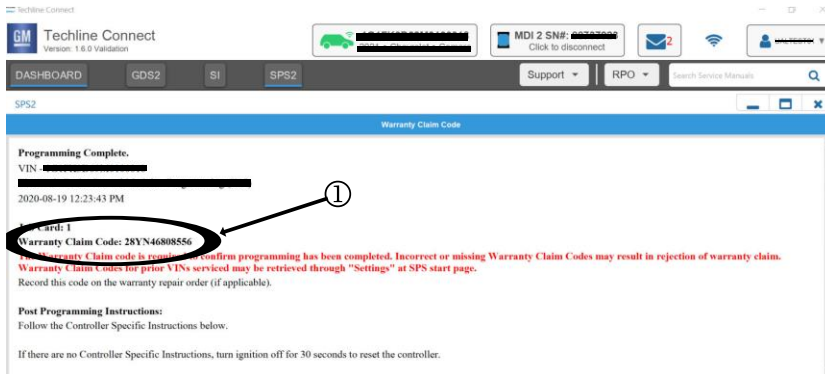
5644478

**Note:** The screenshot above is an example of module programming and may not be indicative of the specific module that is being programmed. Module selection and VIN information have been blacked out.
