GROUP	MODEL
ELE	2023-2024MY Telluride (ON)
NUMBER	DATE
328	March 2024

TECHNICAL SERVICE BULLETIN

CLUSTER SOFTWARE LOGIC IMPROVEMENT FOR LOWER THAN ACTUAL FUEL LEVEL INDICATION

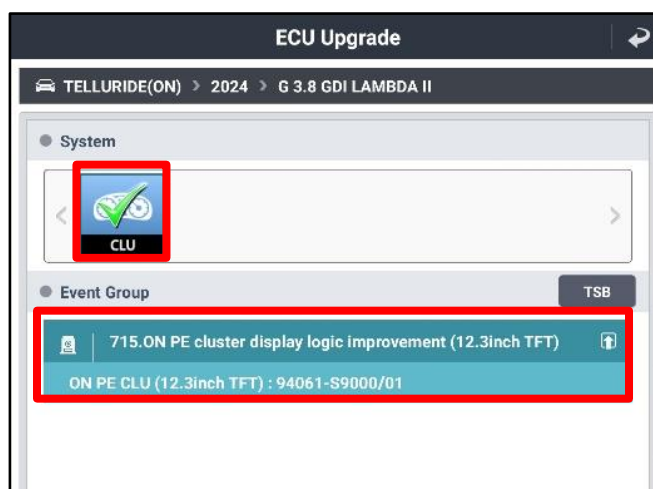
Prior to performing the ECU upgrade, be sure to check that the KDS is fully charged.
