GROUP	MODEL
FUE	2022-2024MY Carnival (KA4)
NUMBER	DATE
062 (Rev 1, 03/22/2024)	December 2022

TECHNICAL SERVICE BULLETIN

SERVICE ACTION: ECM LOGIC UPDATE FOR DTC P2118 AND THROTTLE BODY FREEZING (SA514)

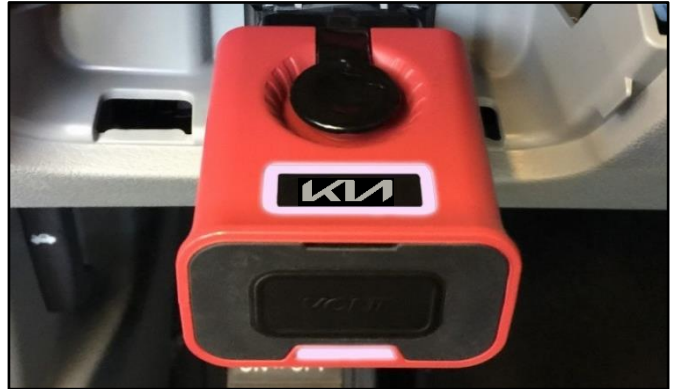
1. Connect the VCI-II to the OBD-II connector, located under the driver's side of the instrument panel.

NOTICE
The ECU upgrade function on KDS operates wirelessly. It is not necessary to perform the upgrade via USB cable.

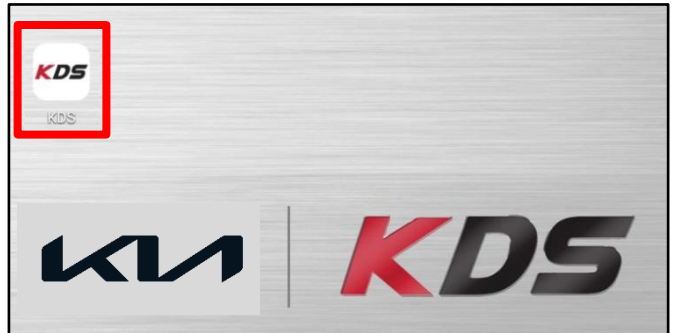
2. With the ignition ON, turn ON the KDS tablet. Select 'KDS' from the home screen.

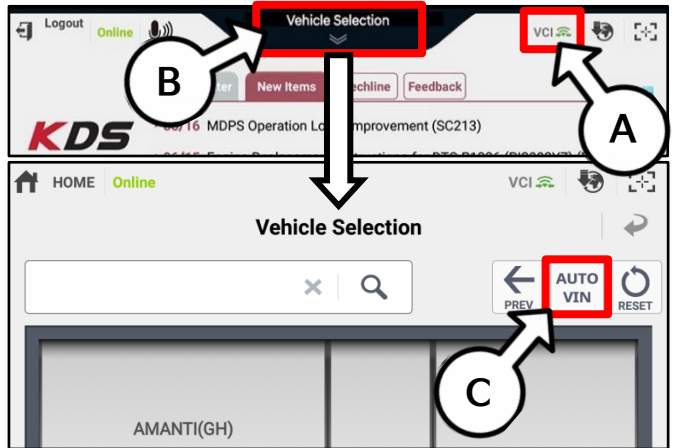
3. Confirm communication with VCI (A) and then configure the vehicle (B) using the 'AUTO VIN' (C) feature.

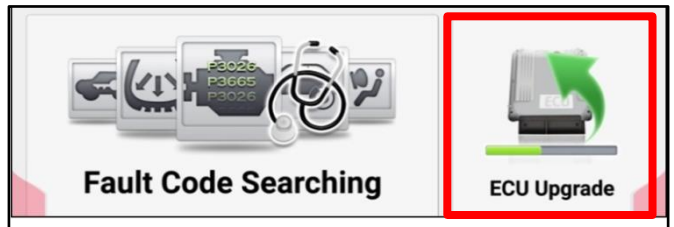
4. Select 'ECU Upgrade'.

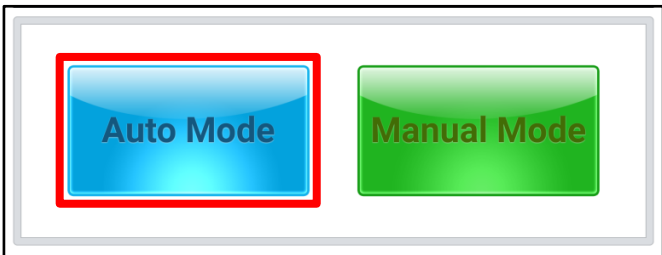
- Select Auto Mode.

CAUTION
Do NOT attempt to perform a Manual Mode upgrade UNLESS Auto Mode fails. Always follow the instructions given on the KDS in either Auto or Manual mode.

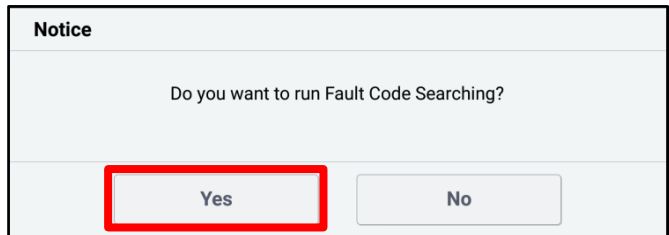
- When prompted, select 'YES' to check for Diagnostic Trouble Codes (DTC) and erase any DTCs stored such as EPS, ESC, and TPMS that may have been set during the upgrade.
