Service Bulletin

Bulletin No.: 24-NA-053

Subject: False Automatic Emergency Braking (AEB) Events

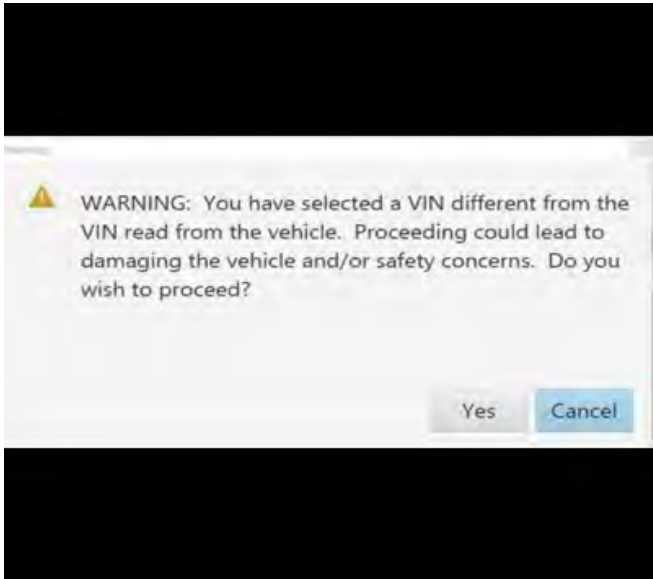
5877000

Important: If the vehicle VIN DOES NOT match, the message below will be shown
