# Service Bulletin

Bulletin No.: 24-NA-056

**Subject: Radio Software Version W27E-172.5.1-M169-SQBR4-126.4**

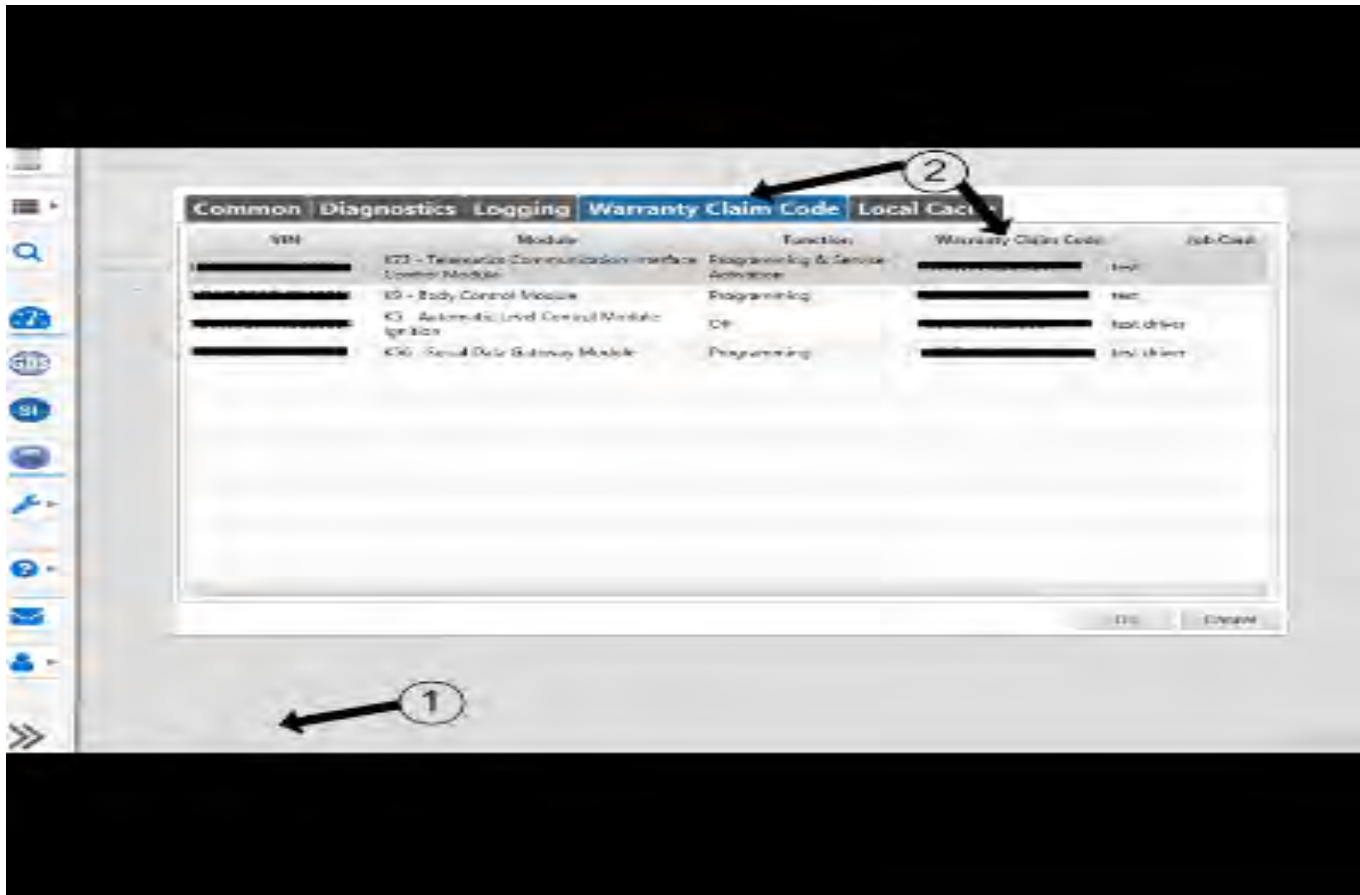
6125774

Warranty Claim Code Information Retrieval

If the Warranty Claim Code was not recorded on the Job Card, the code can be retrieved in the SPS2 system as follows:

The VIN, Warranty Claim Code and Date/Time will be listed on a roster of recent programming events. If the code is retrievable, dealers should resubmit the transaction making sure to include the code in the SPS Warranty Claim Code field.
