CONNECTED VEHICLE SYMPTOM TROUBLESHOOTING

Service Alert No.: SA-017/24

Last Issued : 03/14/2024

2019-2024 Mazda3	2021-2023 CX-9	2024 CX-90
2020-2024 CX-30	2022-2023 MX-30	2024 MX-5
2021-2024 CX-5	2023-2024 CX-50	2025 CX-70

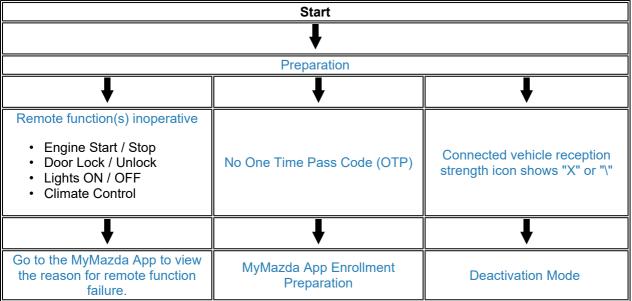
Repair Flowchart

↓	↓	↓
Check Campaign Status	Enrollment	Check Campaign Status
↓	↓	↓
Remote Function Troubleshooting	OTP Troubleshooting	Customer deactivate Connected Services (Opt-Out)
		No reception

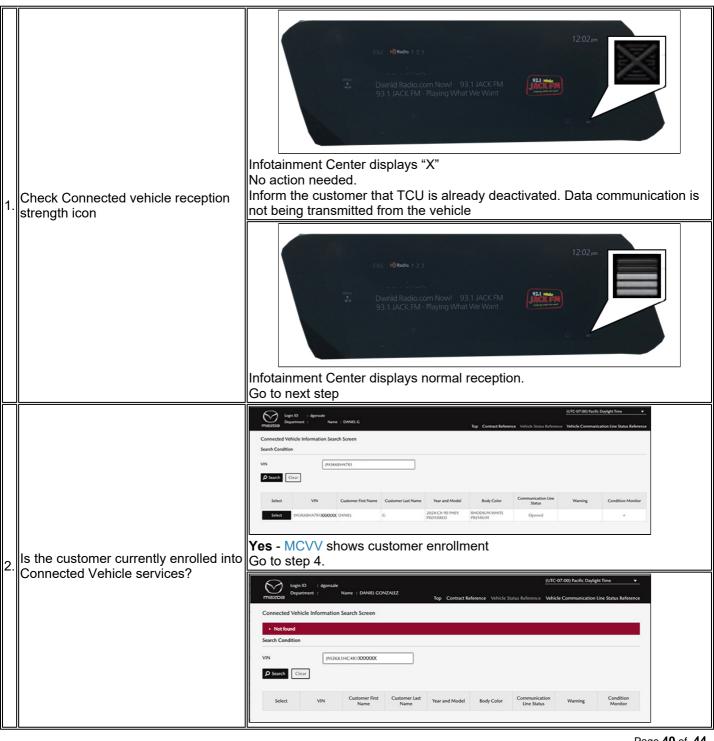
Customer Opt-Out

Some customers may request to stop data communication from their vehicle. Use this procedure to manually deactivate the TCU.
