Authored Date	20/03/2024	
Doc No.	IAMW0003002v2	
Title	Software Update for Vehicles fitted with TRM – US MY24 only	
Affected Vehicle(s)	Grenadier	RF004651 - RF015987
Prior to starting any reworks, please make sure you check the vehicle is affected by checking the VIN using Vehicle Simple Search in the Warranty System.

Software Update for Vehicles fitted with TRM

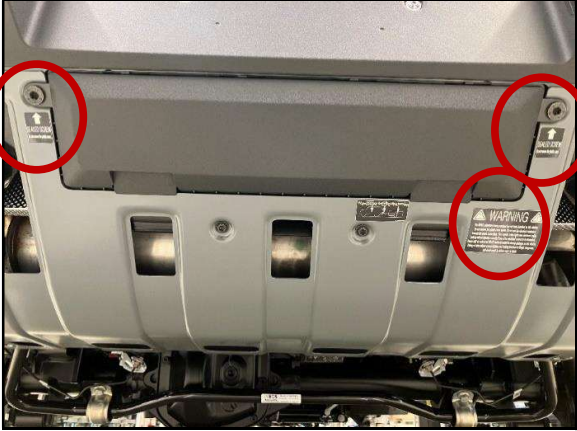
<ul style="list-style-type: none"> - Remove the 3 Warning Labels on the Skid Plate - Using a suitable cleaner, remove any residue from the Skid Plate.
<p>3</p>

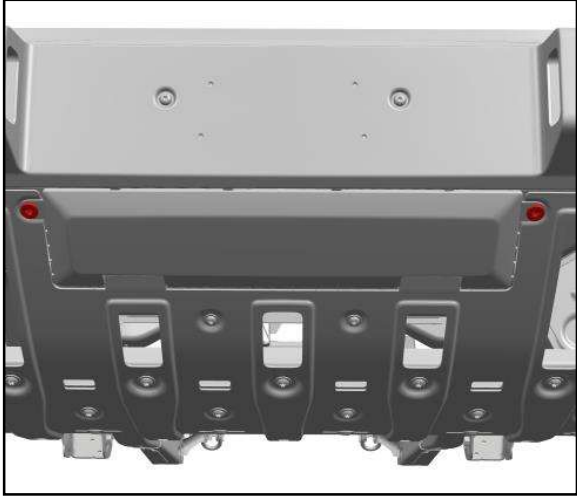
<ul style="list-style-type: none"> - Remove the 2 Towing Hitch Cover screws. - Remove the Towing Hitch Cover.

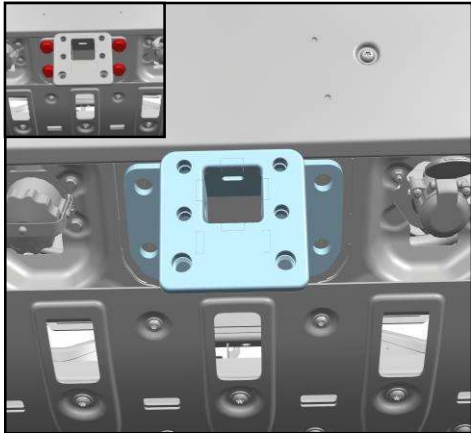
<ul style="list-style-type: none"> - Install the Towing Adaptor Plate - Install and tighten the 4 bolts. <p>Torque: 250Nm</p>
<p>5</p>

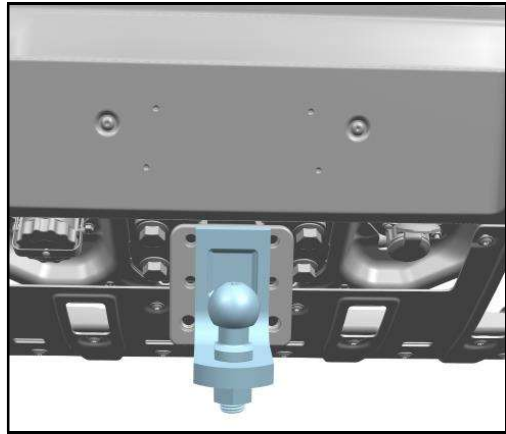
<p>Install the Tow Ball.</p>
<p>6</p>

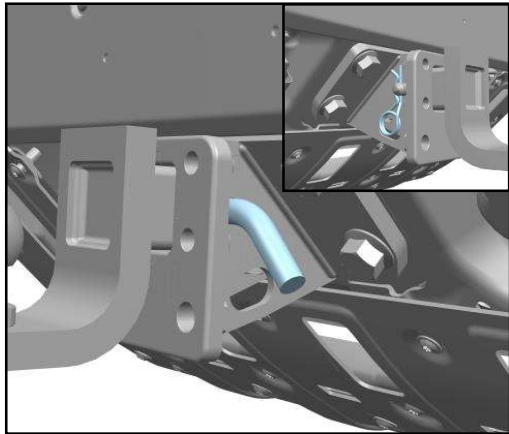
<ul style="list-style-type: none"> - Install the Tow Ball Pin. - Install the R-Clip to the Tow Ball Pin.

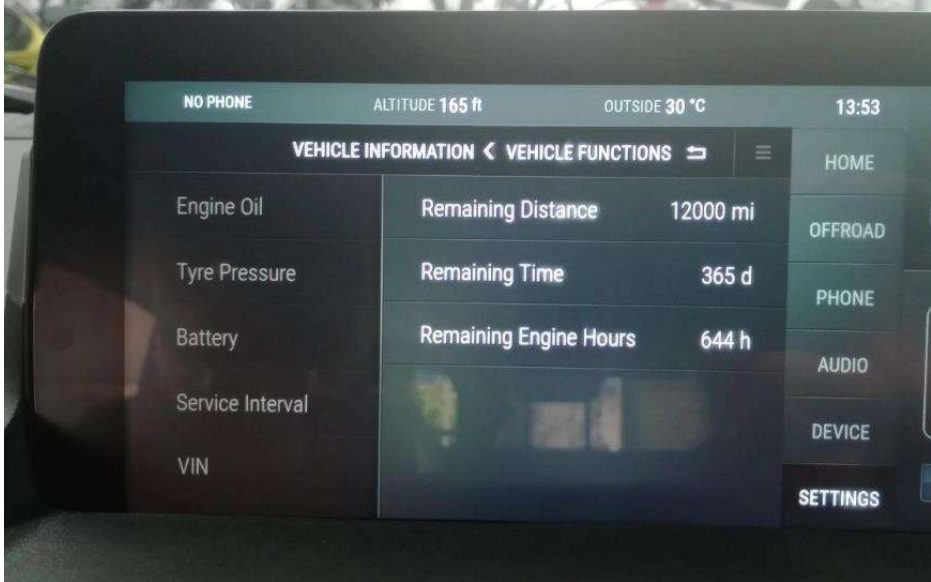
Before the Head Unit is flashed. Write down the Service interval information.

- Distance (miles /kilometres)
- Date
- Engine running time

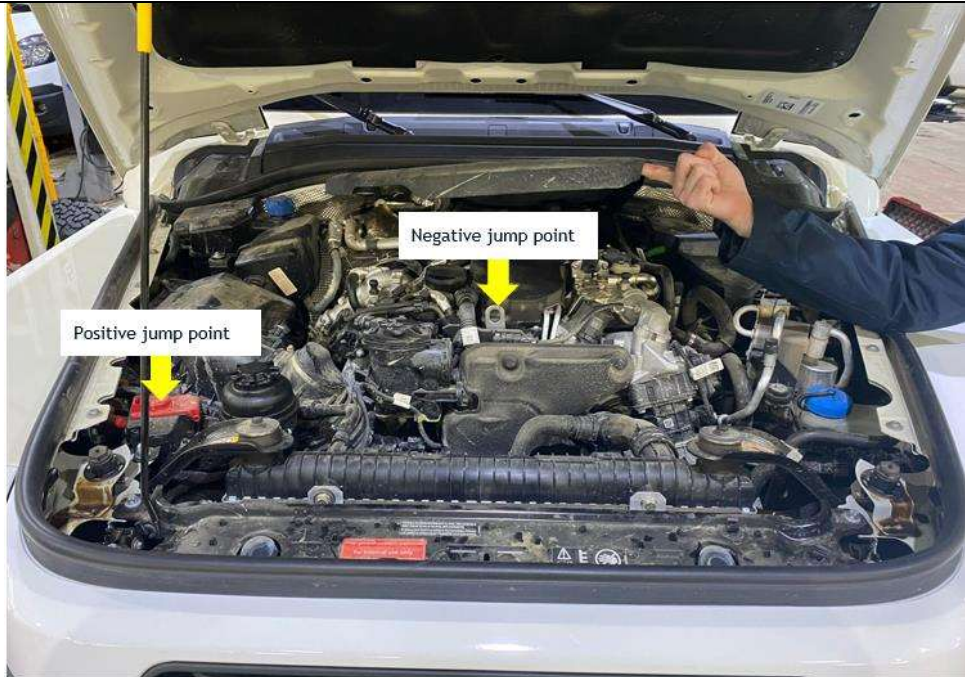
Positive jump point

Negative jump point

Place the vehicle on charge. Ensuring the battery charger can output up to 40 amps to support the vehicle power supply during the process.

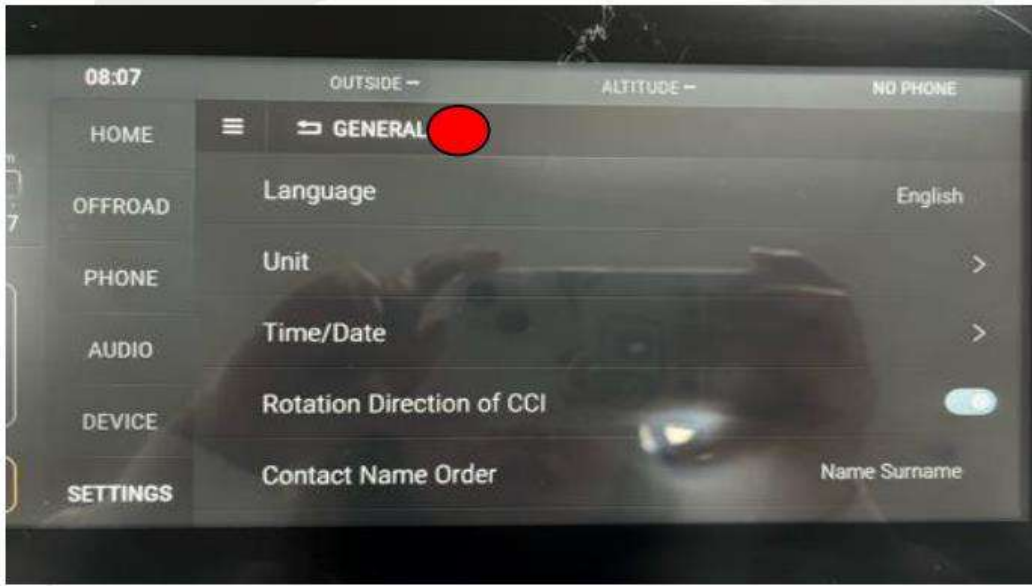
<p>5</p>	<p>Head unit (HU) Hidden Menu Access. On the central display select 'SETTINGS - GENERAL'. On the touchscreen, press and hold the area to the right of the 'GENERAL' title for approximately 8 seconds. A screen will appear for PIN input.</p>

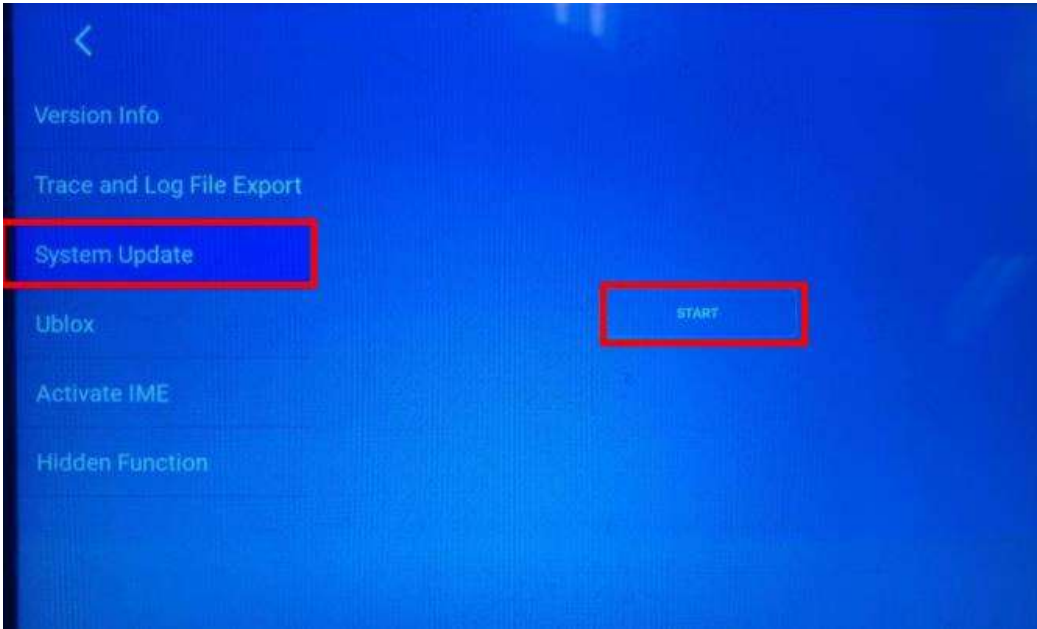
<p>6</p>	<p>Note: the last 2 digits will not change the display 'dots' as there are only 6</p> <p>On the PIN screen, input the PIN number: 46367308</p>
<p>7</p>	<p>On the left side select 'System Update' and then select 'Start'</p>

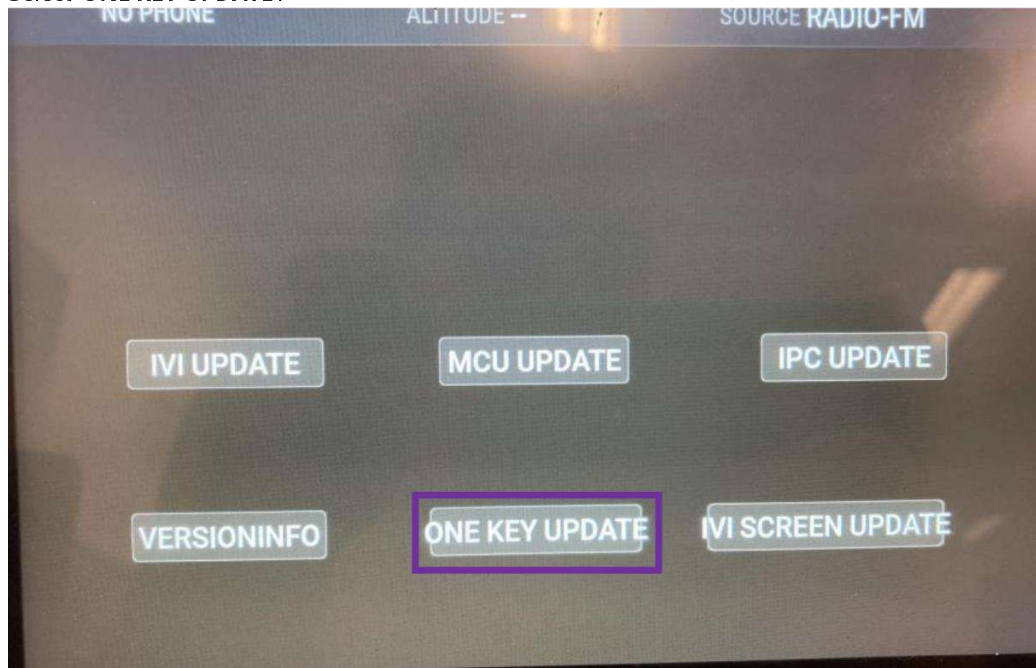
Note: The ONE KEY UPDATE will flash all applications of the Head unit (i.e., IVI UPDATE / MCU UPDATE / IPC UPDATE / IVI SCREEN UPDATE)

Select 'ONE KEY UPDATE'.

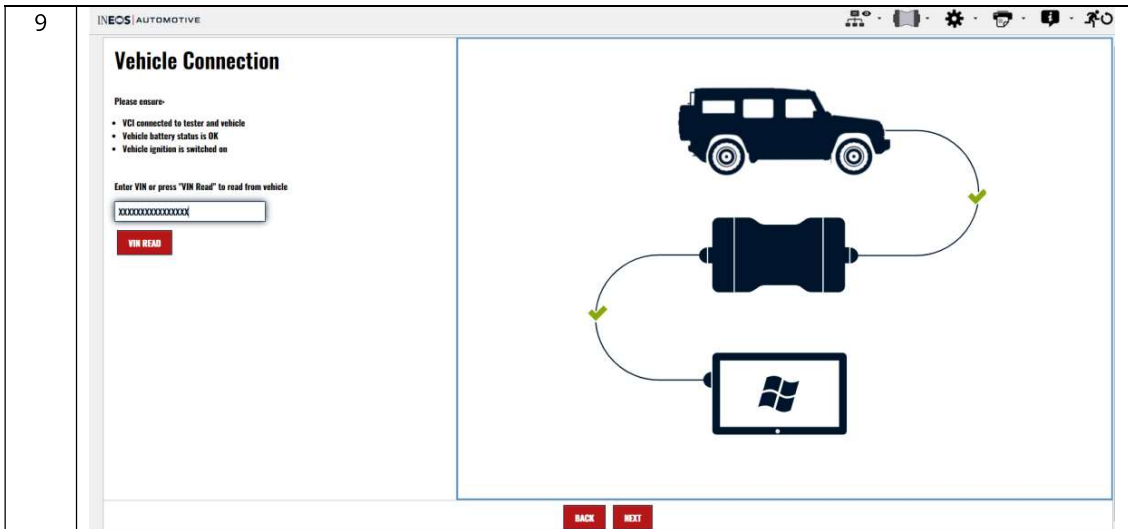
Connect the vehicle to Grade-X using the VCI connected to the OBD port in the driver's footwell.

Select **'VIN READ'**.

Select **'NEXT'**.

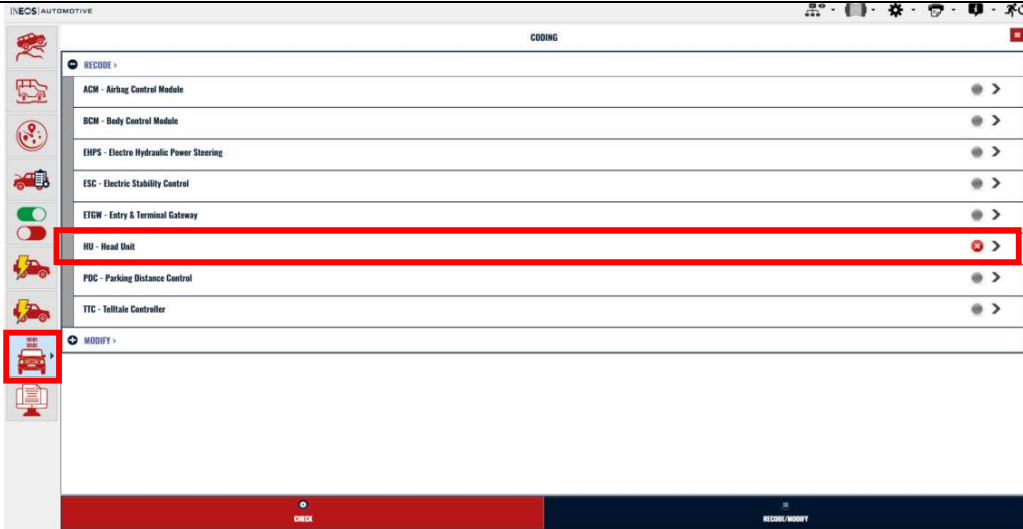
<p>Select the coding tab.</p> <p>Select 'HU -Head Unit'</p>
<p>12</p>

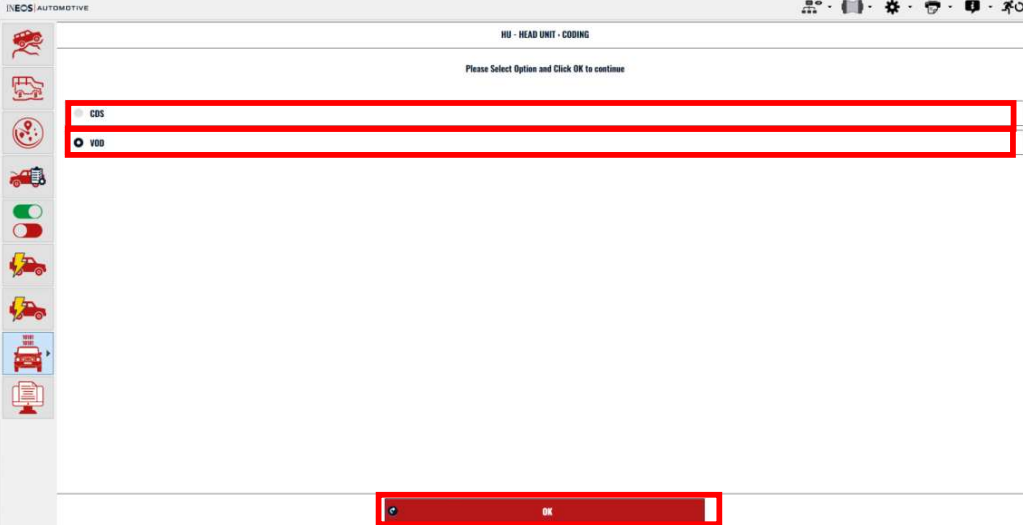
<p>Select 'CDS', select 'OK'. Code the CDS to the Head unit with Grade-X. Select 'VOD', select 'OK'. Code the VOD to the Head unit with Grade-X.</p>

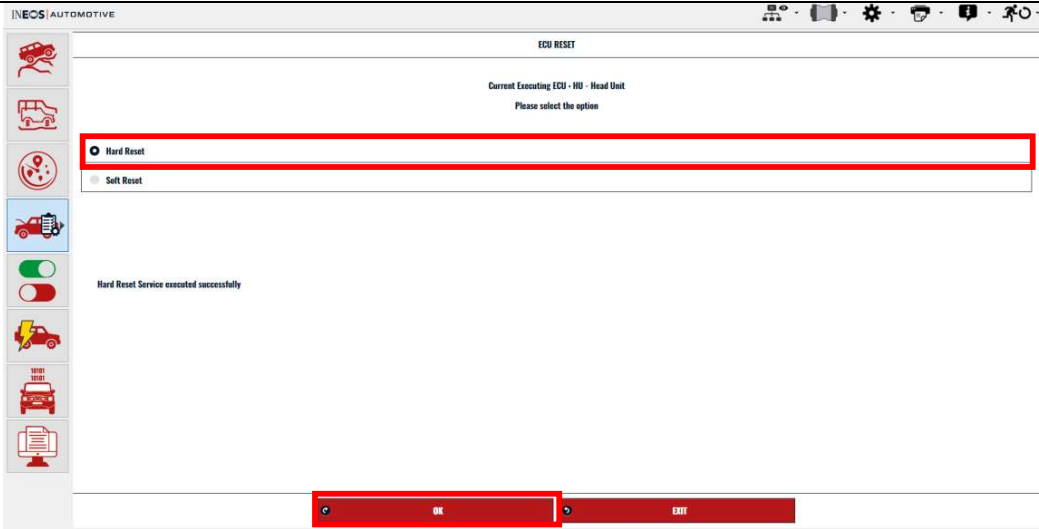
Click **'Hard Reset'**
Click **'OK'**

NOTE: The head unit will reboot. This will take a few minutes. Allow the head unit to complete the reboot process.

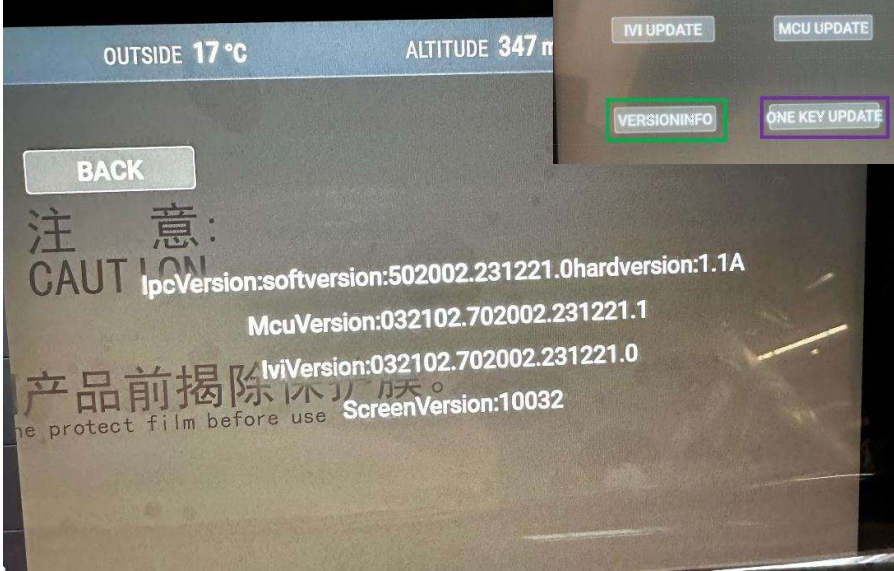
<p>16</p>	<p>Complete a full and comprehensive check on the head unit functionality to ensure there is no operational concerns. Ensuring the Head Unit (HU) is functioning as intended, and the software aligns, the Head Unit (HU) Flash has been successful.</p> <p>Select 'VERSIONINFO' and check that all 3 dates are exactly the same.</p> <p>To identify the dates, the information is written in the below format (Image shown for illustration purposes)</p> <p>IpcVersion:Softversion: XXXXXX.YMMDD.0hardversion:1.1A McuVersion: XXXXXX.XXXXXX.YMMDD.X IviVersion: XXXXXX.XXXXXX.YMMDD.X</p>

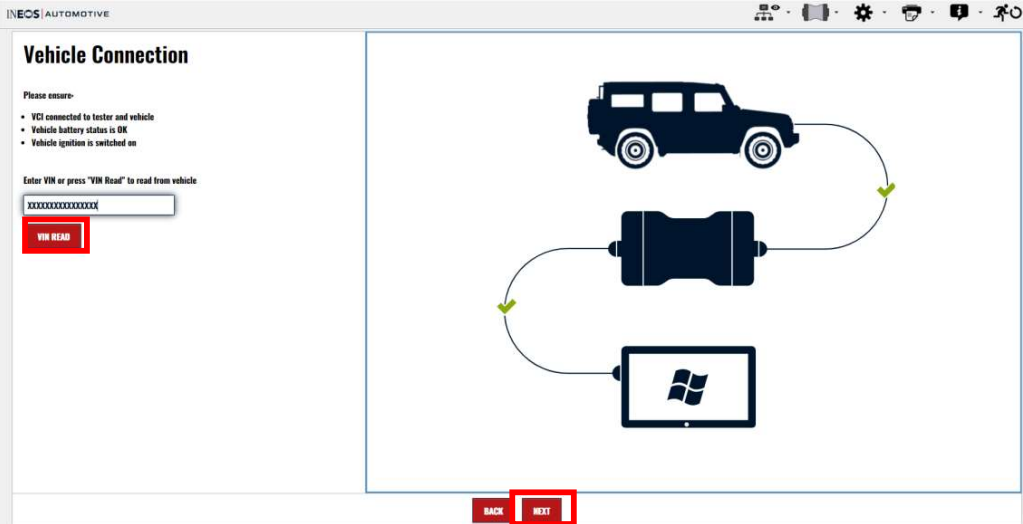
Note: Ensure the connection is **NOT** in simulation
 Connect the vehicle to Grade-X using the VCI connected to the OBD port in the driver's footwell.

- Select **'VIN READ'**, check the VIN is correct to the vehicle.
- Select **'NEXT'**, Grade-X will read the vehicle data.

Within the 'Vehicle Summary' check all installed ECUs have an open communication displaying a green tick.

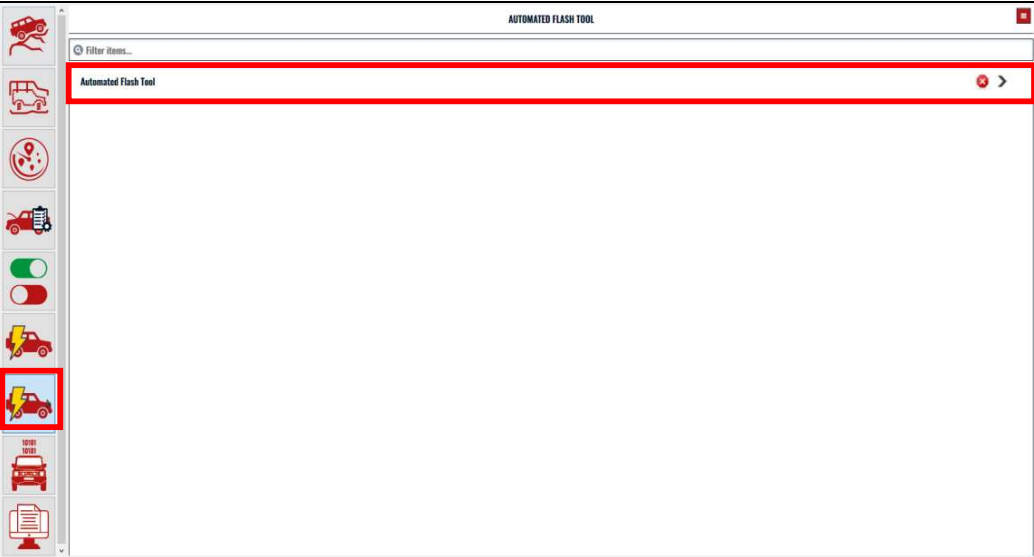
Select 'Automated Flash Tool' tab.

Select 'Automated Flash Tool' action.

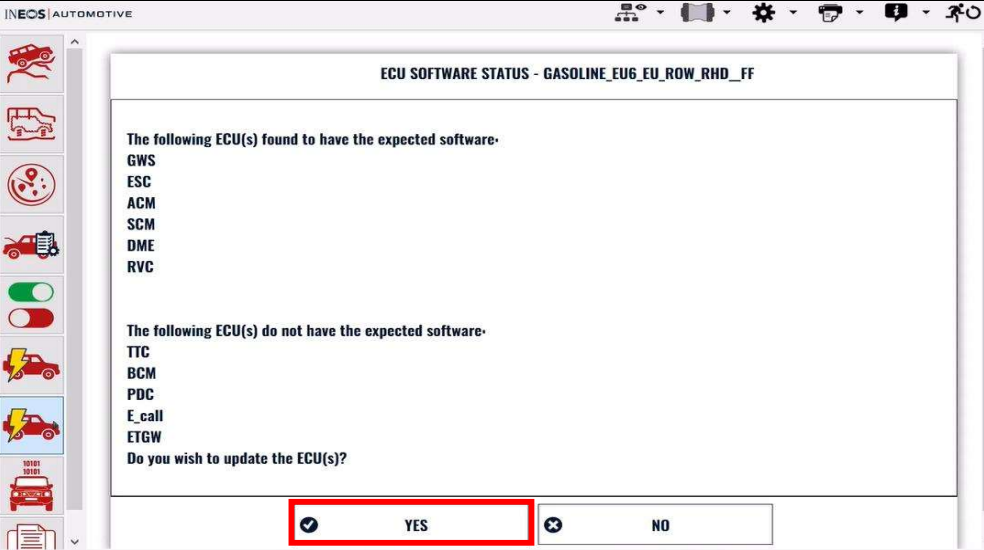
Note: There should be a list of ECUs requiring update that include **TRM**. If the ECUs are not displayed, the software of the ECU is up to date.

Grade-X Automated Flash will assess the ECU software part numbers of the ECUs, displaying the ECUs requiring a software update.

Select 'YES' to update the ECUs software to the latest level.

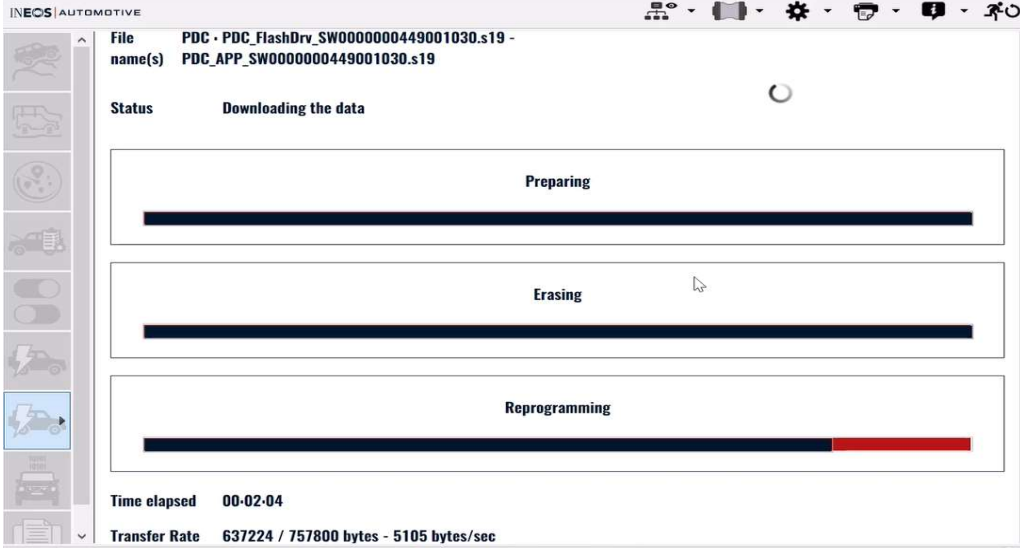
Note: The right engine cooling fan will activate during the update of many ECUs. During the ETGW update, the fan will not activate.

Allow Grade-X to update all ECUs until the update is completed.

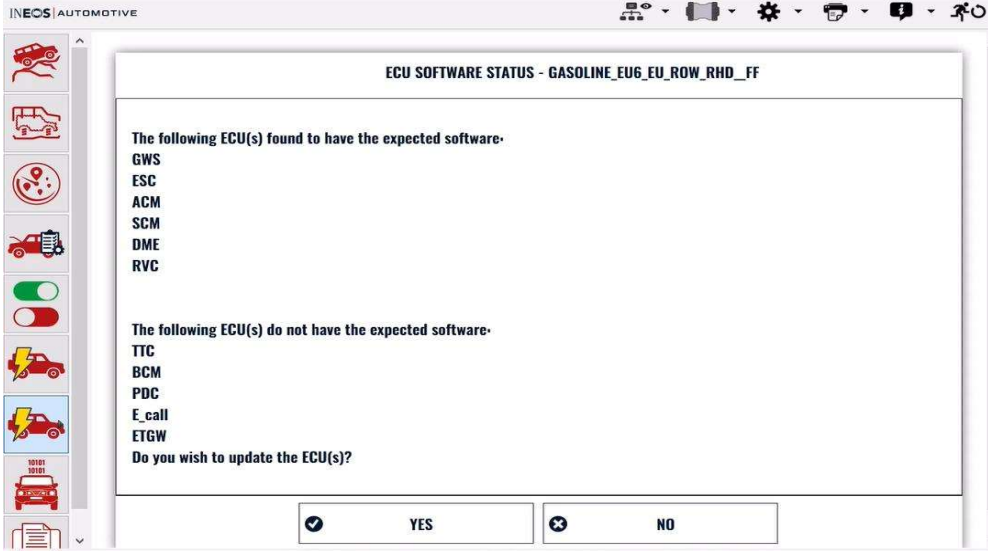
If the flash fails due to the following reason, carry out the check, and attempt the update again:

- Checksum error
- Pre-conditions failed – check preconditions in step 1.
