# Service Bulletin

Bulletin No.: 22-NA-258

**Subject:** No Reverse When Temperatures Fall to -25°C (-13°F) or Colder, Malfunction Indicator Lamp (MIL) Illuminated - DTC P2732, P0776 and/or P18A1 Set

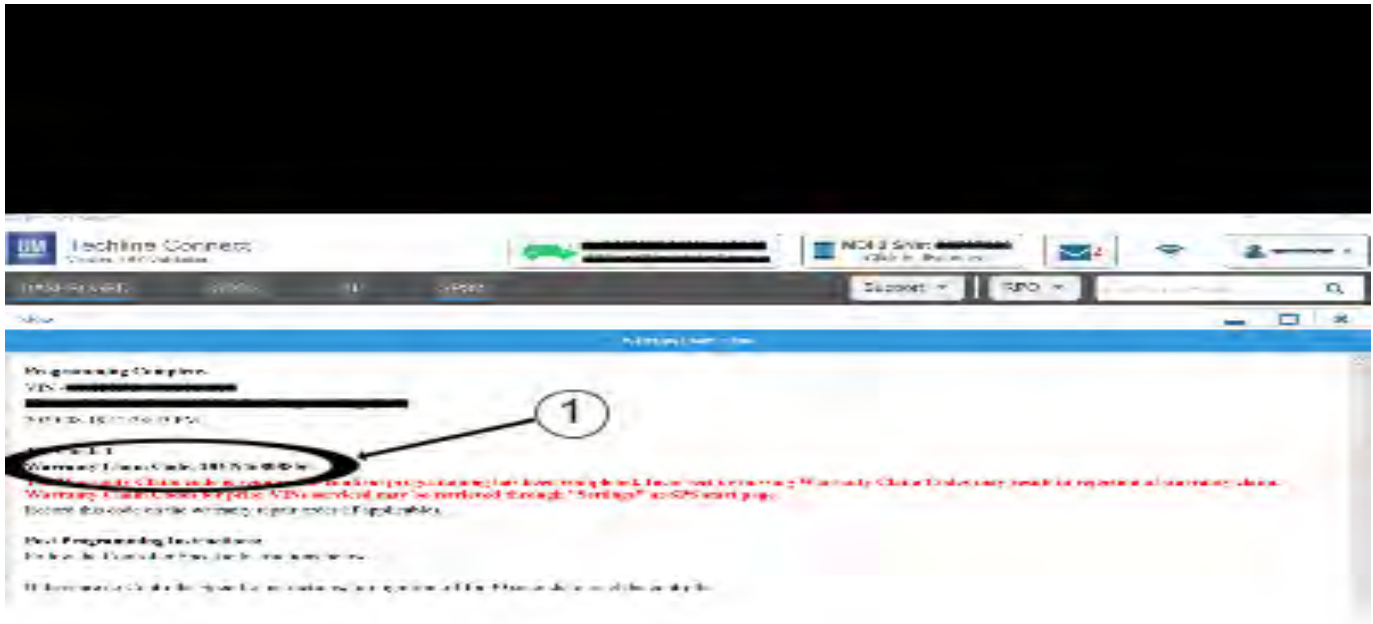
5644478

**Note:** The screenshot above is an example of module programming and may not be indicative of the specific module that is being programmed. Module selection and VIN information have been blacked out.

**Important:** To avoid warranty transaction rejections, you MUST record the warranty claim code provided on the Warranty Claim Code (WCC) screen shown above on the job card. Refer to callout 1 above for the location of the WCC on the screen.

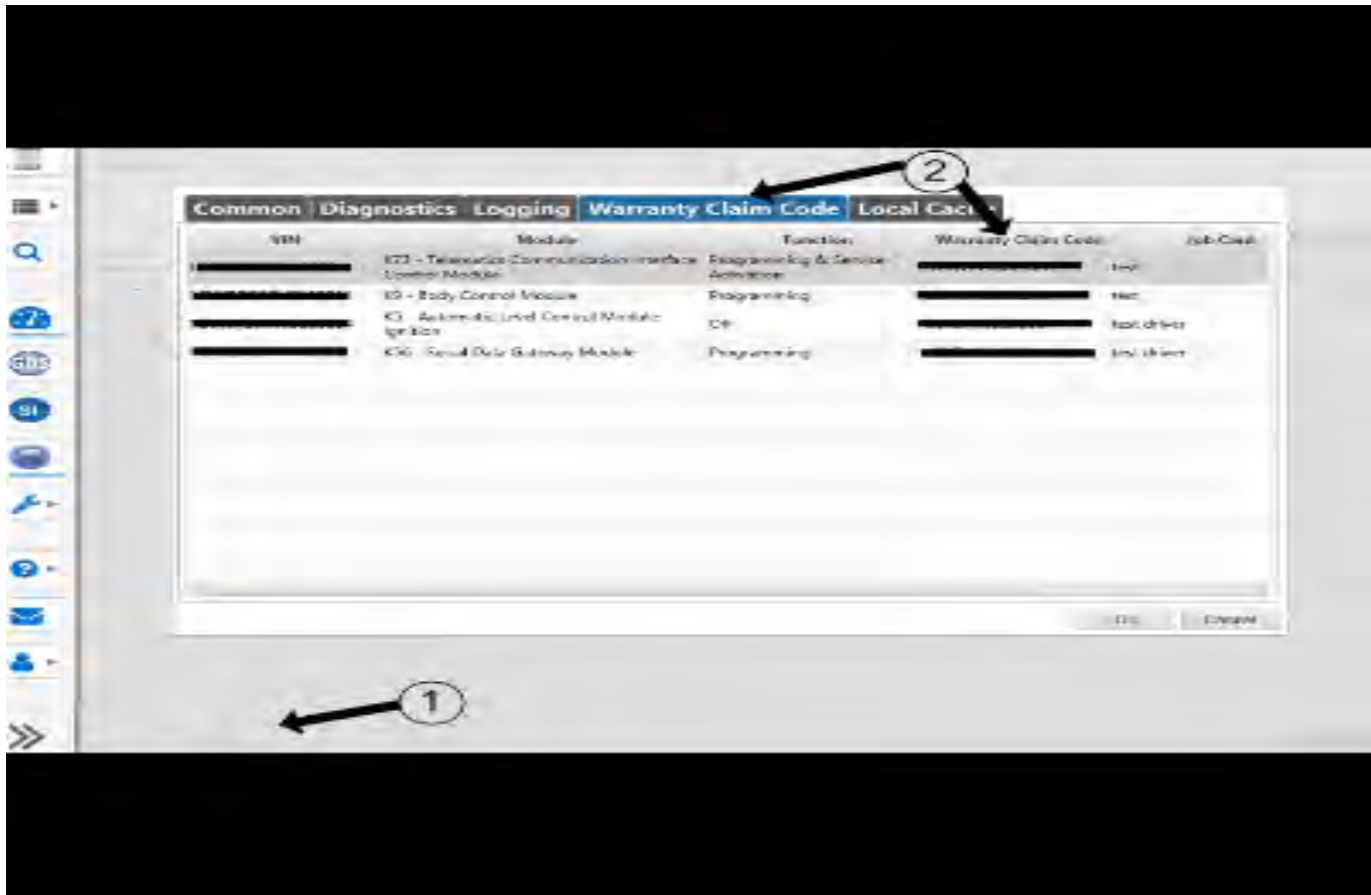
6125774

If the Warranty Claim Code was not recorded on the Job Card, the code can be retrieved in the SPS2 system as follows:

The VIN, Warranty Claim Code and Date/Time will be listed on a roster of recent programming events. If the code is retrievable, dealers should resubmit the transaction making sure to include the code in the SPS Warranty Claim Code field.
