# Service Bulletin

Bulletin No.: 24-NA-064

**Subject: Malfunction Indicator Lamp (MIL) Illuminated - DTCs P0324 and/or P0116 Set — ECM Software Update**

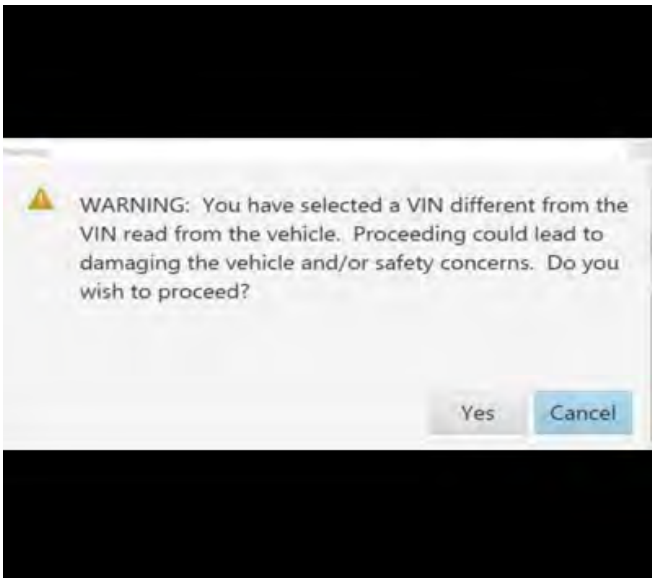
5877000

**Important:** If the vehicle VIN DOES NOT match, the message below will be shown
