Service Bulletin

Bulletin No.: 24-NA-066

Subject: Unable to Complete Serial Data Authentication

Brand:	Model:	Model Year:		VIN:		Engine:	Transmission:
		from	to	from	to		
Chevrolet	Corvette	2020	2023	—	—	—	—

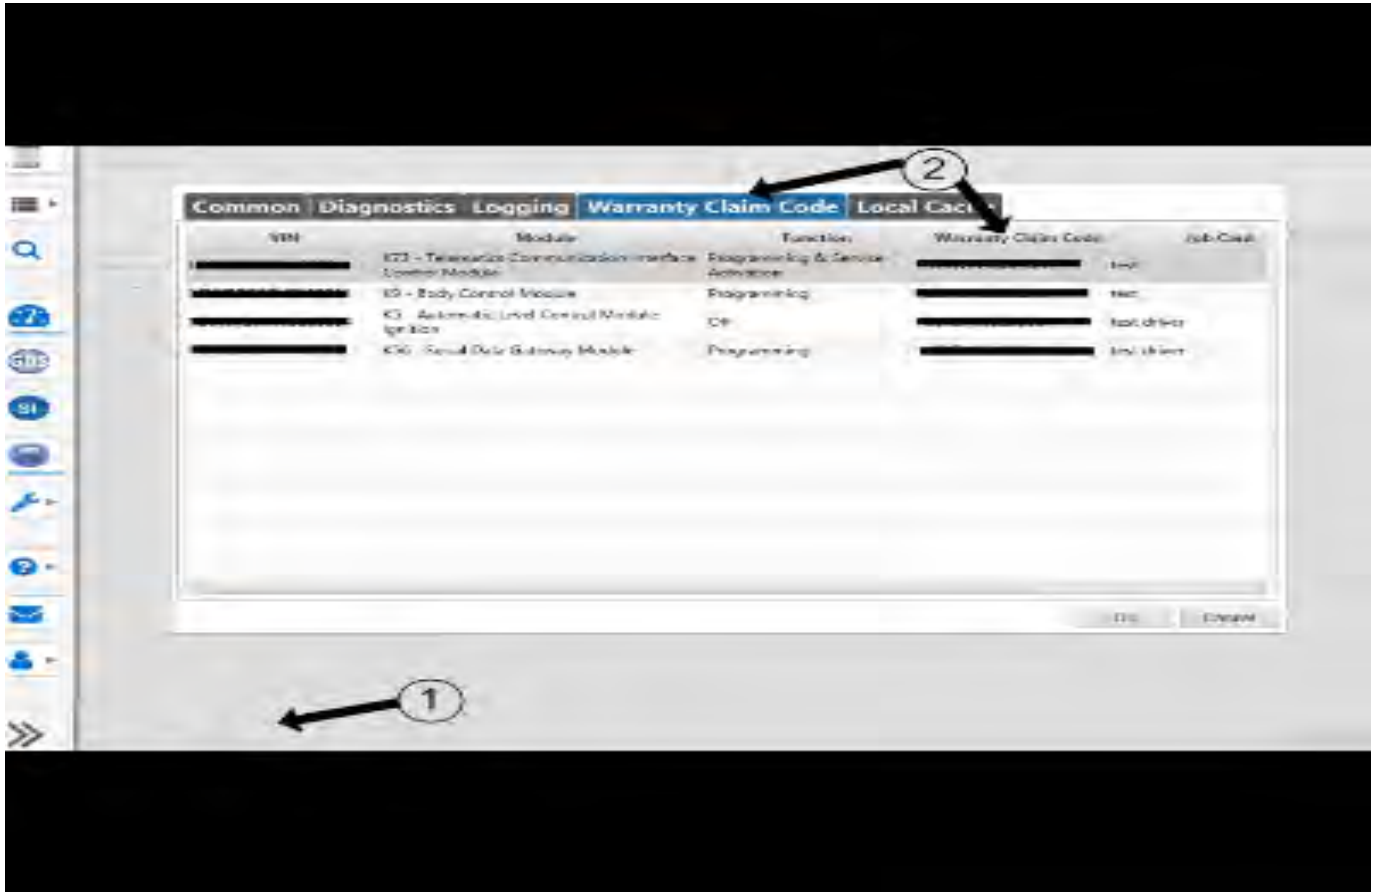
If the Warranty Claim Code was not recorded on the Job Card, the code can be retrieved in the SPS2 system as follows:

1. Open TLC on the computer used to program the vehicle.
2. Select and start SPS2.
3. Select Settings (1).
4. Select the Warranty Claim Code tab (2).

The VIN, Warranty Claim Code and Date/Time will be listed on a roster of recent programming events. If the code is retrievable, dealers should resubmit the transaction making sure to include the code in the SPS Warranty Claim Code field.
