# Head Unit Software Update (Panasonic)

YEAR(S)	MODEL(S)	ADDITIONAL INFORMATION
2023 - 2024	Sequoia HV	
2022 - 2024	Tundra, Tundra HV

## Head Unit Software Update (Panasonic)

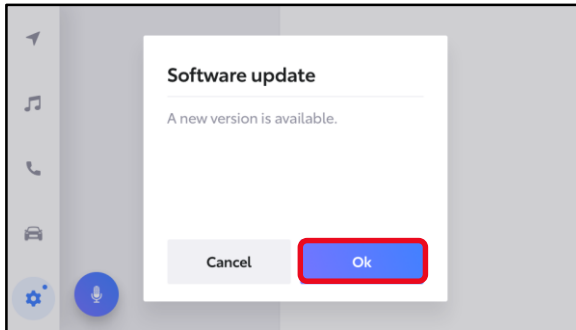
**Figure 1.**

Vehicle operators can perform this update directly by accepting the on-screen notification (see Figure 1), advising the software update is available, or by locating the software update from the Settings menu and initiating the available update (see Figure 2). The release notes text below will be displayed to the customer:

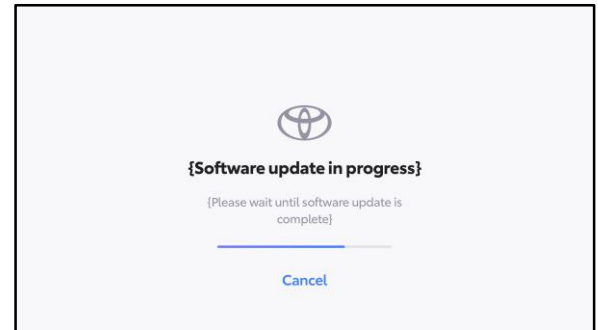
**Figure 18.**

10. If a major update is being installed the message "Software update in progress" will be displayed.

- Do NOT turn OFF the engine or ACC BEFORE the software has updated successfully.
- Selecting Cancel will cancel the installation of the specific component, but it can be installed manually later.

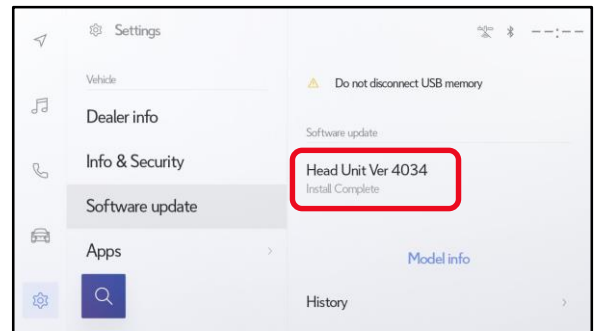
**Figure 28.**

- A. When the update is complete, “Install Complete” will show on the head unit, as shown in Figure 28.
- B. The “Software installation complete” pop-up message may also appear, as shown in Figure 29.
