Head Unit Software Update (Panasonic)

Service Category Audio/Visual/Telematics

Section Audio/Video

A head unit software update is now available for 2023 model year Corolla Cross, Corolla Cross Hybrid, Highlander, Highlander Hybrid, and Mirai vehicles equipped with Toyota Multimedia (earlier than version 2050). This software update includes the following improvements:

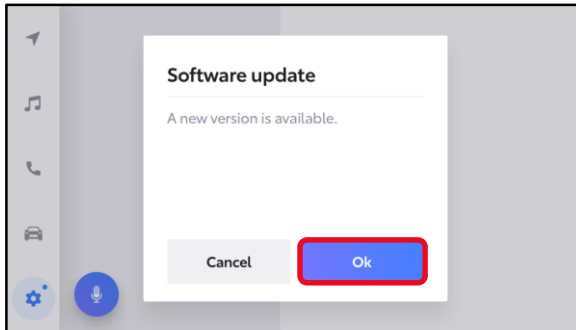
Figure 1.

Vehicle operators can perform this update directly by accepting the on-screen notification (see Figure 1), advising the software update is available, or by locating the software update from the Settings menu and initiating the available update (see Figure 2). The release notes text below will be displayed to the customer:

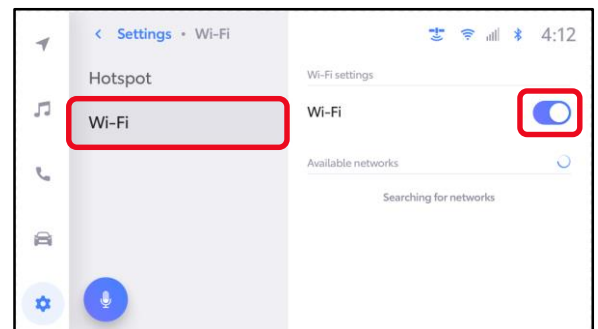
Figure 5.

4. Select Wi-Fi and turn the Wi-Fi toggle to ON.

- This step is used to connect the vehicle to an EXTERNAL Wi-Fi source.
- Wi-Fi connection is NOT required for updates that are delivered through DCM data.

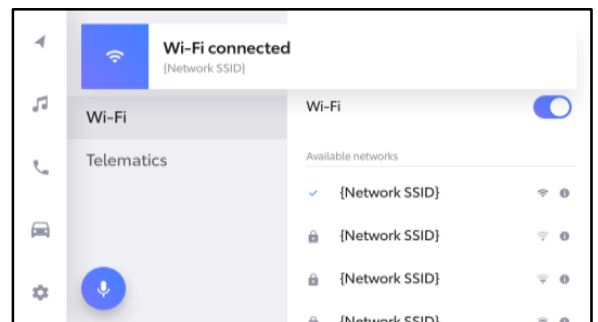
Figure 7.

- Follow the on-screen instructions. A message will appear confirming that the vehicle is successfully connected to the network.

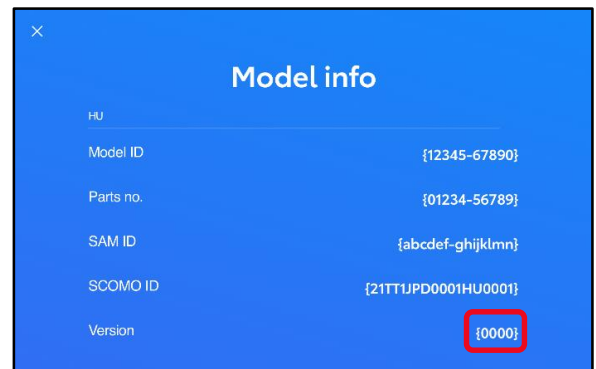
Figure 12.

4. Is the software up to date?
(Refer to Table 1 below.)
- **YES** — This bulletin does NOT apply. Continue diagnosis using the applicable Repair Manual.
 - **NO** — Continue to step 5.

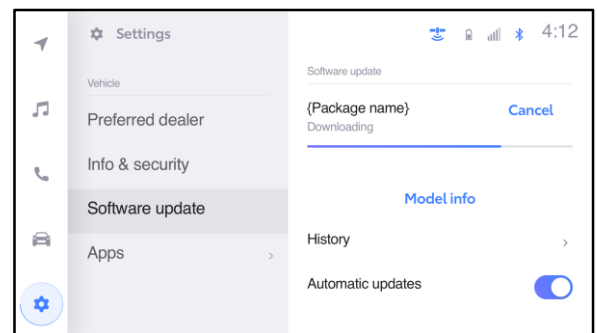
Figure 15.

7. Wait for the update to download.

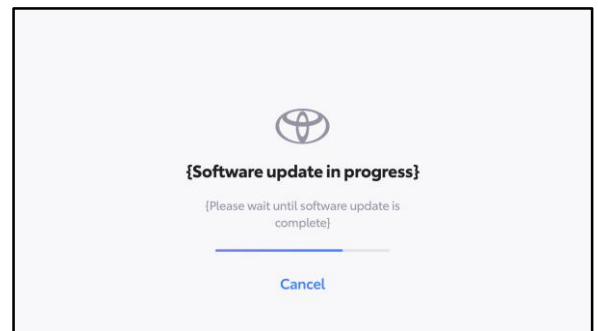
Figure 18.

10. If a major update is being installed the message "Software update in progress" will be displayed.

- Do NOT turn OFF the engine or ACC BEFORE the software has updated successfully.
- Selecting Cancel will cancel the installation of the specific component, but it can be installed manually later.

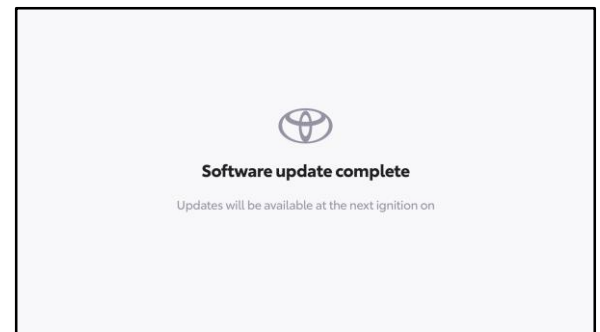
Figure 20.

- The software installation is complete when either a “Software installation complete” banner (Figure 19) or the “Software update complete” screen (Figure 20) is displayed.

If the vehicle has installed a major update, and the “Software update complete” screen is displayed, then an IG-OFF/ON will need to be performed prior to attempting to operate any of the multimedia functions.

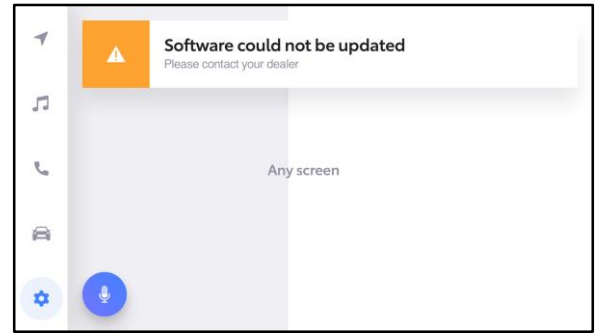
Figure 22.

- If after IG-OFF/ON a “Software could not be updated” banner appears, continue to the [USB Update Procedure](#) subsection.

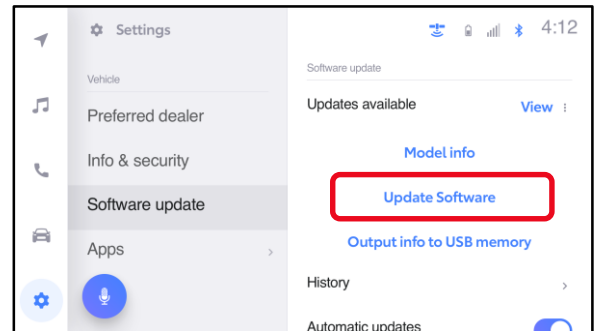
Figure 25.

The Update Software button may not be available immediately after inserting the USB flash drive. The head unit is unzipping the software update file, and it may take up to 15 minutes for this button to become available to press.

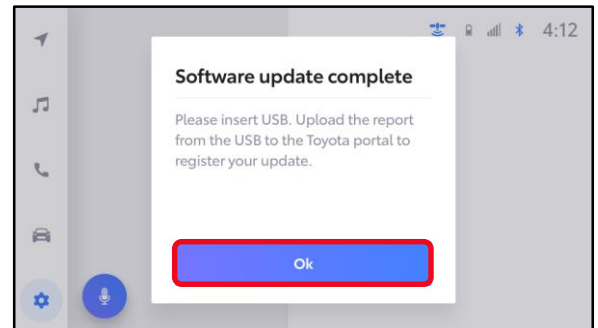
Figure 30.

If you are prompted to upload a report as shown in Figure 30, insert a blank USB to remove the .JSON files. These files are NOT needed.
