GENERAL MOTORS  
DCS6864  
URGENT - DISTRIBUTE IMMEDIATELY

Subject: N242441790 - Service Update  
Intermittent Check Engine Light On

Models: 2024 Cadillac Escalade  
2024 Cadillac Escalade ESV  
2024 Chevrolet Suburban  
2024 Chevrolet Tahoe  
2024 GMC Yukon  
2024 GMC Yukon XL  
Equipped with 3.0L Diesel Engine (RPO LM2)

# Service Update

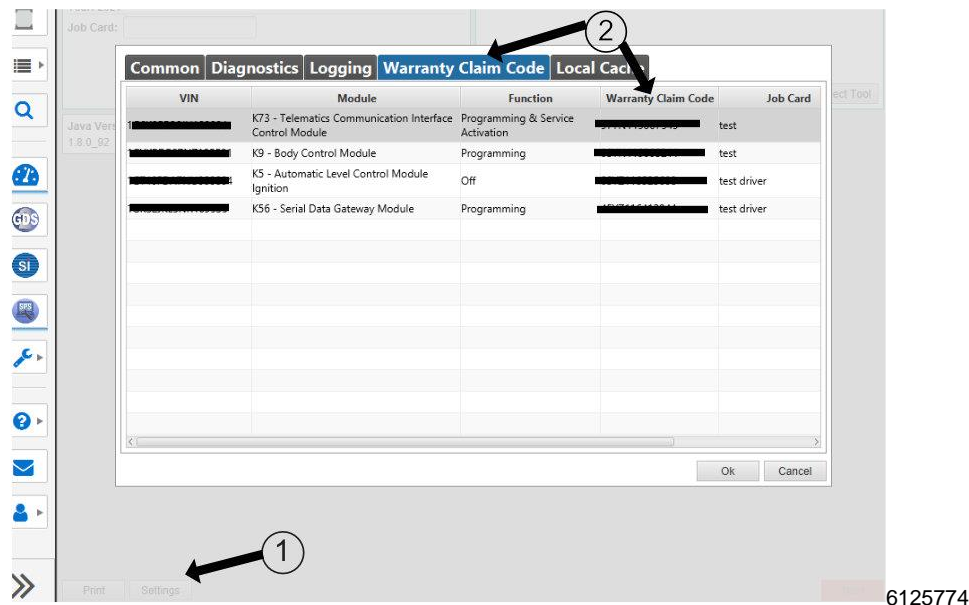
### Warranty Claim Code Information Retrieval

If the Warranty Claim Code was not recorded on the Job Card, the code can be retrieved in the SPS2 system as follows:

1. Open TLC on the computer used to program the vehicle.
2. Select and start SPS2.
3. Select Settings (1).
4. Select the Warranty Claim Code tab (2).

The VIN, Warranty Claim Code and Date/Time will be listed on a roster of recent programming events. If the code is retrievable, dealers should resubmit the transaction making sure to include the code in the SPS Warranty Claim Code field.
