GROUP	MODEL
ELE	2024MY EV9 (MV)
NUMBER	DATE
337	April 2024

TECHNICAL SERVICE BULLETIN

SERVICE ACTION: INTEGRATED CHARGING CONTROL UNIT LOGIC IMPROVEMENT (SA568)

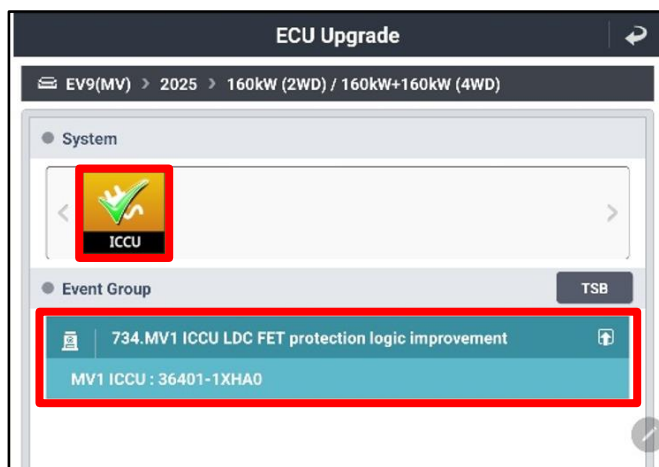
Prior to performing the ECU upgrade, be sure to check that the KDS is fully charged.
