Mil Is On With DTC P0011

AFFECTED VEHICLES

| Year | Model | Trim Level | VIN Range |
|---|---|---|---|
| 2024 | Integra | Type S | ALL |

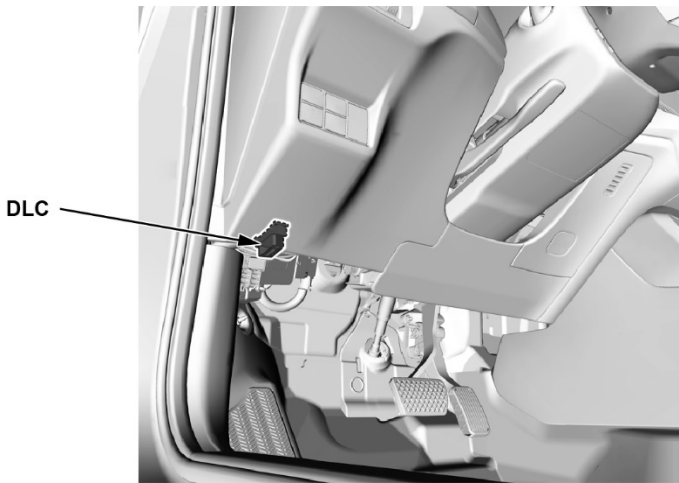
4. Connect the i-HDS to the DLC.

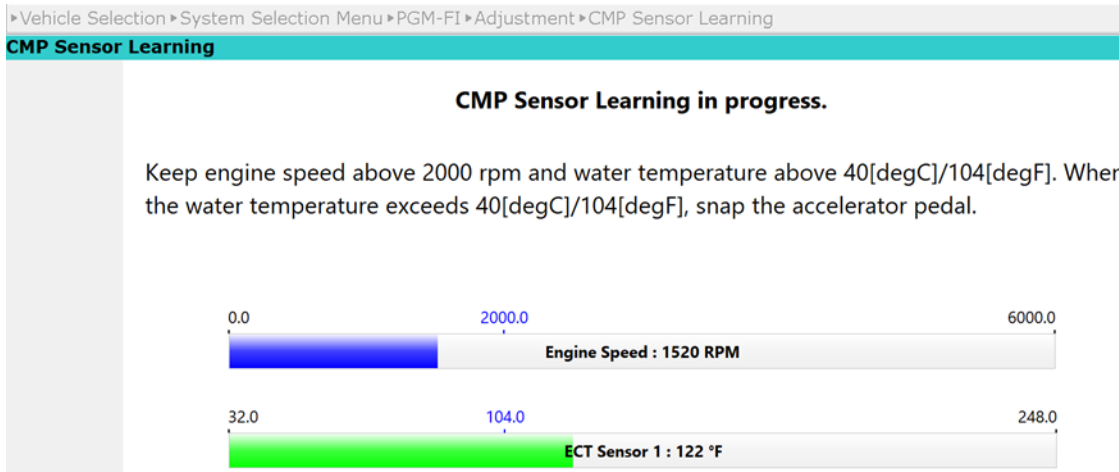
5. Select the following menu buttons on the i-HDS screen in sequence and learn the CMP sensor learning value.

- PGM-FI (System Selection Menu)
- Adjustment
- CMP Learning
- Follow on-screen prompts until CMP learning is completed.

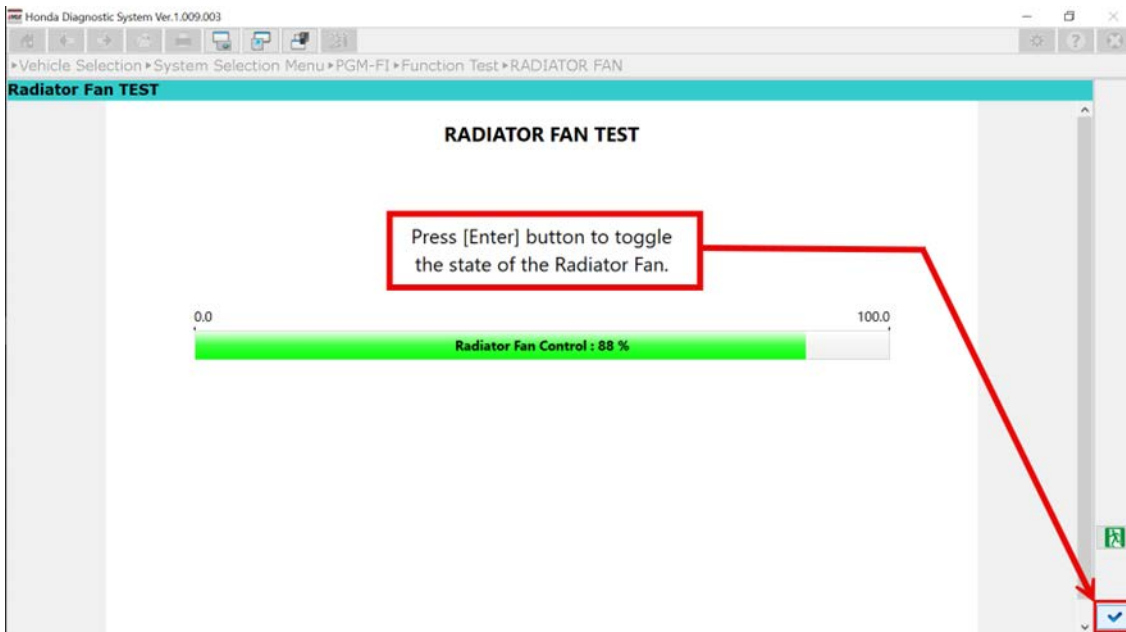
12. To aid the cool-down process, use the radiator fan function Test. Select the following menu buttons on the i-HDS screen in sequence.

- 12-volt power supply should still be connected.
- PGM-FI (System Selection Menu)
- Function Test
- Radiator Fan Test
- Hit enter button to increase Radiator Fan Control to 88%

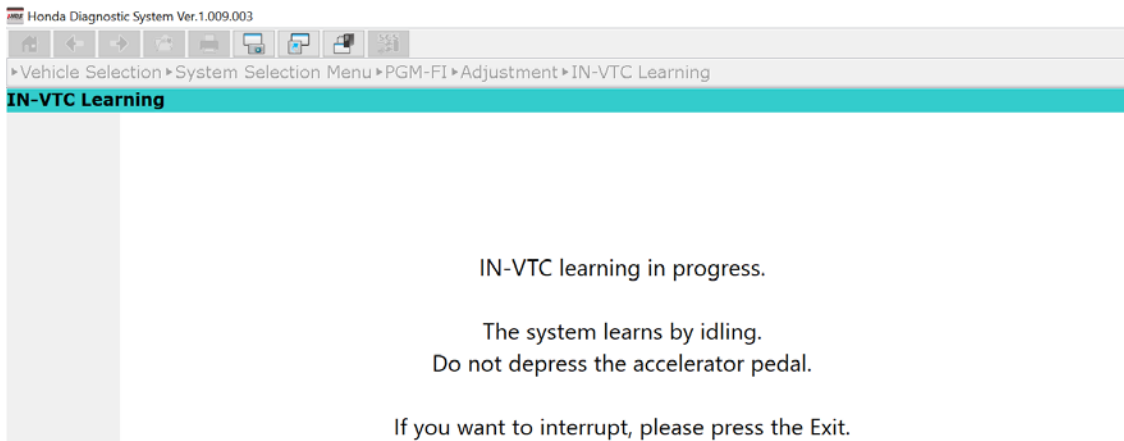
14. Select the following menu buttons on the i-HDS screen in sequence and learn the IN-VTC learning value.

- PGM-FI (System Selection Menu)
- Adjustment
- IN-VTC Learning
- Follow the on-screen prompts.
