# Service Action Code: 97H1

**Subject** Vehicle Software Update to Level 3.2.12

Volkswagen is providing a software update for certain 2021 model year Volkswagen ID.4 vehicles in order to bring the vehicle's software level up to 3.2.12. This will make it possible for these vehicles to receive future over-the-air (OTA) software updates.

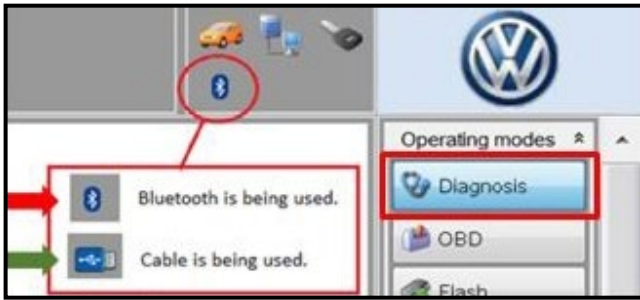
- Confirm that scan tool is communicating with the diagnostic head by USB <Green Arrow>.
  - If the Bluetooth symbol is shown <Red Arrow> then disconnect the diagnostic head from the vehicle and reconnect the USB cable to the diagnostic head and then reattach to the vehicle.
- Upon ODIS startup, verify the “Diagnosis” operating mode is selected <as shown>.
- Turn the hazards on.

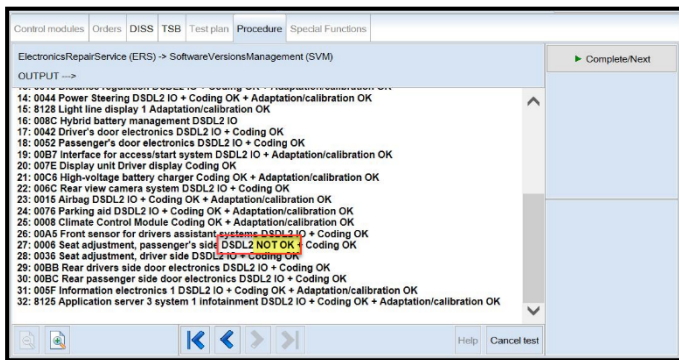
- Pay attention to the status report of the control module updates.
- Any module stating NOT OK will have to be updated again.
- Selecting “Complete/Next” will begin another attempt to update the control module.
- It may take more than one attempt to update every control module.

- Do not end the diagnostic session
- **DO NOT proceed to the next SVM update until SVM 4D80 has 100% completed successfully.**

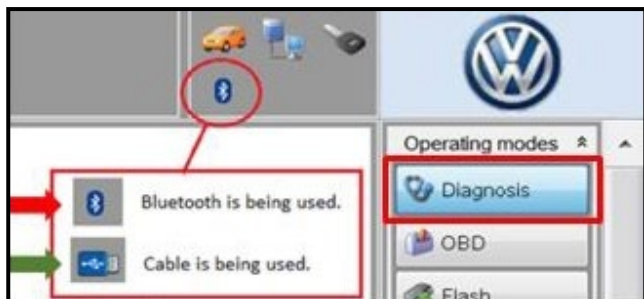
- Turn battery charger OFF, then back ON.
- Connect battery charger.
- Turn the hazards on.
- Confirm that scan tool is communicating with the diagnostic head by USB <Green Arrow>.
  - If the Bluetooth symbol is shown <Red Arrow> then disconnect the diagnostic head from the vehicle and reconnect the USB cable to the diagnostic head and then reattach to the vehicle.
- Upon ODIS startup, verify the “Diagnosis” operating mode is selected <as shown>.
- Once the GFF scan is complete, select “Special functions” <arrow 1>, then “Adapting software” <arrow 2>, then select “Perform test” <arrow 3>.

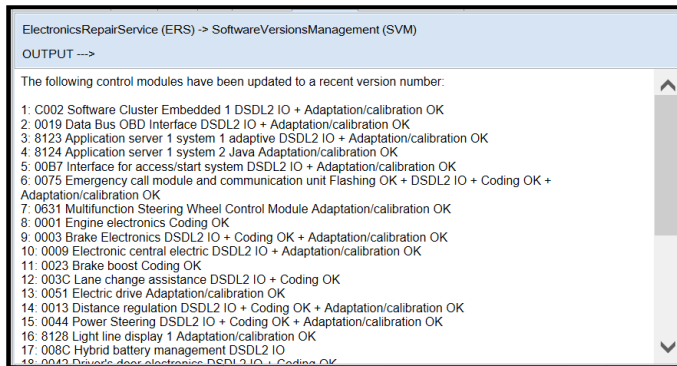
- Select “Accept” <arrow> and follow the on screen prompts.
- Pay attention to the status report of the control module updates.
- Any module stating NOT OK will have to be updated again.
- Selecting “Complete/Next” will begin another attempt to update the control module.
- Do not end the diagnostic session.

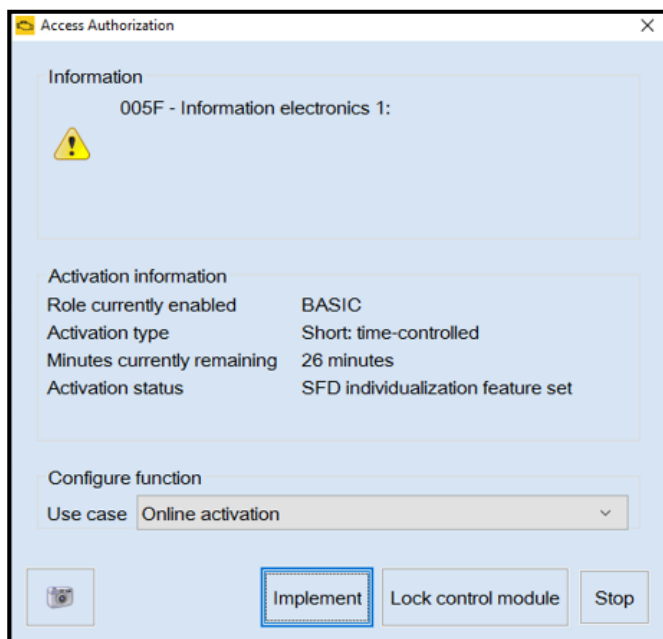
- From the OBD menu, go to: OBD > DA 005F > *Access authorization*.
- Select “Implement” and then enter ODIS login/password if prompted (to unlock SFD).
- Select “stop” to close the window.

- Using Operating mode “OBD”, check 005F adaptation channels \$0548 and \$0549 for the current service interval settings (OBD > DA 005F > *Adaptations*).
- If the values are the same as the previously recorded values, no change is necessary.
- If the values have changed, enter the correct values as needed.

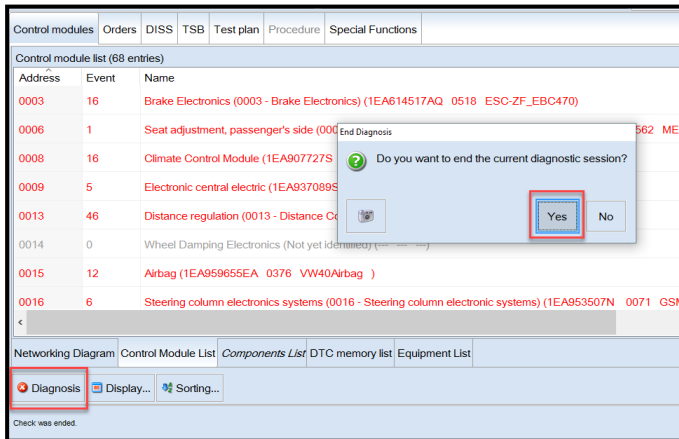
- Exit Diagnosis and select “Yes” to end the diagnostic session.
