SERVICE BULLETIN

APPLICABILITY: 2022-24MY BRZ Models **NUMBER:** 15-297-22R
SUBJECT: Reprogramming File Availability for Optimization of Gen 4 Denso CP1 Infotainment Systems **DATE:** 07/01/22
REVISED: 04/19/24

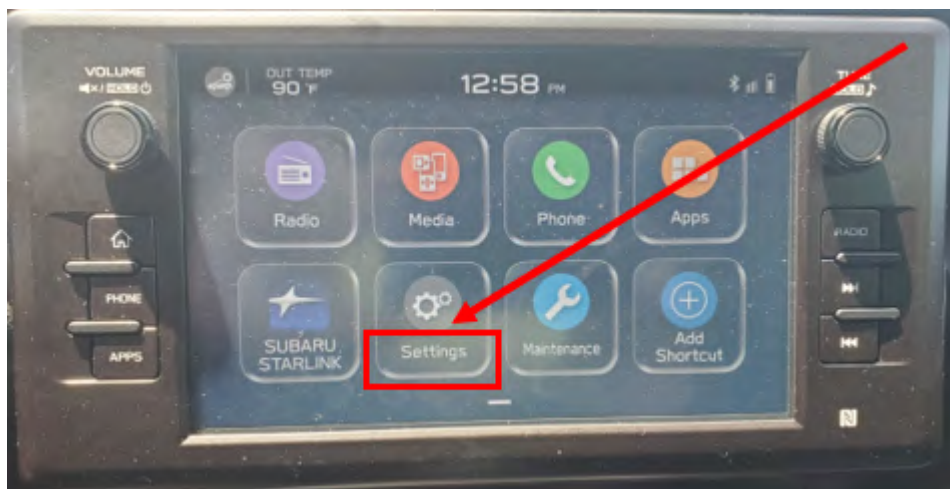
- 1a) After starting the engine and system boot-up completes, from the HOME screen, touch the **Settings** button.

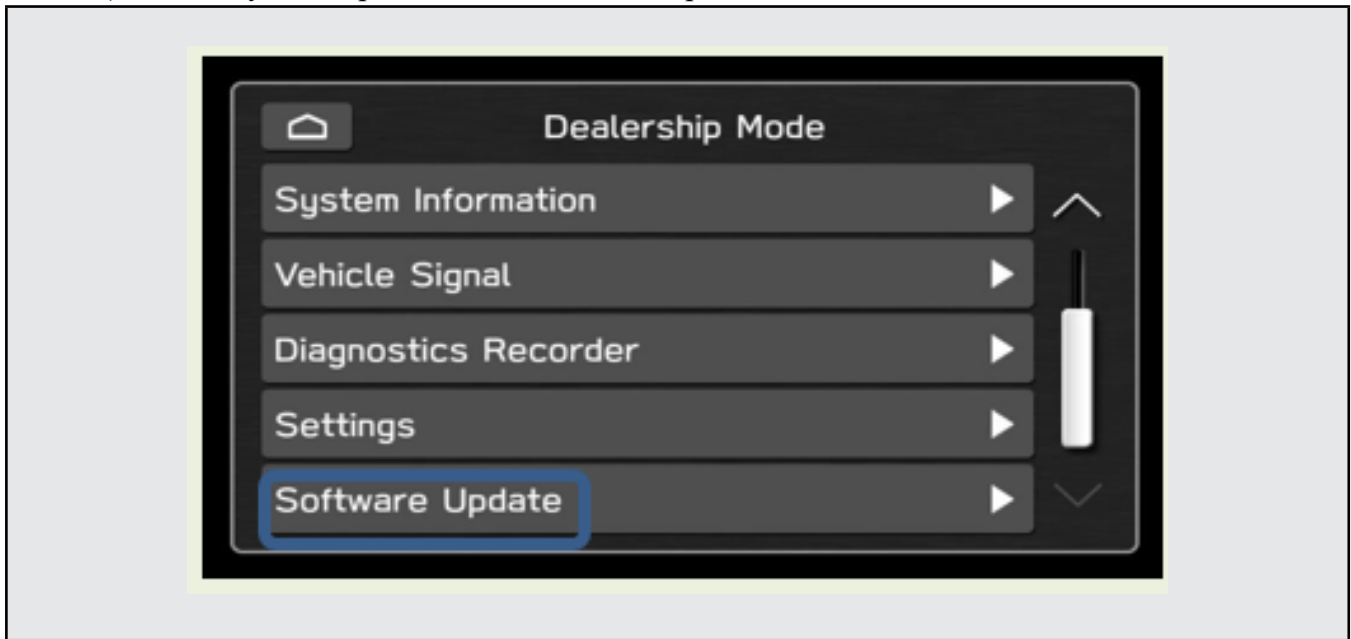
4c) Select System Update from the Dealership Mode Menu

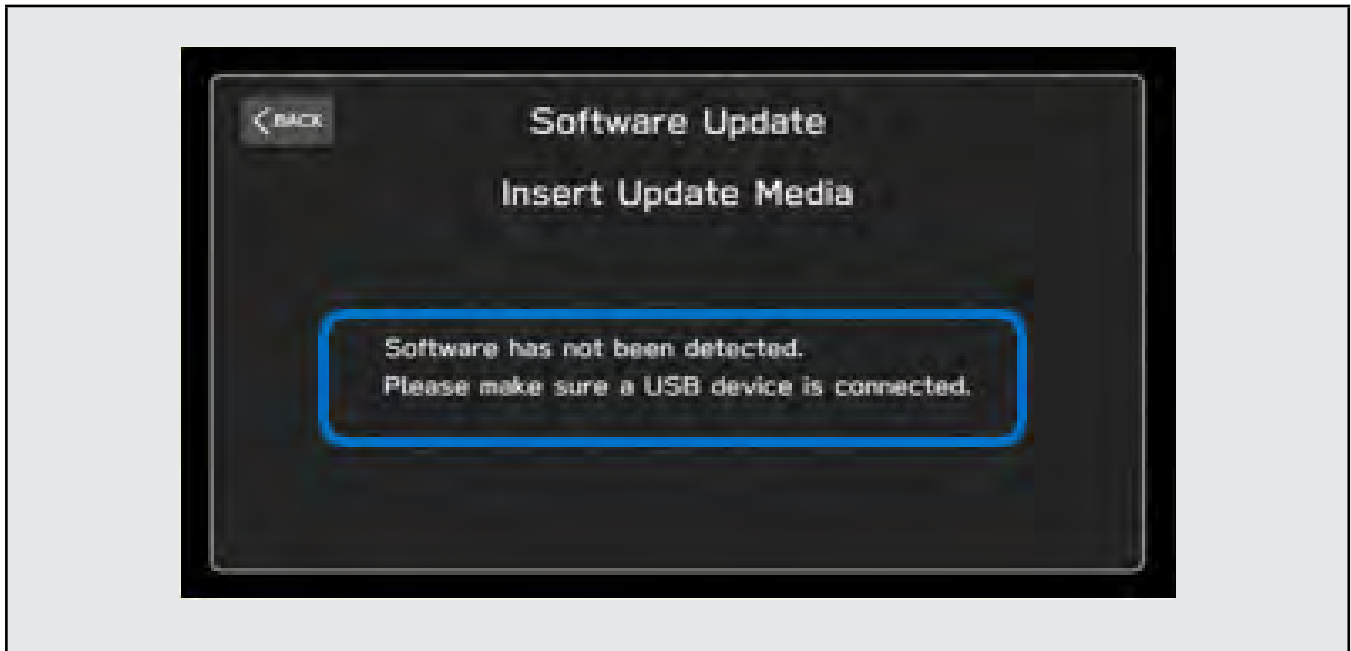
4d) The screen below will be displayed.

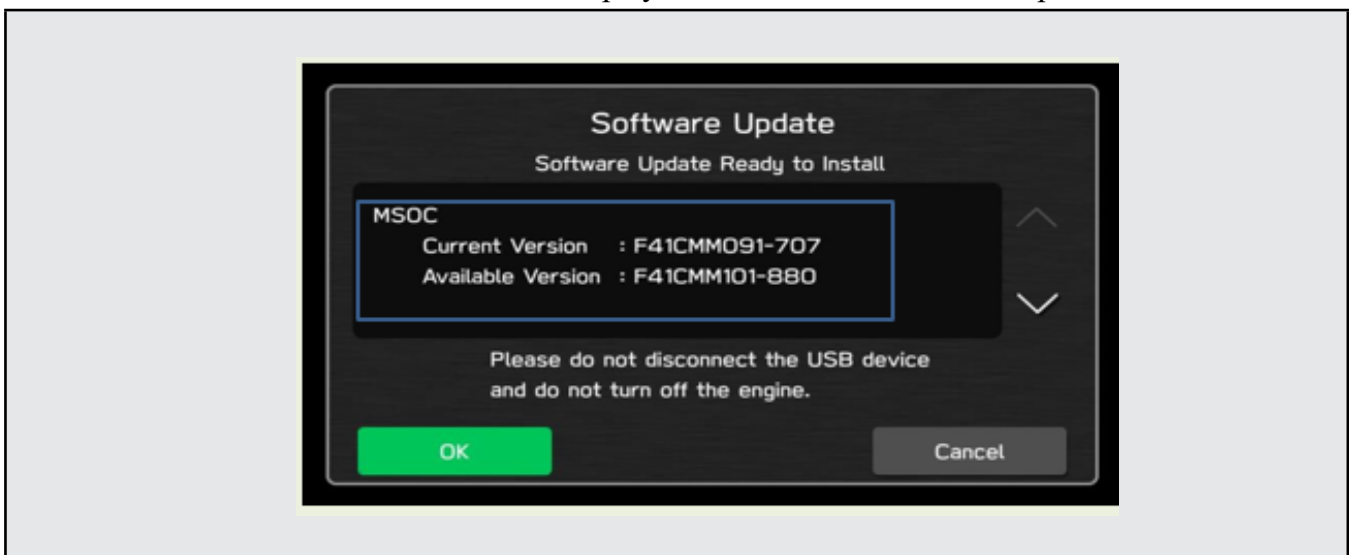
4f) The screen below will be displayed. Press **OK** to start the software update.

NOTE: The actual software version displayed will be different from the picture shown below.

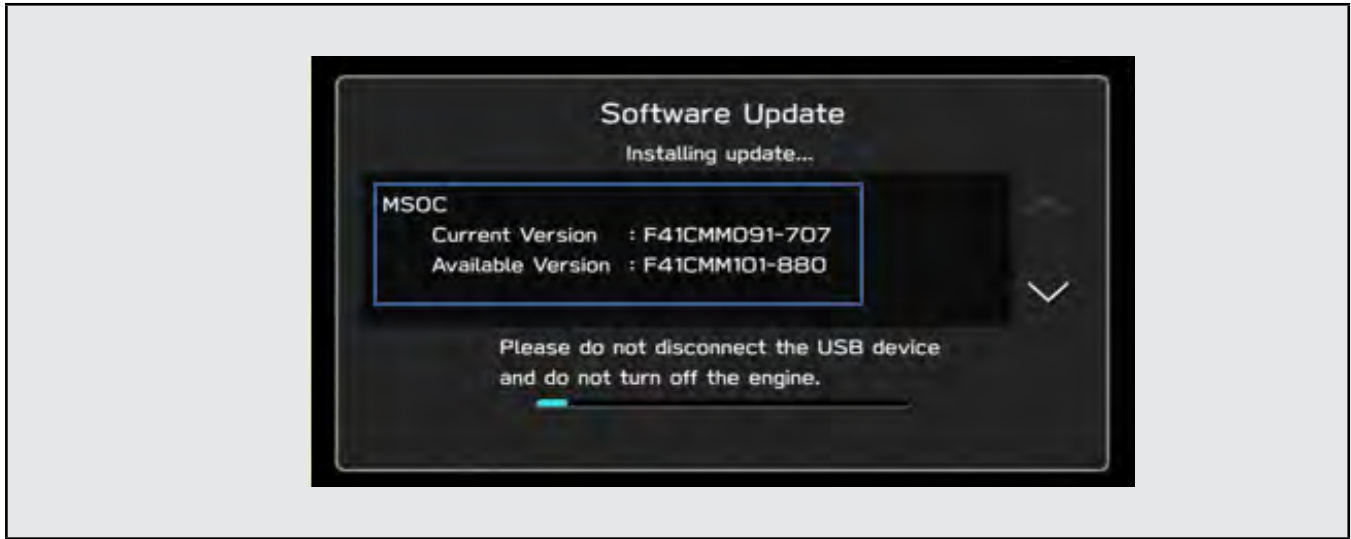
4g) Once the update begins, the screen below will be displayed with a progress bar. It takes about 15 to 20 minutes for the update to complete.

VERY IMPORTANT: NEVER turn off the ignition while the software update is in process.

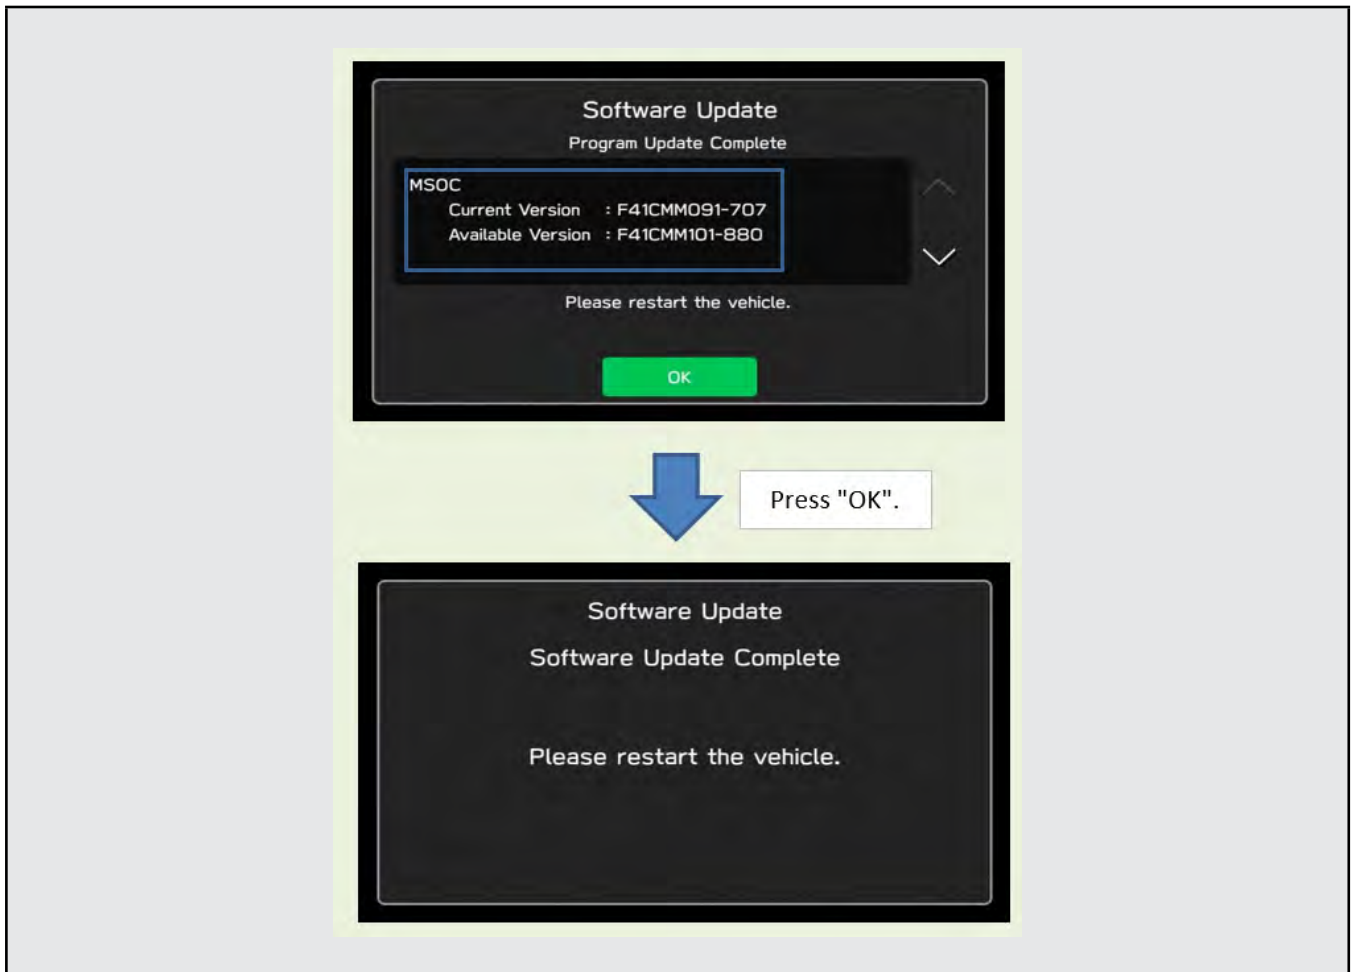
4h) When the software update is complete, the following screen will be displayed (the actual software version will be different).

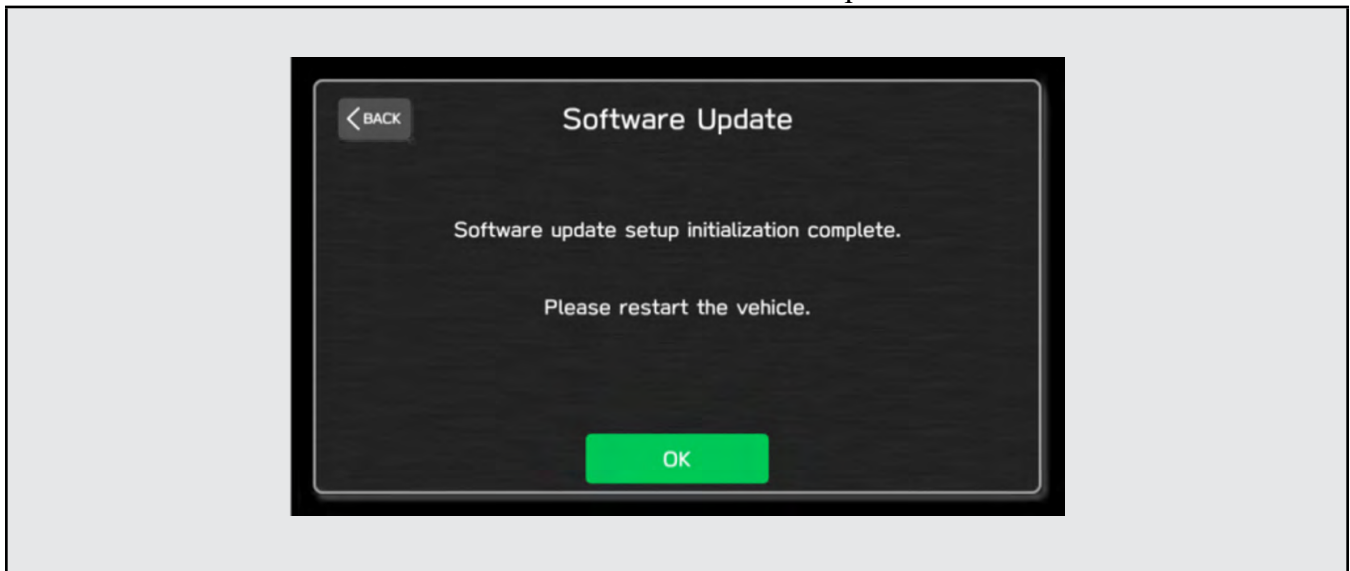
- You will see the screen below when the initialization is complete.

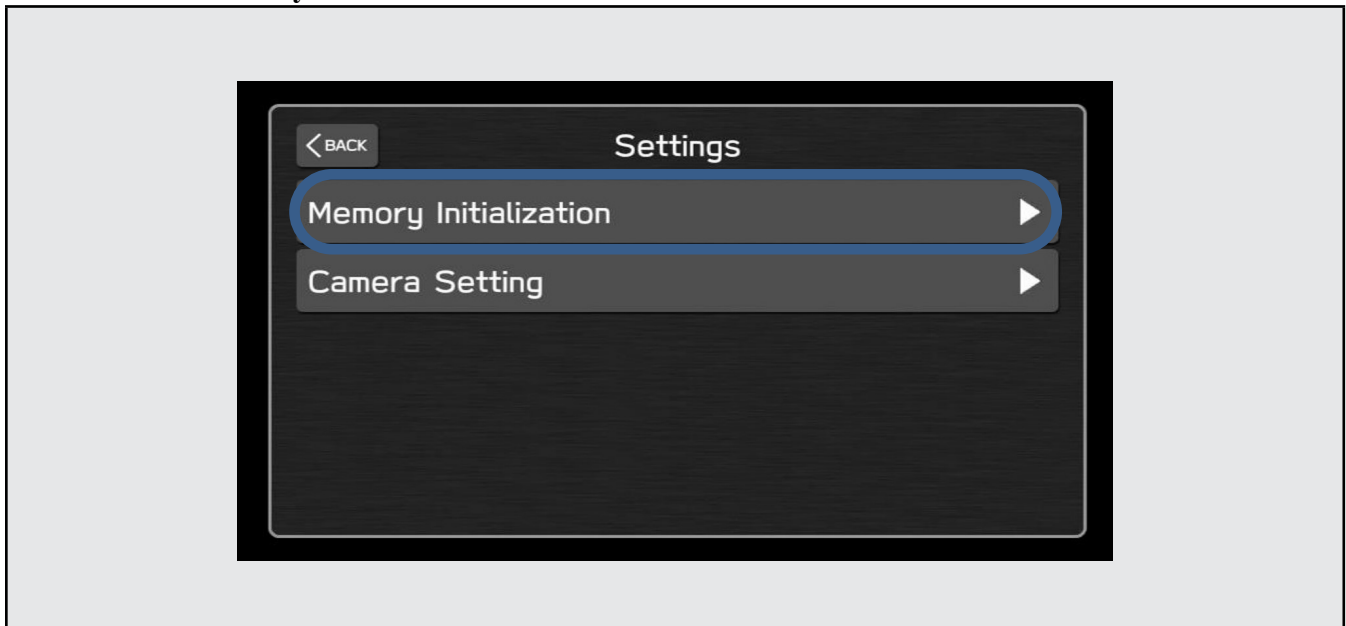
2-2. Select “Memory Initialization”

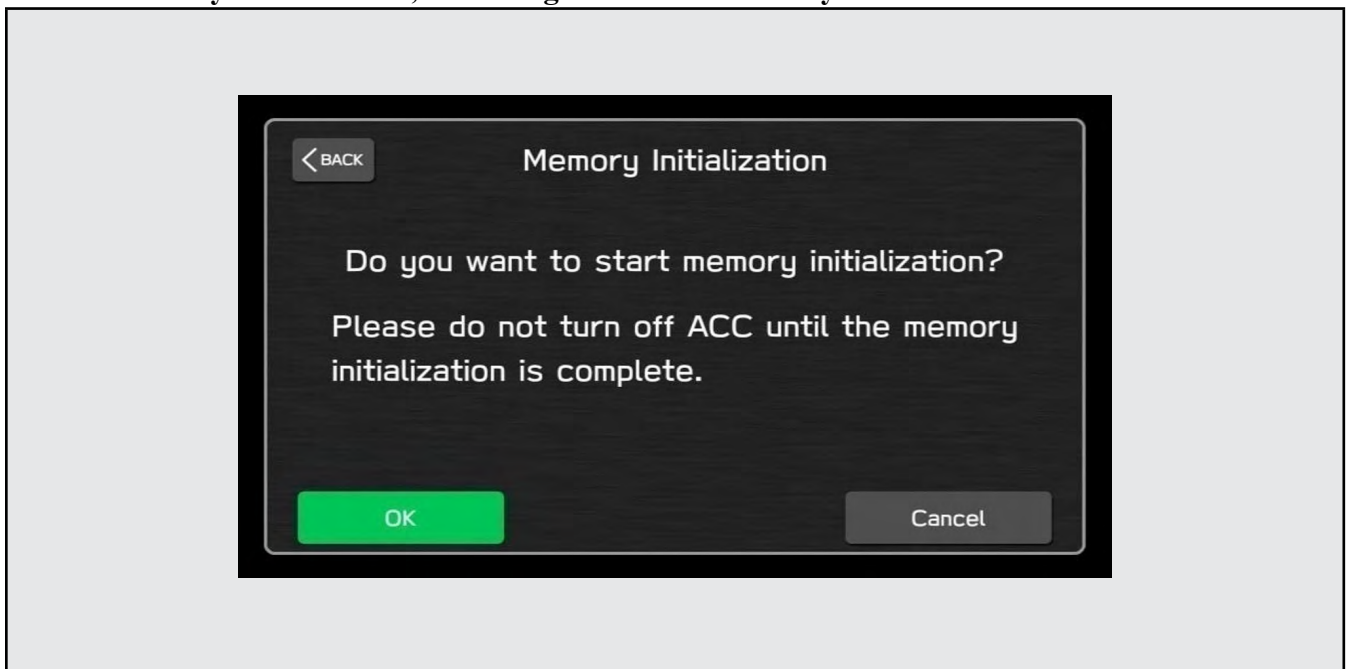
2-3. Select “OK”

After Memory Initialization, all settings are reset to factory default.

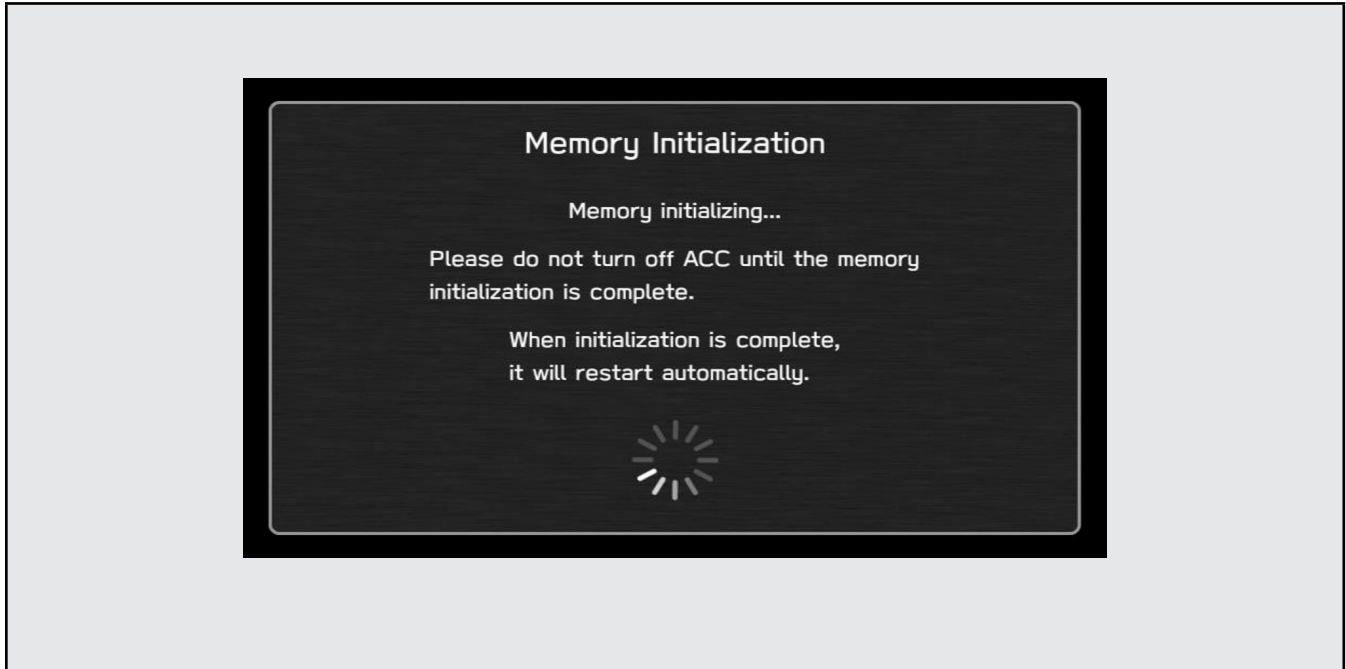
2-4. You will see the following screen

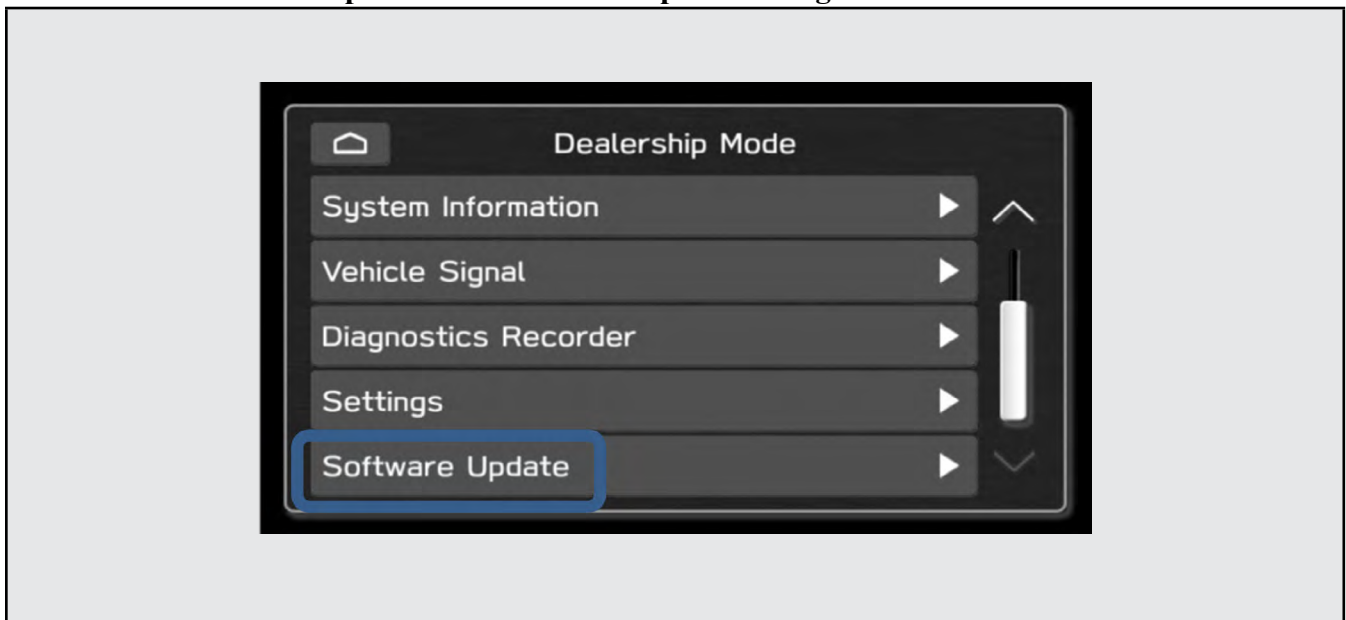
2-6. Select "Software Update" in the Dealership Mode diagnostics screen.

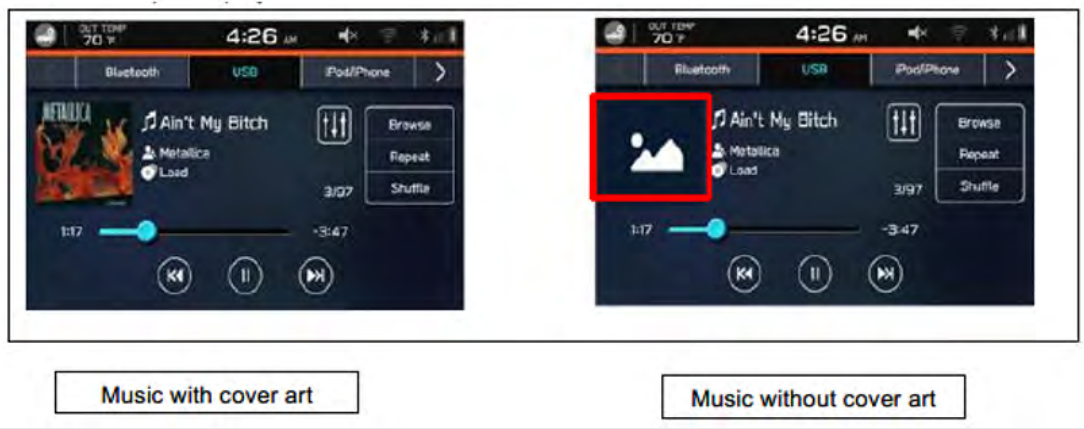
Number	Symptoms to be Improved:
15	Even when using the same mobile device that was paired previously, a message of “Are you sure you want to activate this profile?” is prompted and confirmation is needed to activate the device.
16	<p>Cover art of previous music is displayed when playing music without cover art in USB audio. It can occur when music with and without cover art is mixed and stored together a single USB.</p> <div data-bbox="365 415 1442 840" style="text-align: center;">

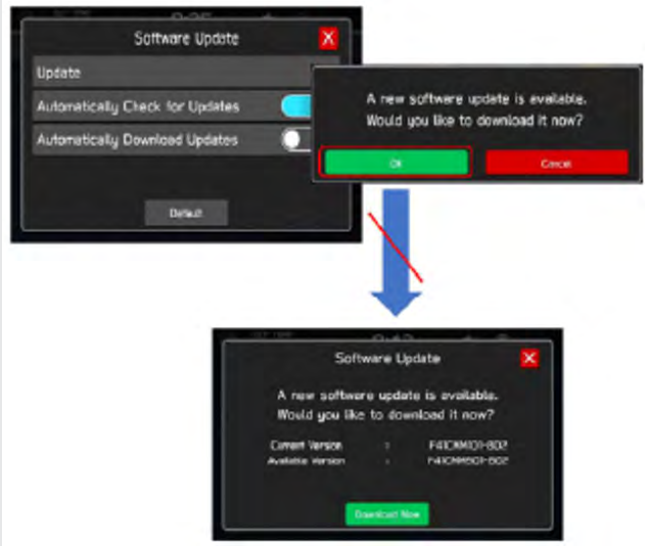
Number	Symptoms to be Improved:
22	<p>When using FOTA service to update the software by selecting “Setting” > “Software Update,” a message of “A new software update is available. Would you like to download it now?” is displayed but the downloading does not start after pressing “OK.” When this symptom occurs, it comes back to the “Software Update” screen. The downloading can be started by pressing the “Update” on the “Software Update” screen. (Temporary solution.)</p>

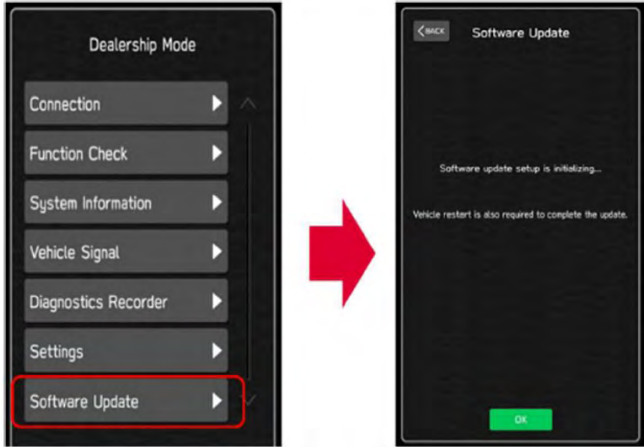
<p>Insert USB</p> <p>Tap OK</p> <p>Confirmation screen</p> <p>Error screen</p>
<p>13</p>	<p>When “Software Update” is selected in the Dealership Mode, the following initialization process does not end more than 20 minutes. *</p>

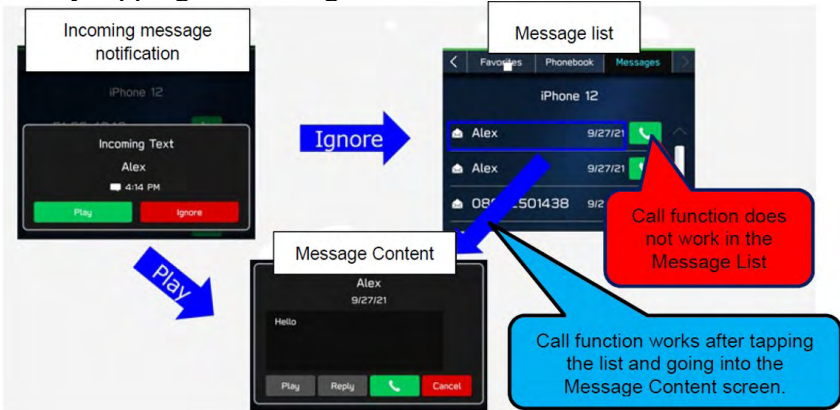
Number	Symptoms to be Improved:
15	<p>Call function does not work in the Message List (after ignoring the incoming message notification.). However, the call function can still be used after getting into the Message Content screen by tapping the message list.</p>

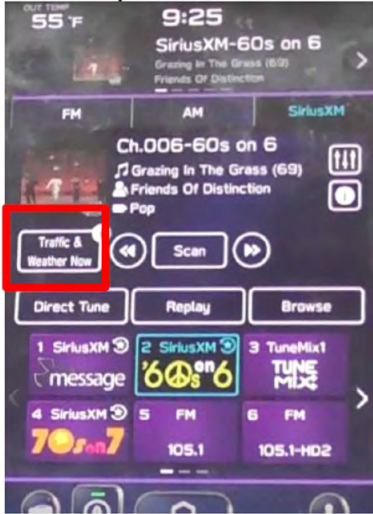
Number	Symptoms to be Improved:
25	<p>No response when touching “Traffic & Weather Now (TWN)” on SMX screen.</p>

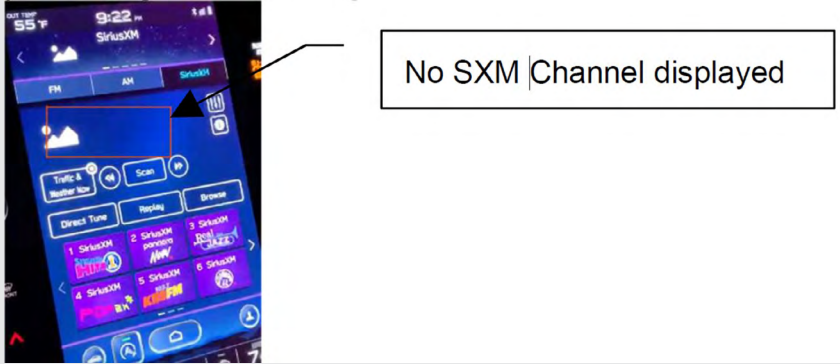
26	<p>SXM has blank screen and no sound when the SXM screen had been selected as audio source at the previous ignition off timing.</p>

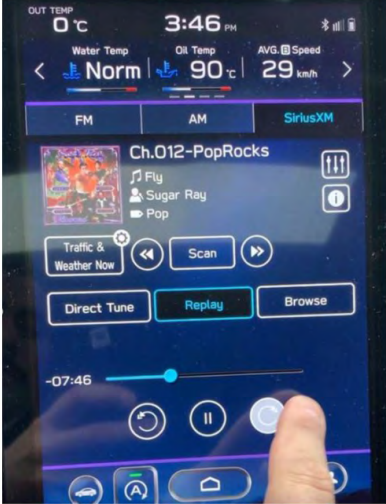
Number	Symptoms to be Improved:
29	<p>“Fast forward” does not work in SXM replay function. (Fast Rewind works.)</p>

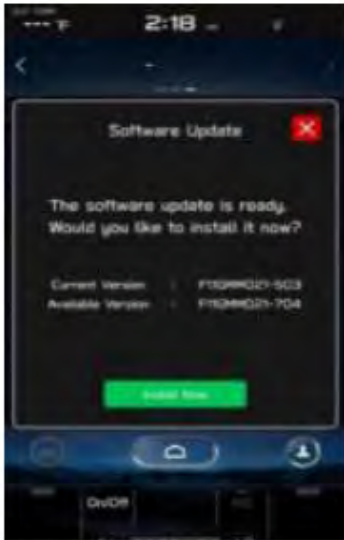
<p>Note* Even if this symptom occurs, after approximately 2 minutes, the system resumes, and the CID comes back to the below screen. Customer can then push the “Install Now” to proceed with the installation.</p>
