SERVICE PROGRAM BULLETIN

APPLICABILITY: 2023 MY Legacy
2023 MY Outback

NUMBER: WRI-22R

SUBJECT: Telematics DCM Replacement

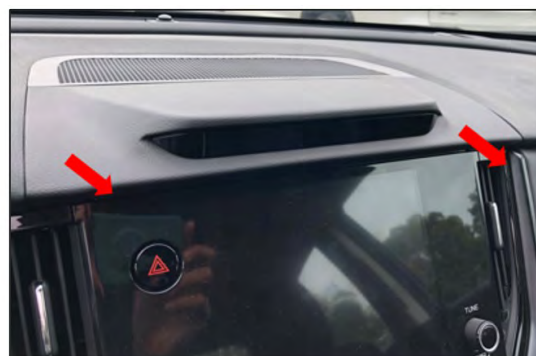
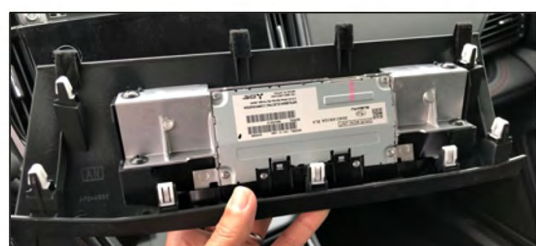
STEP 7: Release the 7 mounting clips from the driver monitoring unit. Once released, pull the unit toward the rear of the vehicle in a straight direction. Release the electrical connection and remove the unit from the vehicle.

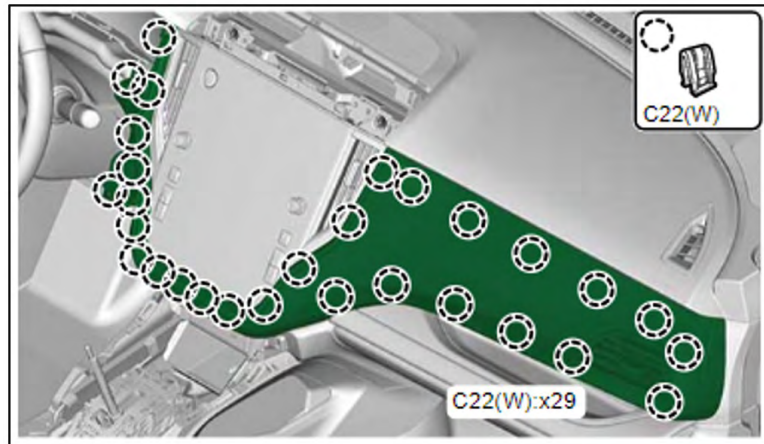
STEP 11: Release the mid passenger ornament panel mounting clips and remove the panel.

NOTE: Vehicles equipped with push button start will require the push button ignition switch to be disconnected prior to removal.
