Technical Service Bulletin

GROUP CAMPAIGN	NUMBER 24-01-034H
DATE APRIL 2024	MODEL(S) IONIQ ELECTRIC (AE EV)

SUBJECT: HIGH VOLTAGE BATTERY SOFTWARE UPDATES – IMPROVED LOGIC APPLICATION (SERVICE CAMPAIGN TBF)

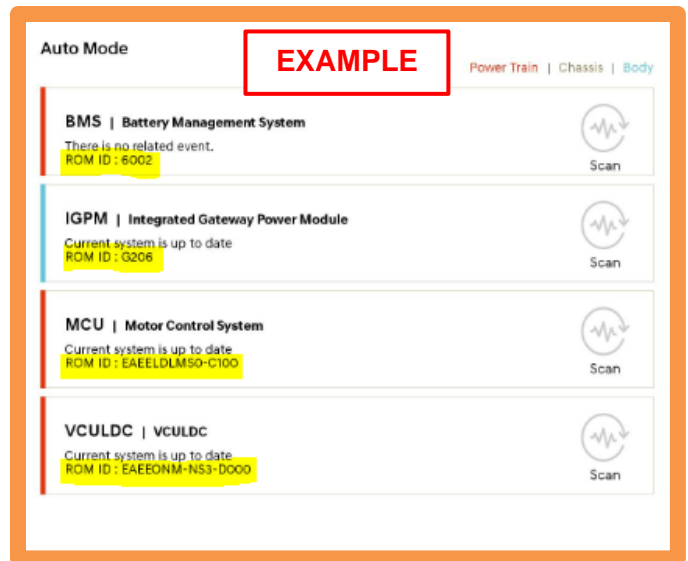
Take a screenshot of all four (4) systems updated with the latest ROM ID's using your particular tablet's screenshot save method and upload to STUI.

4. After the ECU Upgrade process shows 100% complete, cycle the ignition key to OFF for at least 10 seconds to reset the control units.
5. Verify the **NEW** VCULDC, MCU, IGPM, and BMS ROM ID with the ROM ID information table on Page 5.
6. Perform an All-Systems Fault Code search and erase the history of the DTC that had incidentally occurred from the ECU updates.
7. Start the vehicle to confirm proper operation of the vehicle.
8. Service Procedure is now completed.
