SERVICE CAMPAIGN BULLETIN

SUBJECT: LANE KEEP ASSIST REPROGRAM FOR ADAS ECU – SERVICE CAMPAIGN			No: SC-24-001
			DATE: April 2024
			MODEL: Outlander
CIRCULATE TO:	<input type="checkbox"/> GENERAL MANAGER	<input checked="" type="checkbox"/> PARTS MANAGER	<input checked="" type="checkbox"/> TECHNICIAN
<input checked="" type="checkbox"/> SERVICE ADVISOR	<input checked="" type="checkbox"/> SERVICE MANAGER	<input checked="" type="checkbox"/> WARRANTY PROCESSOR	<input type="checkbox"/> SALES MANAGER

This bulletin provides instructions to reprogram the ADAS ECU software on 2022 Model Year Outlander.

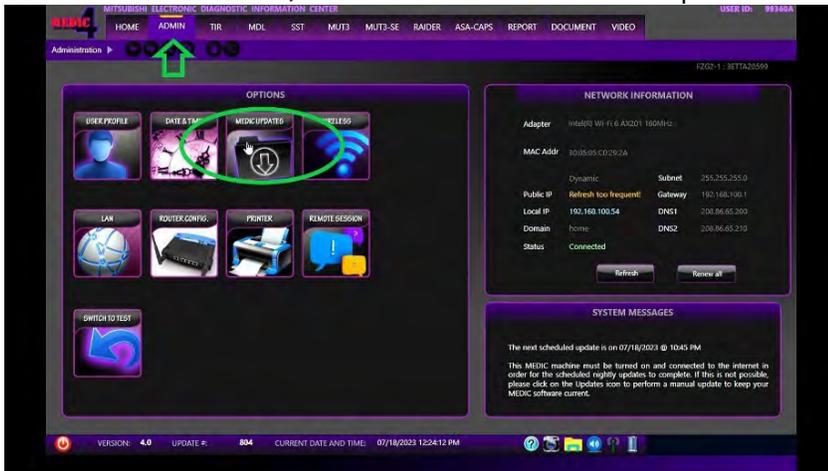
3. Select the MEDIC 3.5/4 Admin tab and click on "Updates".

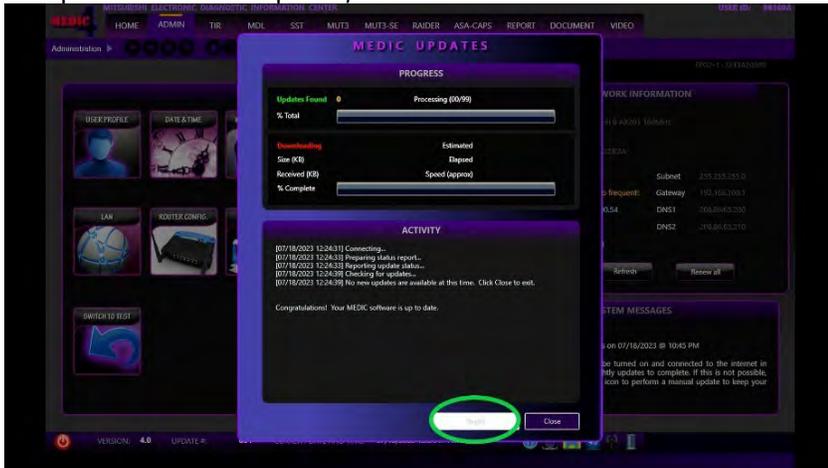
4. If the MEDIC update screen advises updates are available, click the "Begin" button. After all updates are complete, **GO TO THE REPROGRAMMING PROCEDURE.**

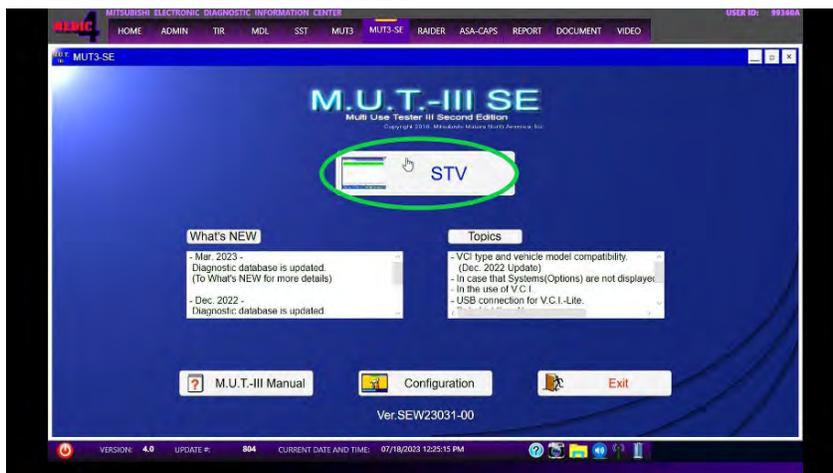
a. Press the MUT-III SE STV icon.

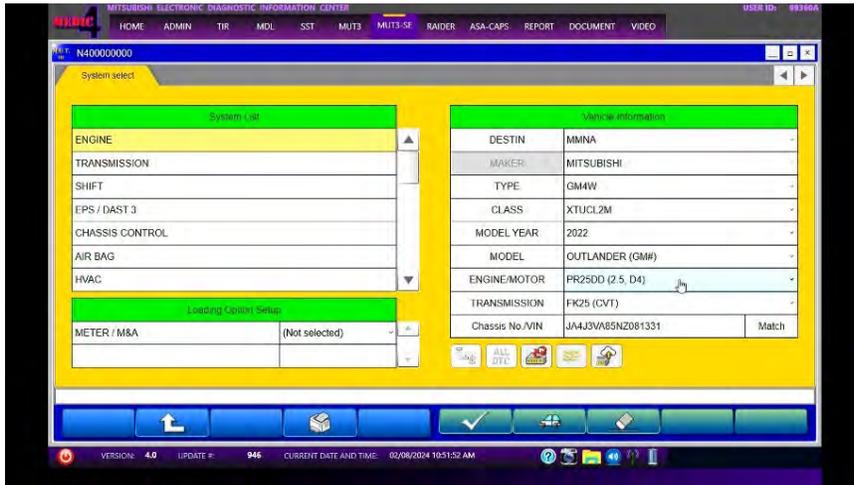
- b. Confirm the vehicle information displayed is complete/correct and press Reprogramming button.

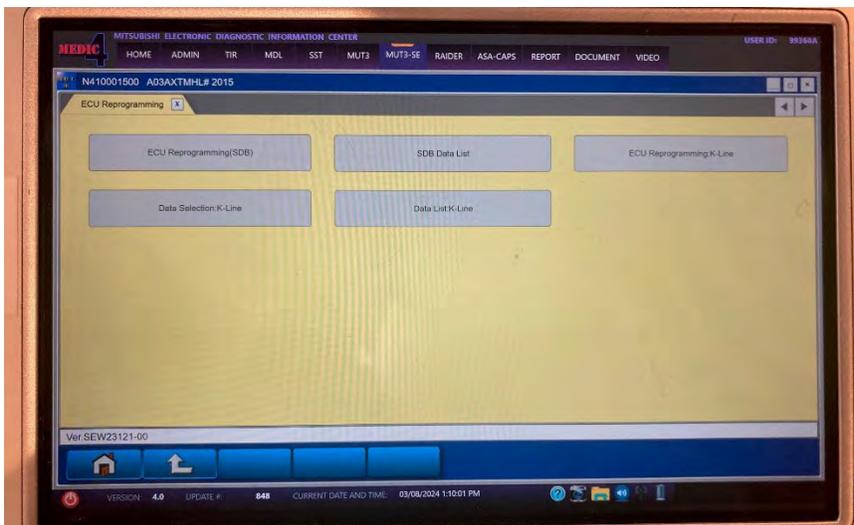
- c. Select "SDB Data List" button.

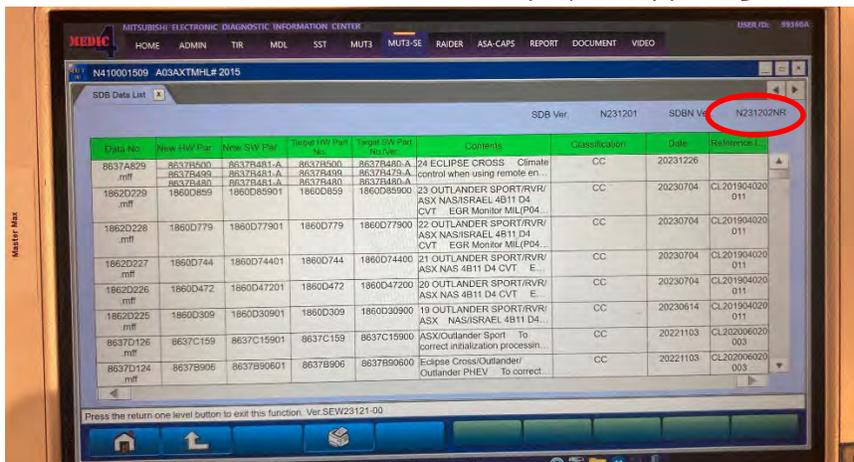
- d. Confirm that the database number displayed (upper right) is SDBN N231101NR or higher.

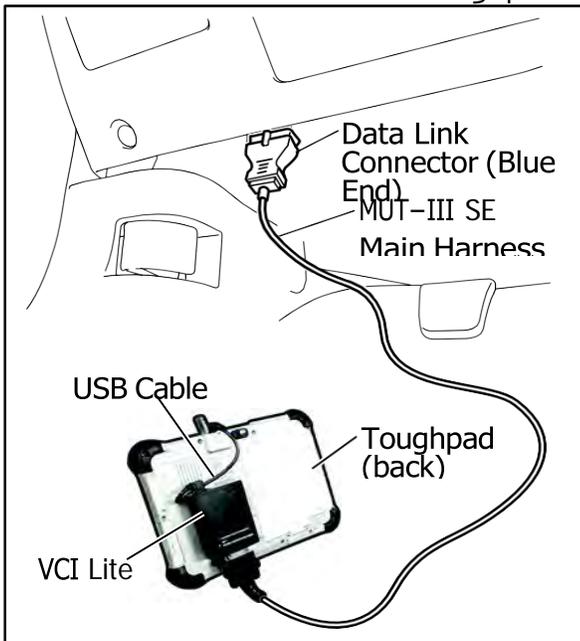
1. Connect the equipment as follows:

NOTE: VCI Lite and MEDIC 4.0 Toughpad shown for illustration purposes only.

- Turn the MEDIC PC/tablet on. If the battery indicator in the lower right hand corner of the screen does not show a full charge, it is recommended that either the battery be charged prior to beginning or be used with the A/C power adaptor connected.
- Connect the USB cable to the VCI/VCI Lite. When the laptop/tablet displays the MUT-III SE main screen, connect the USB cable to the device.
- Connect the MUT-III SE main harness with the blue DLC connection to the VCI/VCI Lite. Connect the blue connection of the MUT-III SE main harness to the vehicle's data link connector.
- For VCI only: Turn the VCI power switch ON. Verify that the indicator lamp in the upper right corner of the screen is green.

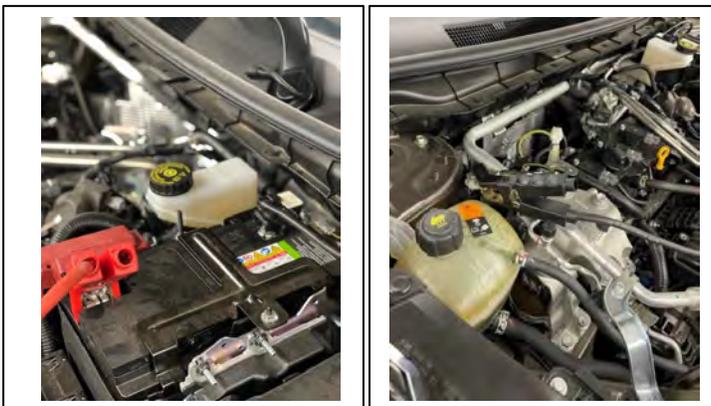
NOTE: Due to limited space it may be easiest to connect battery charger cable onto ground point.

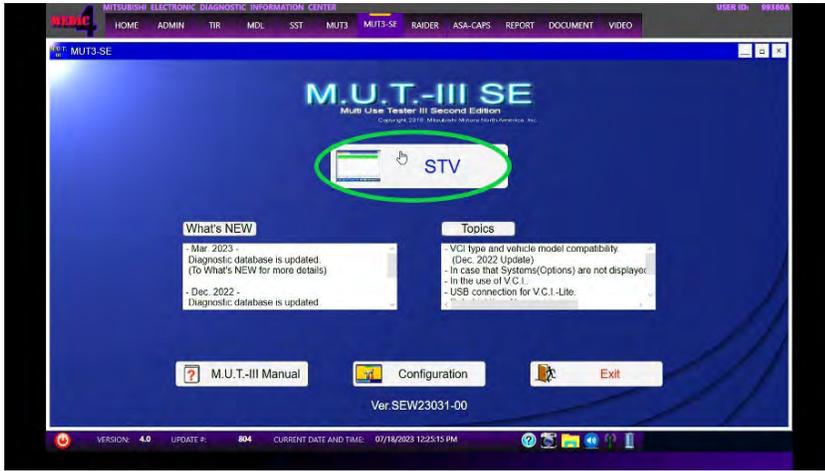
2. Turn the ignition switch to the "ON" position.
3. Turn on flashers to prevent vehicle from shutting/powering down.
4. Press the MUT-III SE STV button.

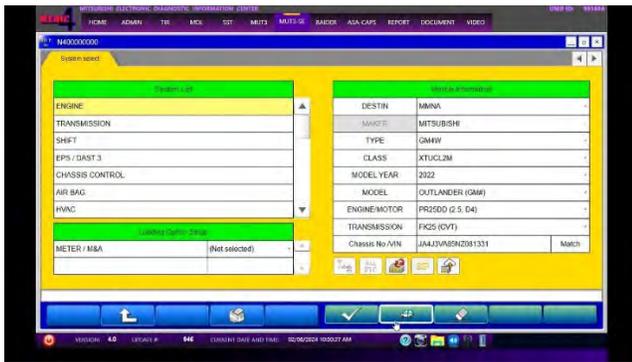
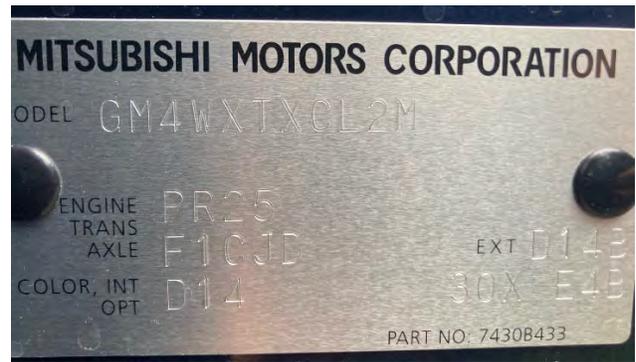
5. Press the model information display button (car icon) and verify all vehicle information. Look at the label on the passenger side B pillar to identify the appropriate class. (See B pillar label below; class is labeled as "model"). Select the correct class from the Loading Option Setup drop-down list.

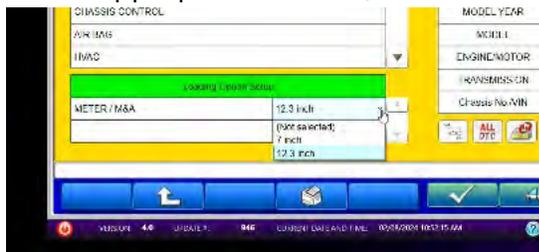
6. Verify that the ECU has not already been updated with the latest S/W number.
 - a. Select appropriate "Meter / M&A" from Loading Option Setup drop-down..

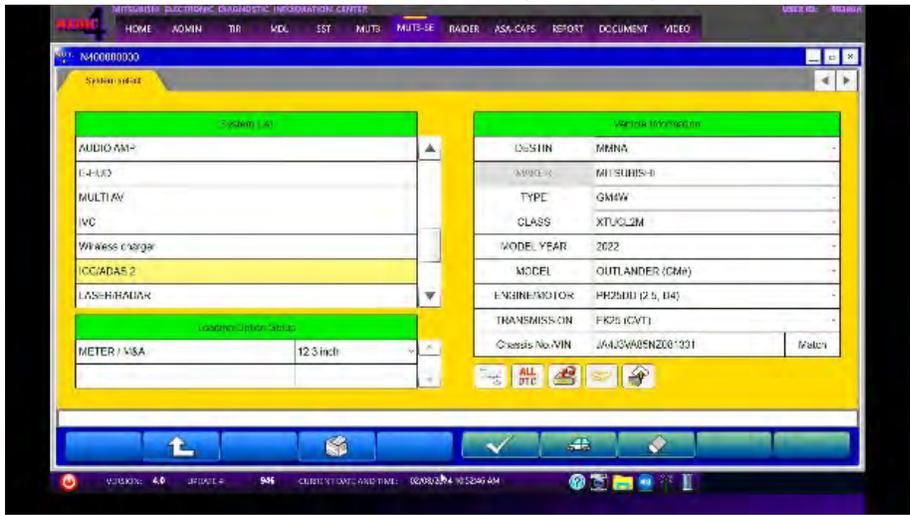
b. Select "ICC/ADAS 2" and press the programming icon button.

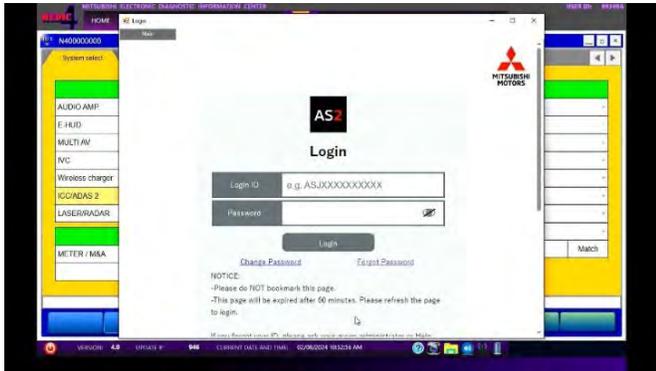
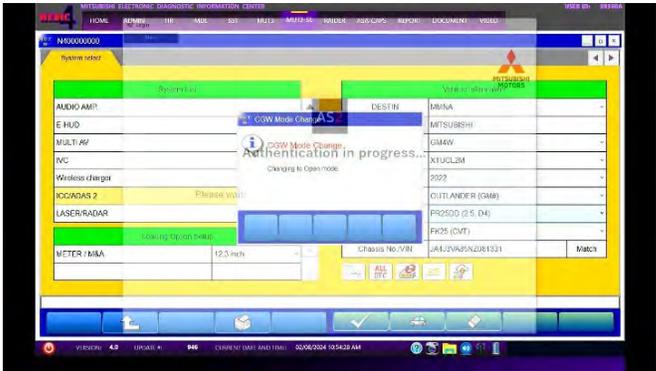
c. Log into AS2.

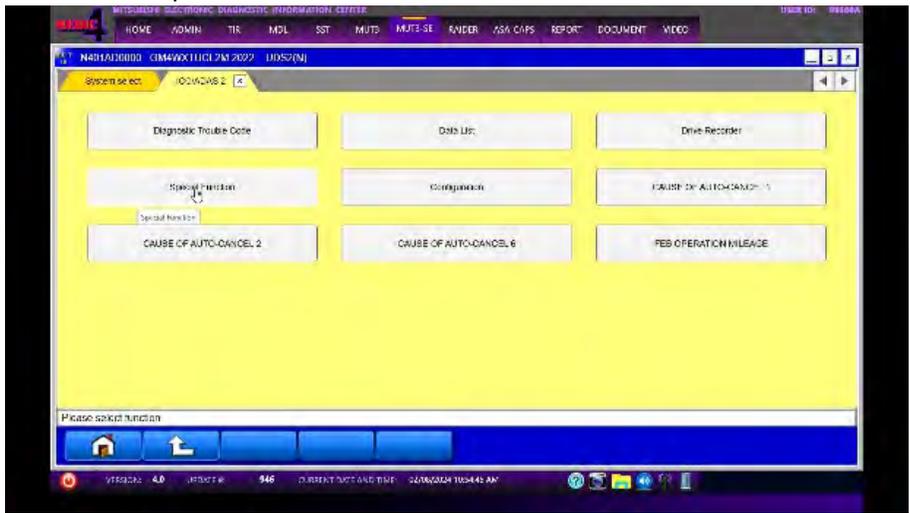
d. Press the "Special Function" button.

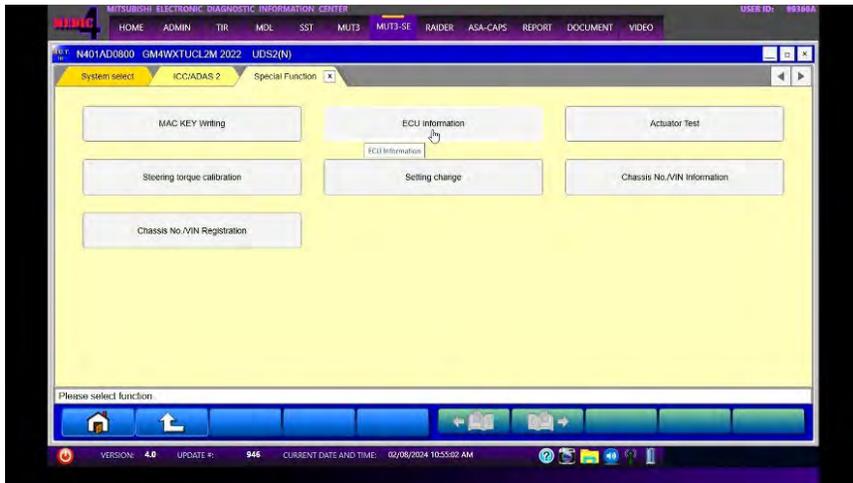
e. Select the "ECU Information" button.

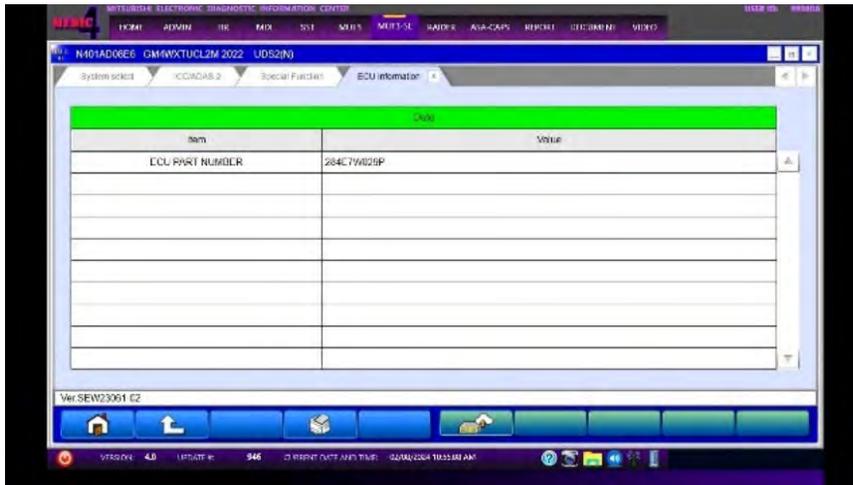
f. The current ECU Part Number will be displayed. If the ECU is at the latest level, reprogramming **is not** necessary.

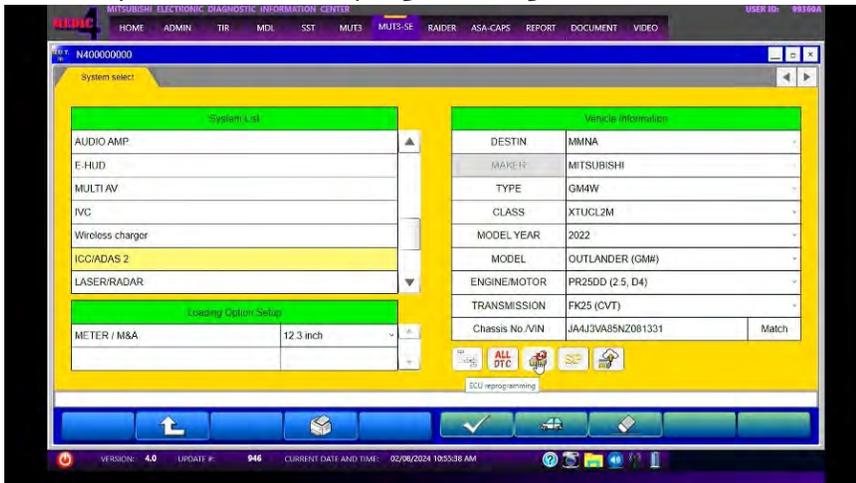
7. If reprogramming is necessary, proceed with the following steps. Return to the "System Select" tab and press the "ECU reprogramming" button.

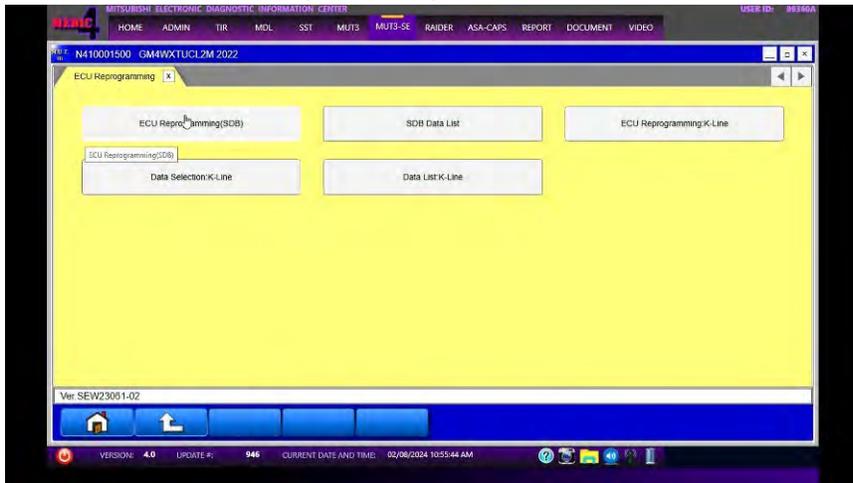
a. Select the "ECU Reprogramming(SDB)" button.

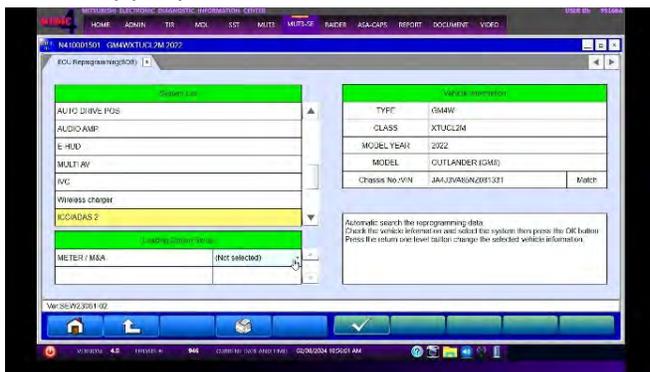
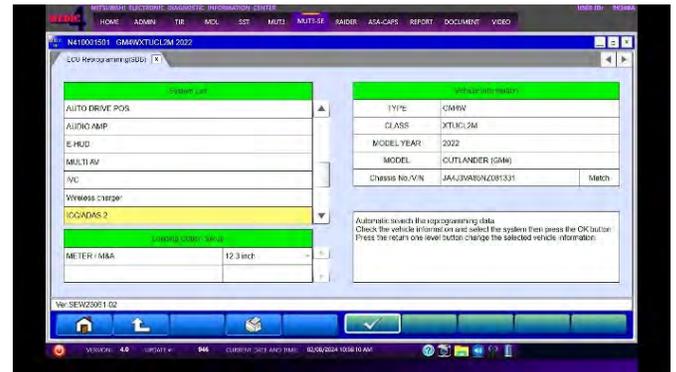
b. Select appropriate "Meter / M&A" and select the OK button.

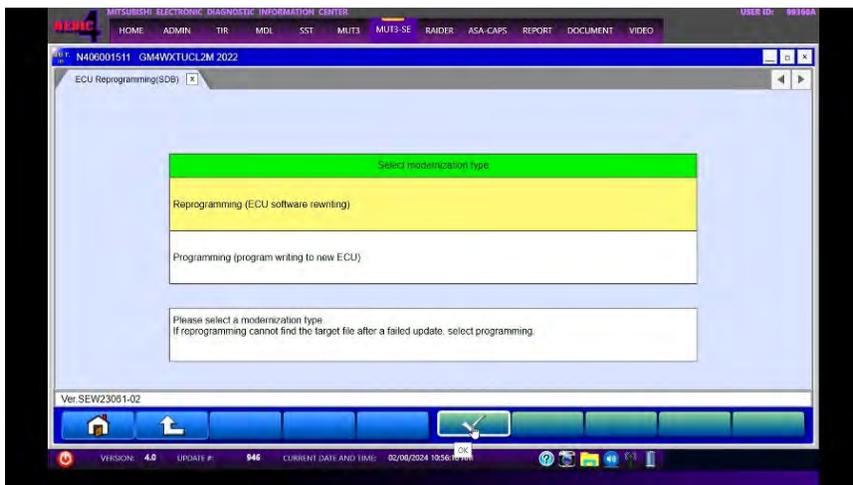
c. Select a modernization type - "Reprogramming (ECU software rewriting)" button and select the OK button.

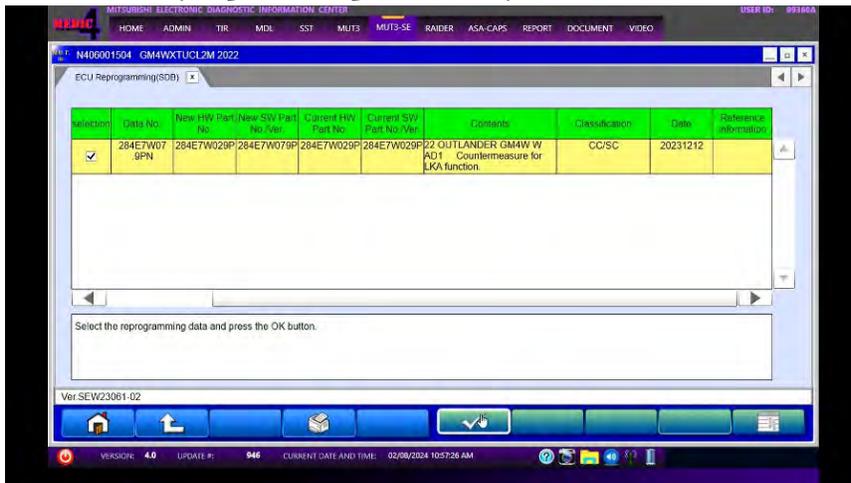
d. Select the reprogramming data and press the OK button.

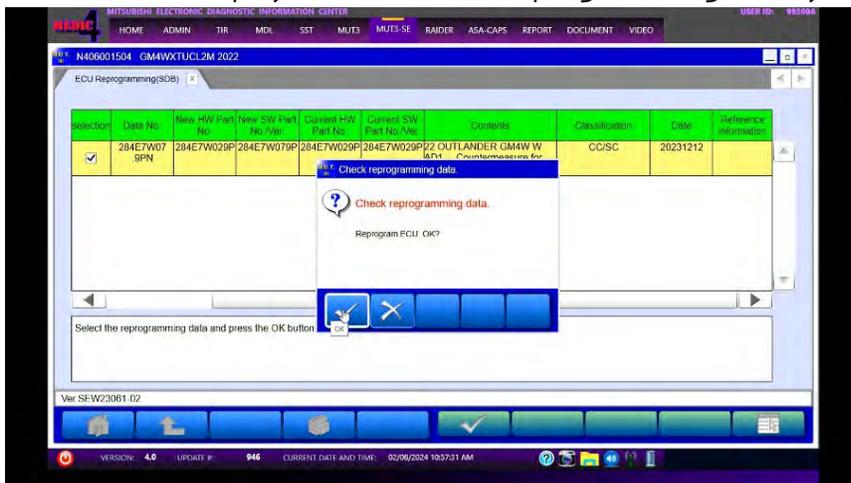
e. Confirm data displayed and confirm reprogramming ECU by selecting the OK button.

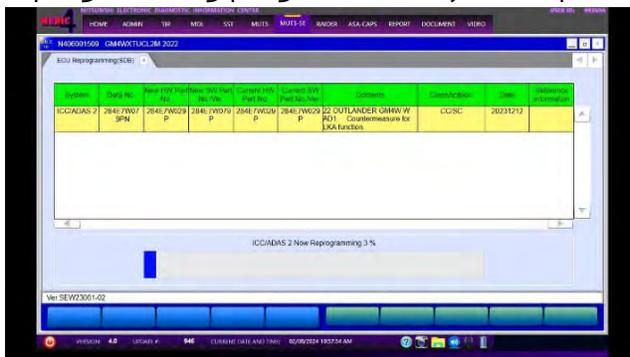
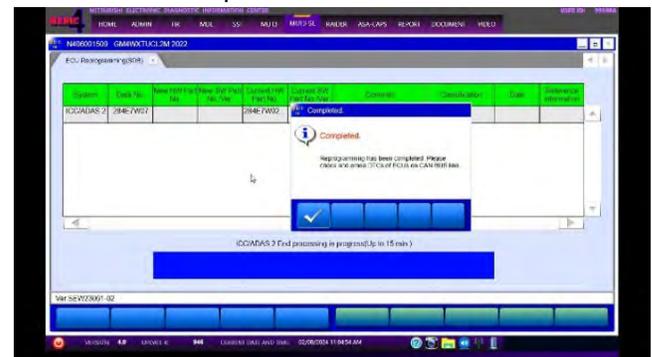
f. Once the reprogramming is initiated the screen (shown below) will indicate the reprogramming progress. It may take up to 15 minutes to complete.

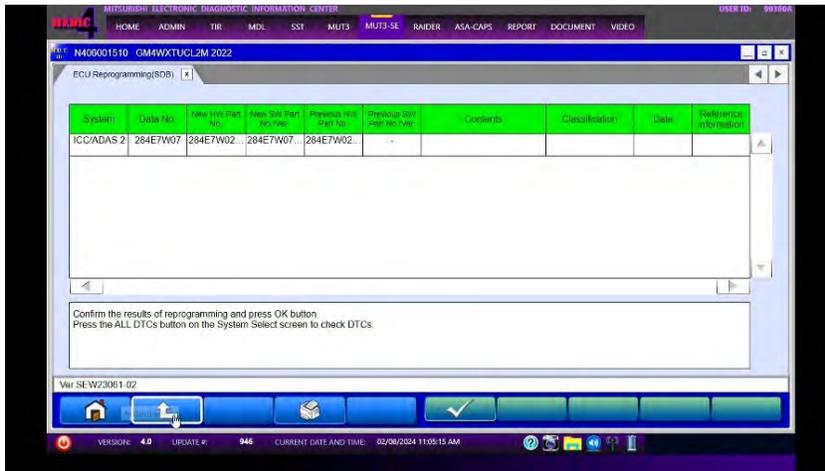
g. Verify that the software version has been updated to the new data number.

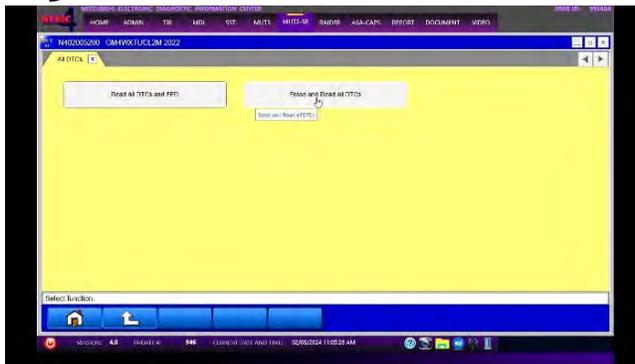
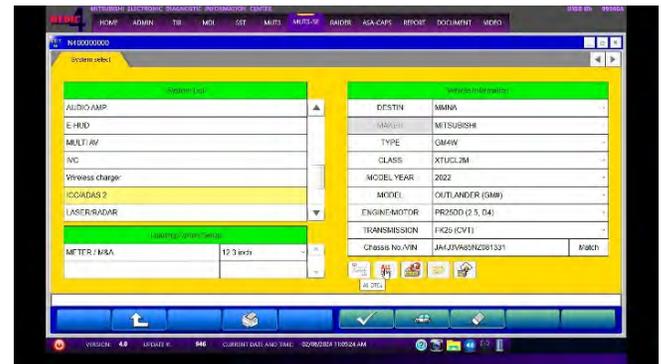
a. Return to the System Select screen. Press " ALL DTC " button to initiate the " Erase and Read all DTCs ". **IMPORTANT: The " Erase and Read all DTCs " must be performed since DTCs may be generated and stored.**

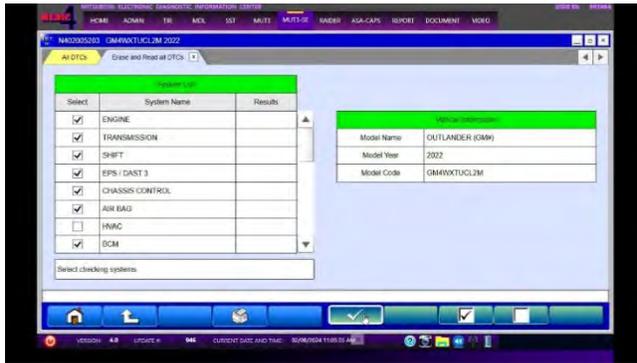
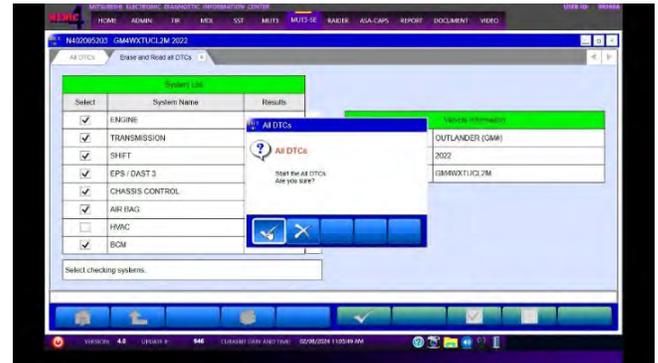
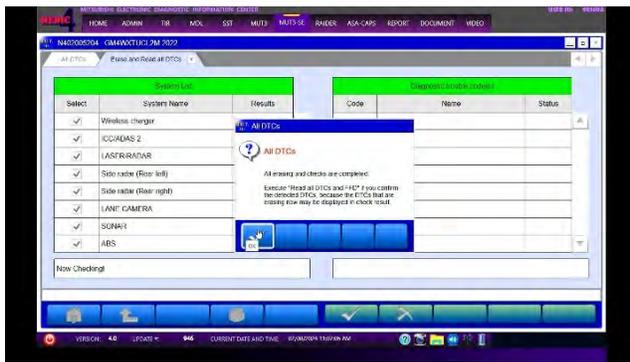
- b. Press OK to initiate erasing all DTCs. When completed, a confirmation message will be displayed. Click the OK Button.
