Subject: UPDATE: N232428540 - Customer Satisfaction Program  
Multiple Module Reprogramming  
Population Expansion

Models: 2023 Cadillac LYRIQ

## N232428540 Multiple Module Reprogramming

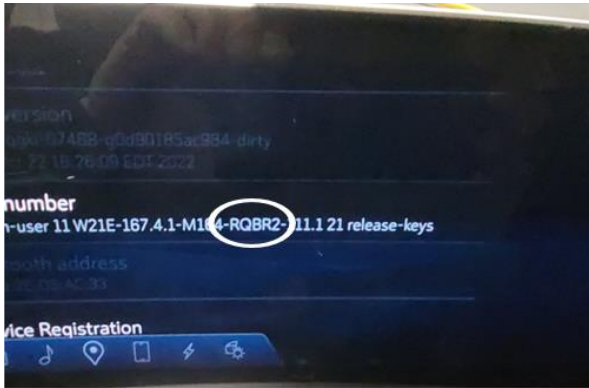
6554765

1. Ignition On, verify the build number:

5.1. If the build number is W37E-169.1.2-M164-RQBR2-198.1. continue to step 2. **RQBR2 is what should be verified.**

5.2. If the build number is 170.5.1-M166-SQBR3-187.1 continue to step 20.

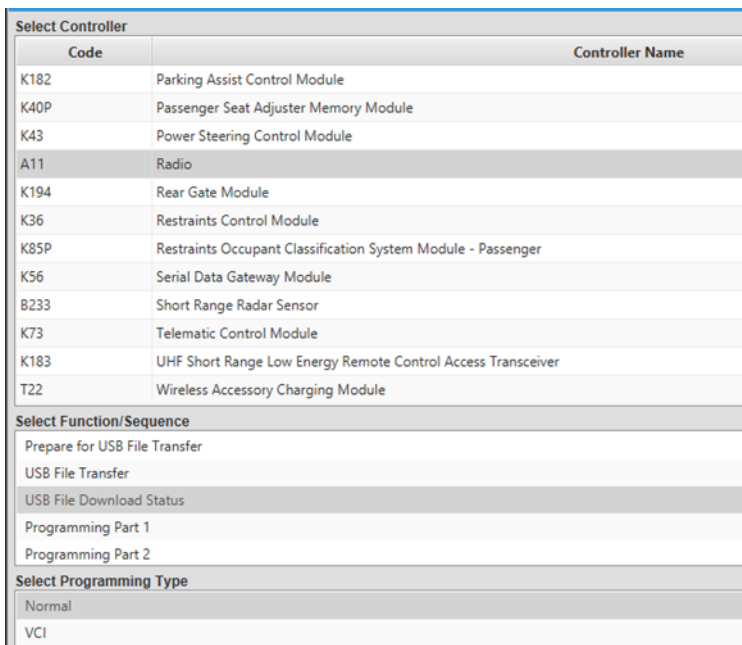
6576531

**Note:** The radio may go black and restart multiple times during the update, please do not shut the vehicle off if this happens, this is a normal part of the programming process.

11. The infotainment system will recognize that update files are available. Follow the infotainment display on-screen instructions and select Update when prompted. Programming may take up to 30 minutes.

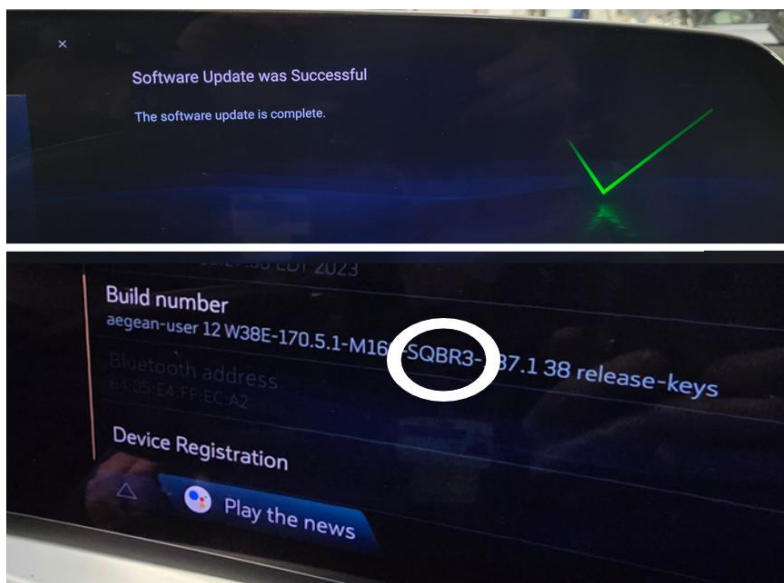
6554770

20. Ignition On, verify the build number is 170.5.1-M166-**SQBR3**-187.1. **SQBR3** is what should be verified. If build number displays 170.5.1-M166-**SQBR3-187.1**, continue to step 22.
21. If the radio does NOT display 170.5.1-M166-**SQBR3-187.1** please go back to step one and go through the update and programming process again.
22. Ignition Off.
23. Connect a USB drive to the computer.
