GROUP	MODEL
	Voluntary Service Campaign	2020-2024MY Telluride (ON)
	NUMBER	DATE
	SC301	May 2024

WSS SOFTWARE UPGRADE (SC301)

This bulletin provides information to update the Wheel Speed Sensor (WSS) software on certain 2020-2024MY Telluride (ON) vehicles manufactured from January 9, 2019 through March 10, 2024. The wheel speed sensor(s) (WSS) in the subject vehicles may be contaminated with moisture and cause corrosion, which may result in WSS signal fluctuation. If this condition occurs, in rare cases, WSS signal fluctuation may result in intermittent and momentary Anti-lock Braking System (ABS) activation at low speeds while braking. Customers may also experience an illumination of the ABS Warning light. The ability to stop the vehicle is unaffected by this issue.

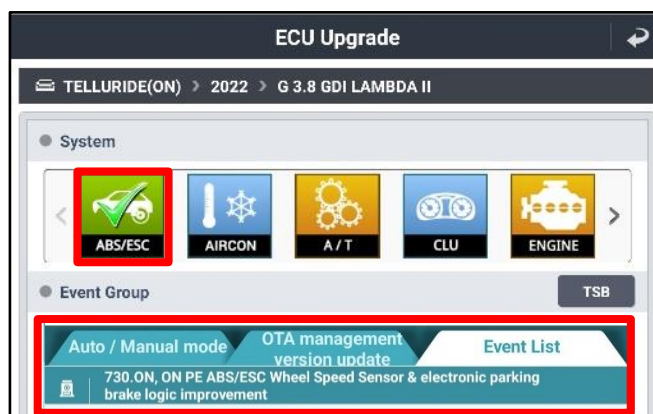
NOTICE

Prior to performing the ECU upgrade, be sure to check that the KDS is fully charged.
