GROUP	MODEL
ELE	2024MY Sportage (NQ5)
NUMBER	DATE
342	May 2024

TECHNICAL SERVICE BULLETIN

SERVICE ACTION: WIRELESS POWER CHARGER LOGIC IMPROVEMENT (SA572)

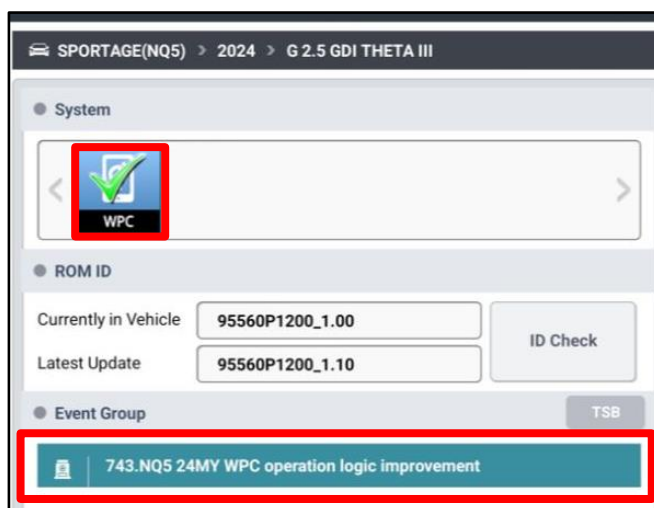
UPGRADE EVENT:

743.NQ5 24MY WPC Operation Logic Improvement

Prior to performing the ECU upgrade, be sure to check that the KDS is fully charged.
