# Technical Service Bulletin

| <b>SUBJECT:</b><br><br><b>EV SYSTEM ERROR MESSAGE WITH DTC CODE P2100-00,<br/>ENGINE WARNING LIGHT AND ENGINE POWER REDUCTION<br/>DURING COLD TEMPERATURES</b> | | | No: <b>TSB-24-16-001</b> |
| | | | MODEL: <b>Outlander Plug-in Hybrid</b> |

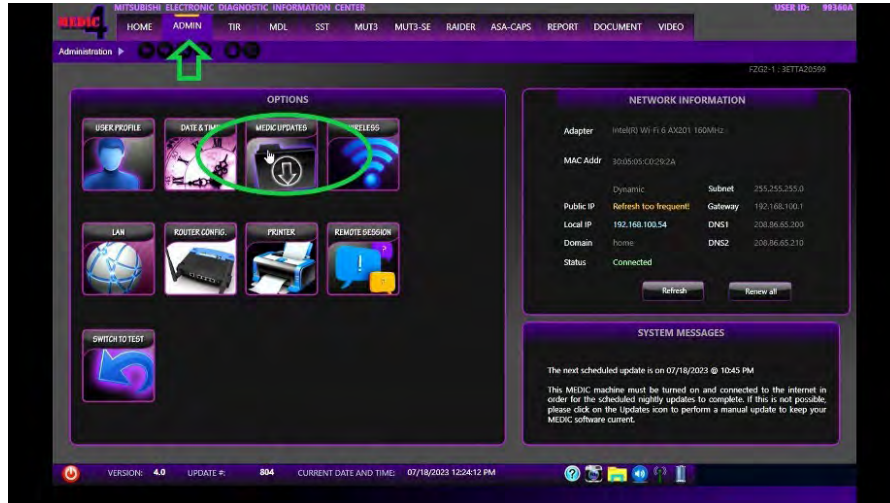
3. Select the MEDIC 3.5/4 Admin tab and click on "Updates".

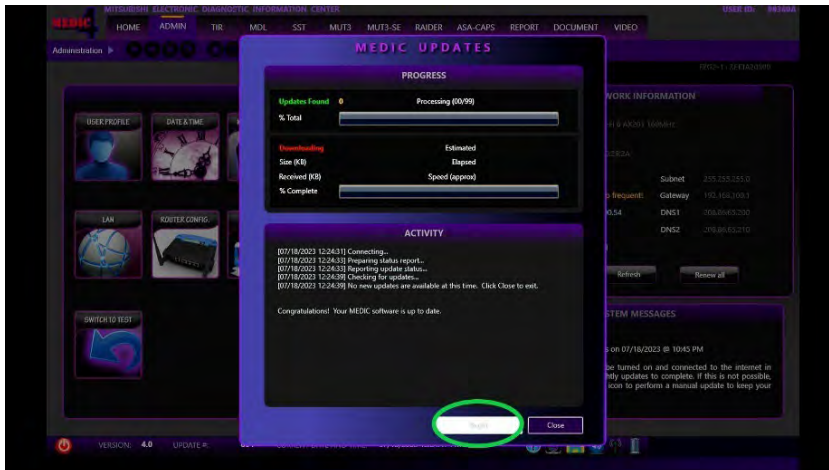
4. If the MEDIC update screen advises updates are available, click the "Begin" button. After all updates are complete, **GO TO THE REPROGRAMMING PROCEDURE.**

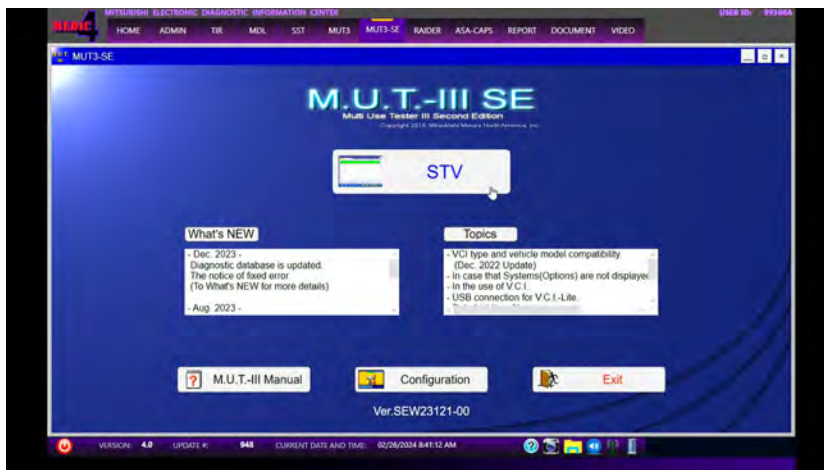
- a. Press the MUT-III SE STV button.

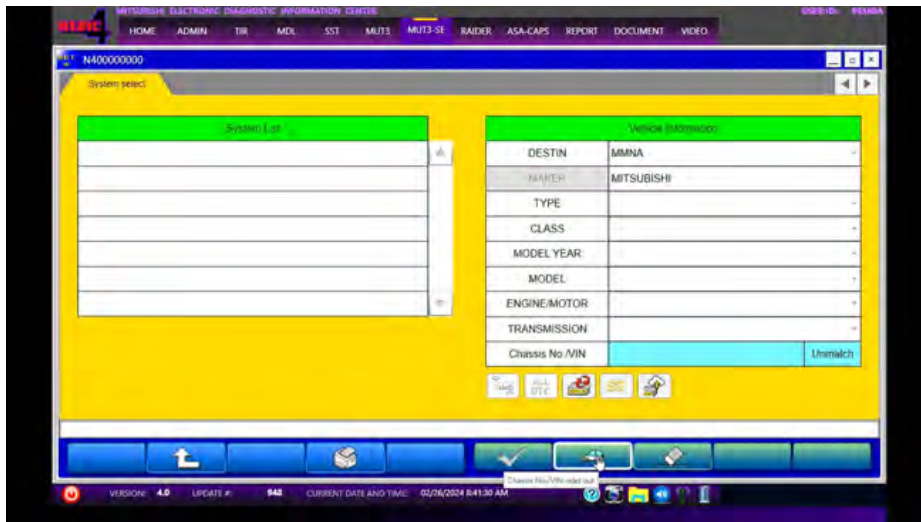
b. Push the car icon for Chassis No./VIN read out.

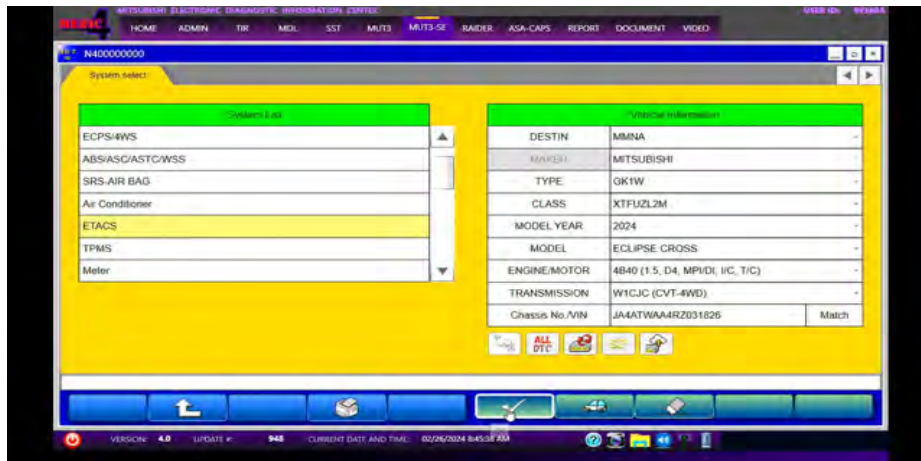
c. Confirm the vehicle information displayed is complete/correct, press the ECU reprogramming button.

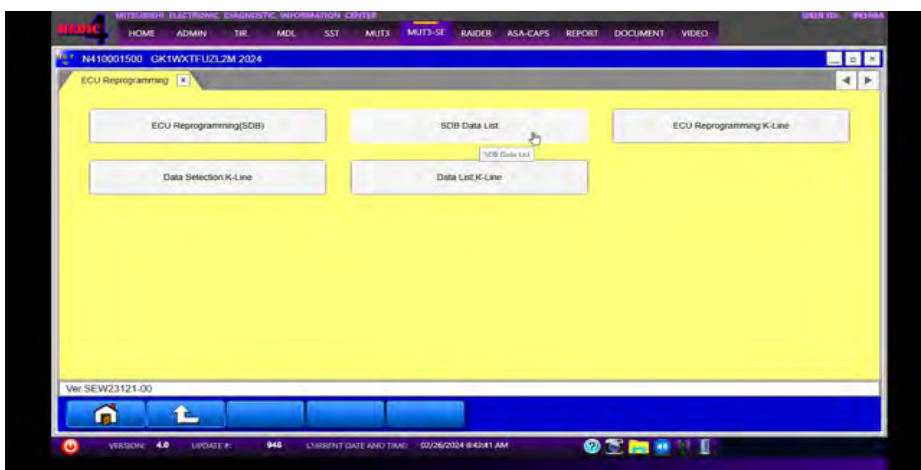
d. Select SDB Data List button.

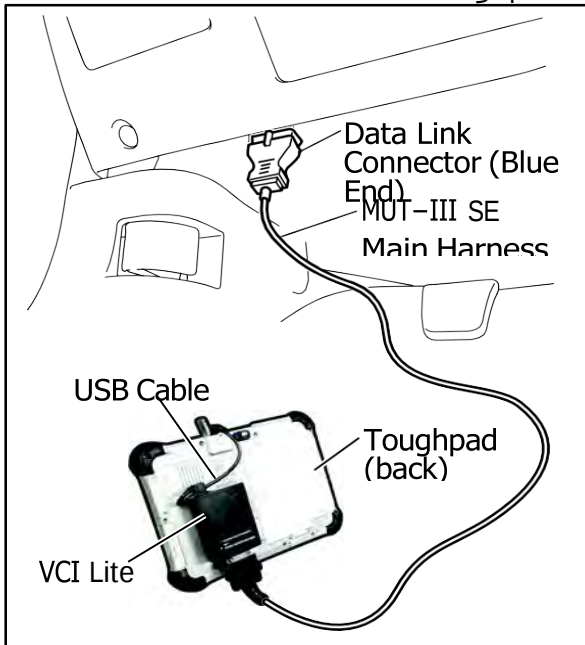
1. Connect the equipment as follows:

**NOTE:** VCI Lite and MEDIC 4.0 Toughpad shown for illustration purposes only.

- Turn the MEDIC PC/tablet on. If the battery indicator in the lower right hand corner of the screen does not show a full charge, it is recommended that either the battery be charged prior to beginning or be used with the A/C power adaptor connected.
- Connect the USB cable to the VCI/VCI Lite. When the laptop/tablet displays the MUT-III SE main screen, connect the USB cable to the device.
- Connect the MUT-III SE main harness with the blue DLC connection to the VCI/VCI Lite. Connect the blue connection of the MUT-III SE main harness to the vehicle's data link connector.
- For VCI only: Turn the VCI power switch ON. Verify that the indicator lamp in the upper right corner of the screen is green.

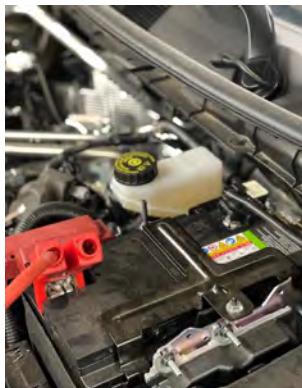
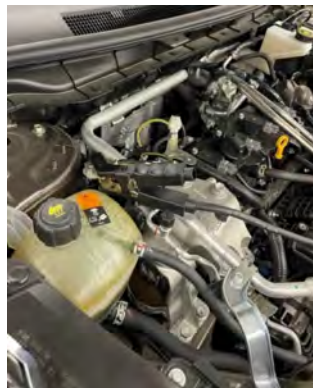
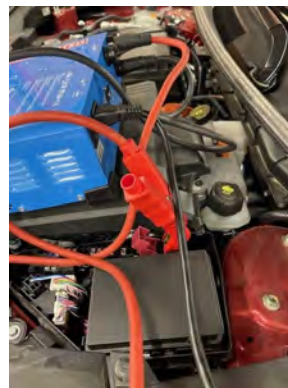
**NOTE:** Due to limited space it may be easiest to connect battery charger cable onto ground point.

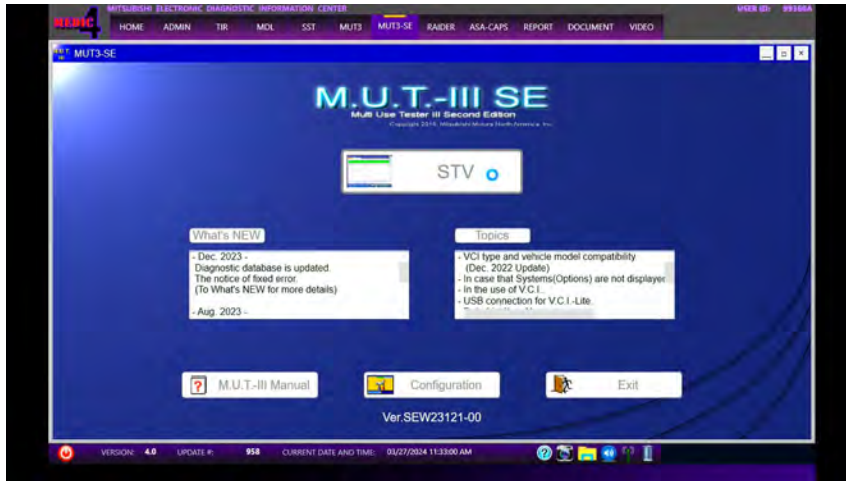
2. Turn the power switch to the "ON" position.
3. Turn on flashers to prevent vehicle from shutting/powering down.
4. Press the MUT-III SE STV button.

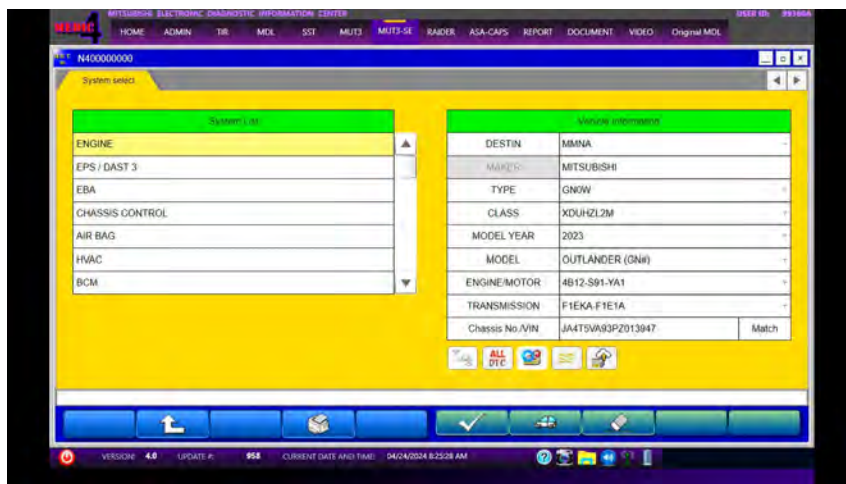
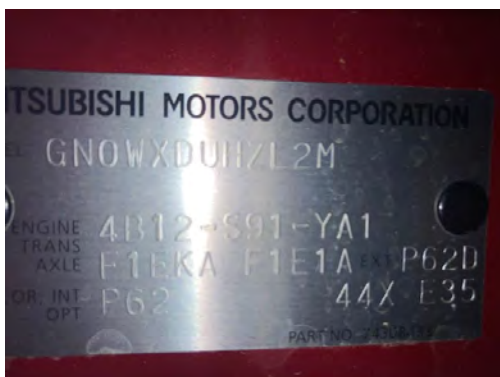
5. Press the Chassis No/VIN read out (car icon). Look at the label on the passenger side B pillar to identify the appropriate class. (See B pillar label below; class is labeled as "model"). Verify all vehicle information.

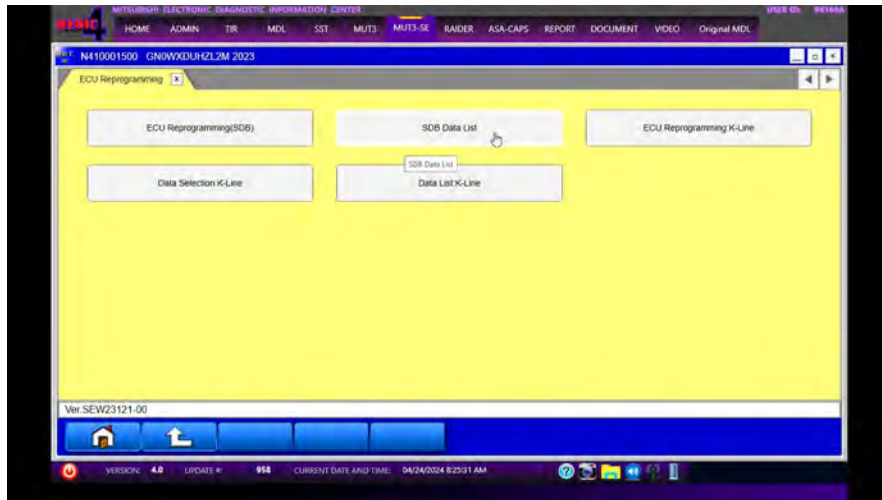
6. Select SDB Data List.

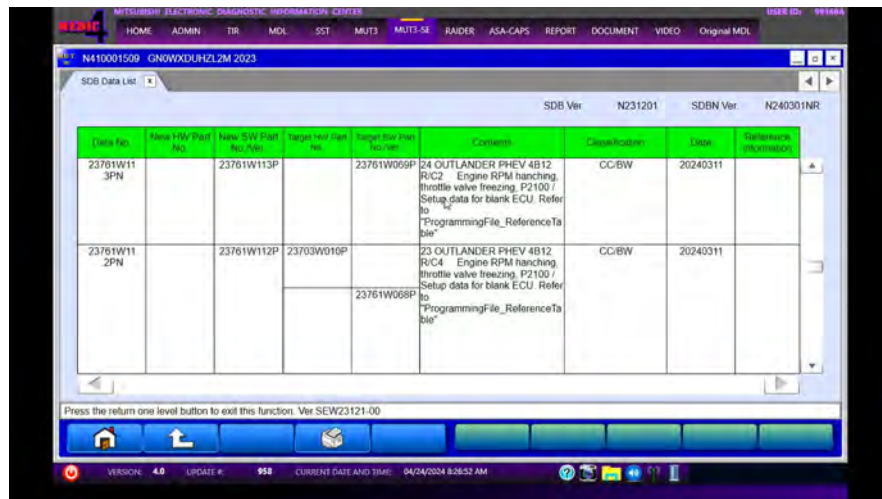
7. Verify software Information according to the chart in this bulletin.

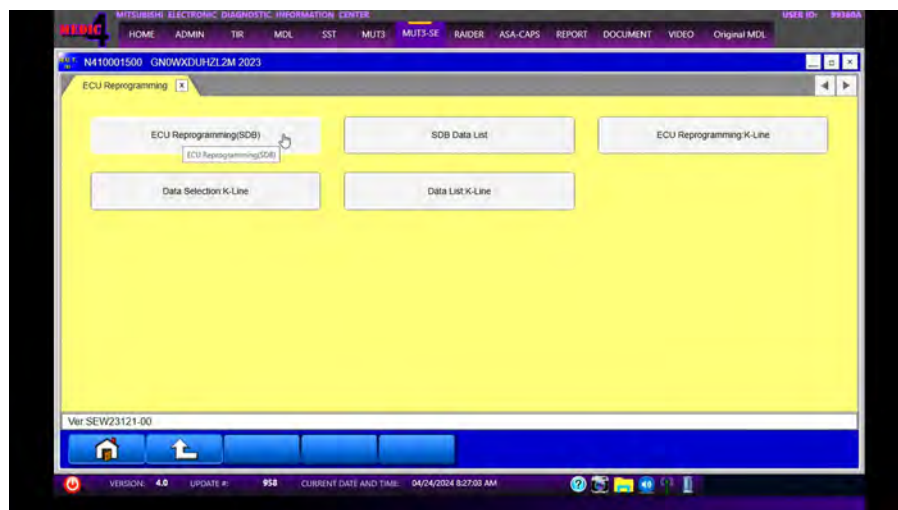
8. Select ECU Reprogramming (SDB).

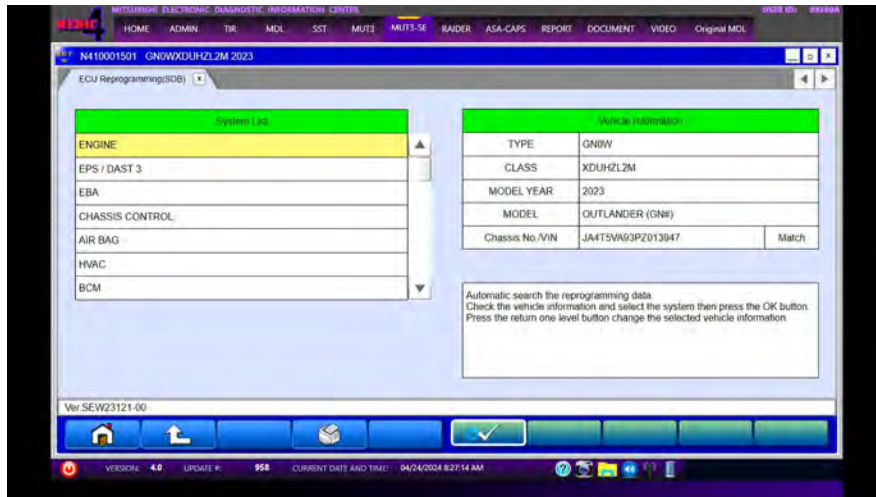
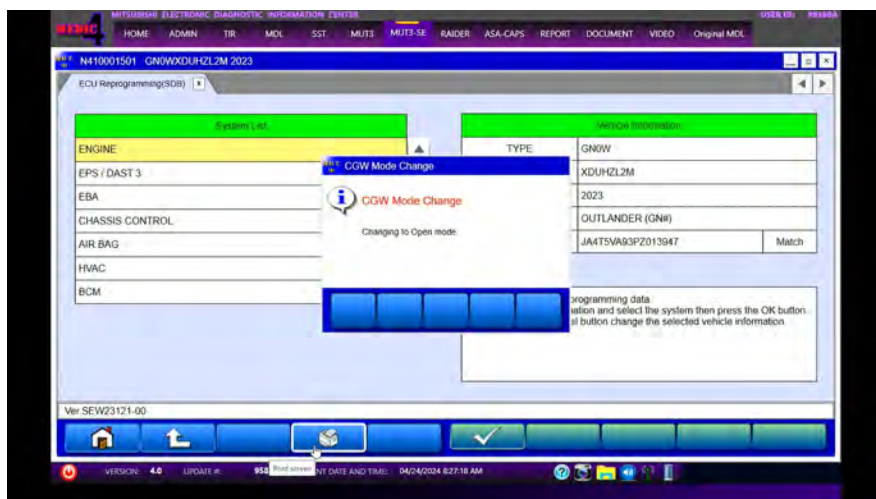
9. Select ENGINE and press the OK button.

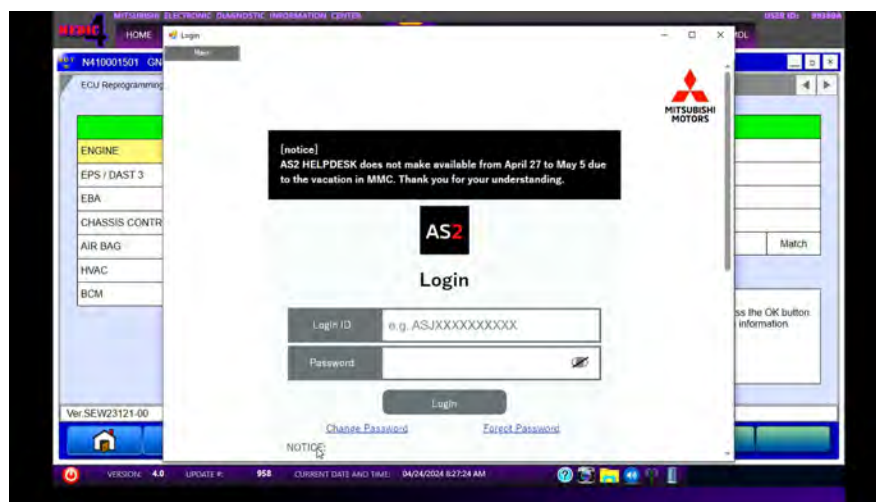
10. Log into AS2.

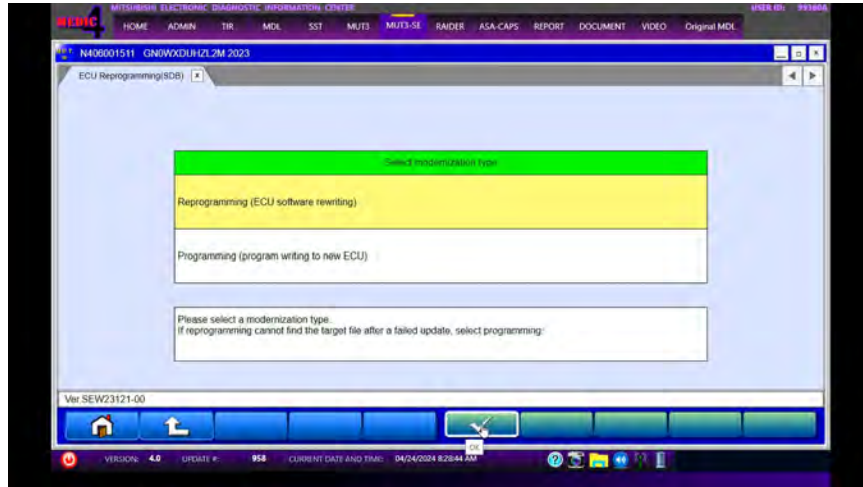
11. Select Reprogramming (ECU) software rewriting and press the OK button.

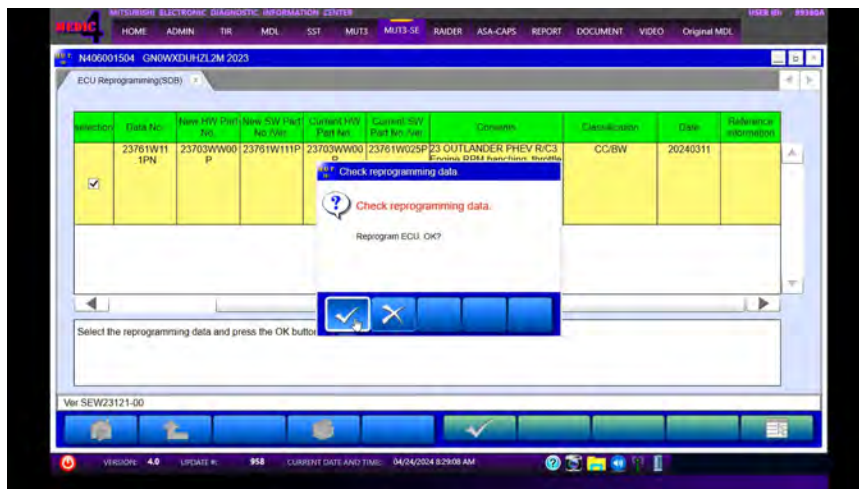
12. Check the reprogramming data, check the box and press the OK button to reprogram.

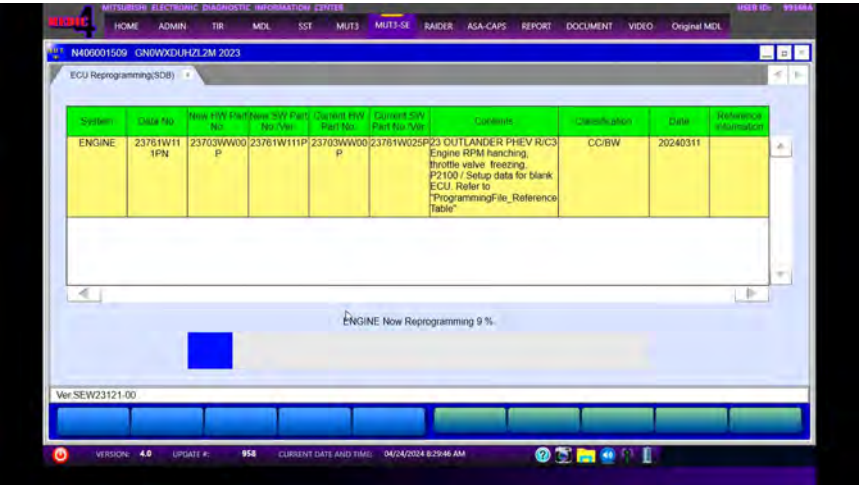
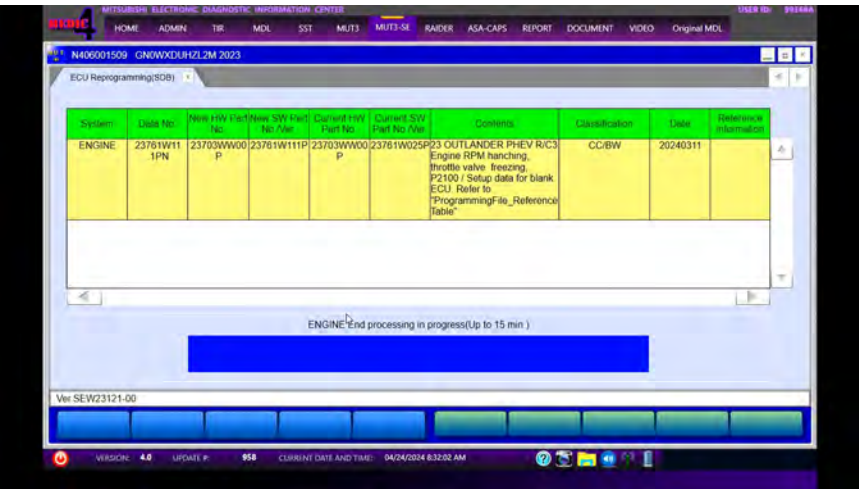
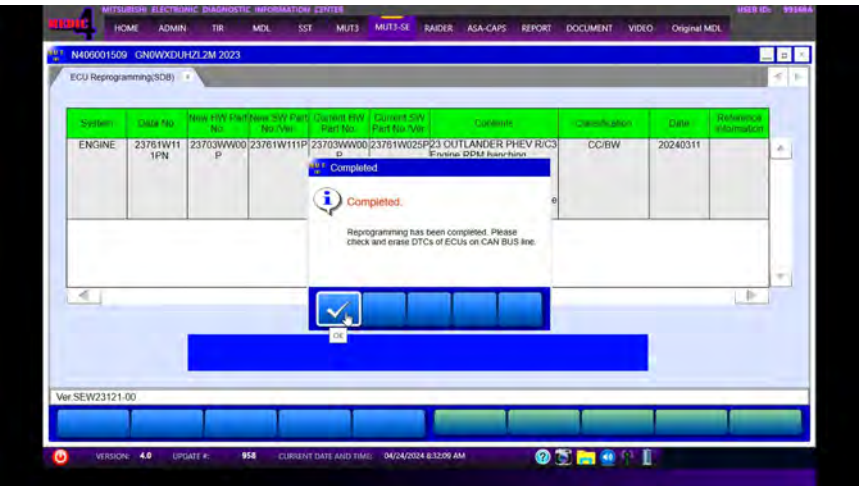
13. ENGINE reprogramming status bar will be displayed (allow approximately 15 minutes). When completed press OK.

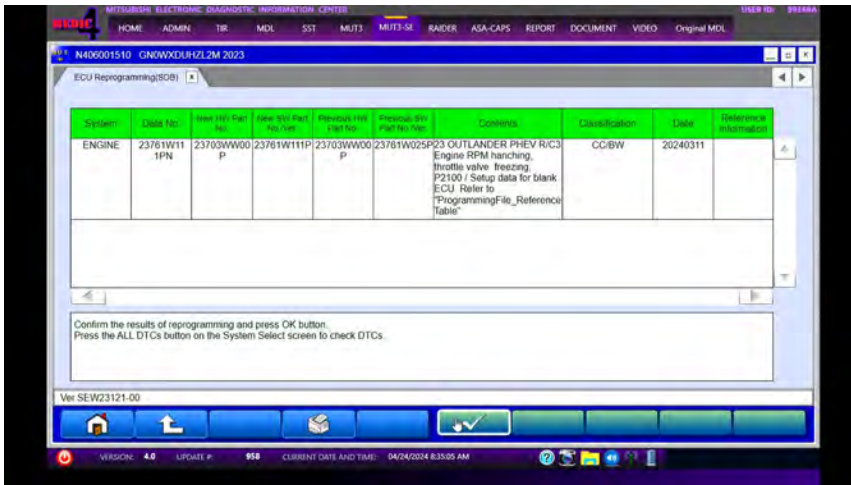
14. Confirm the reprogramming results and press the OK button.

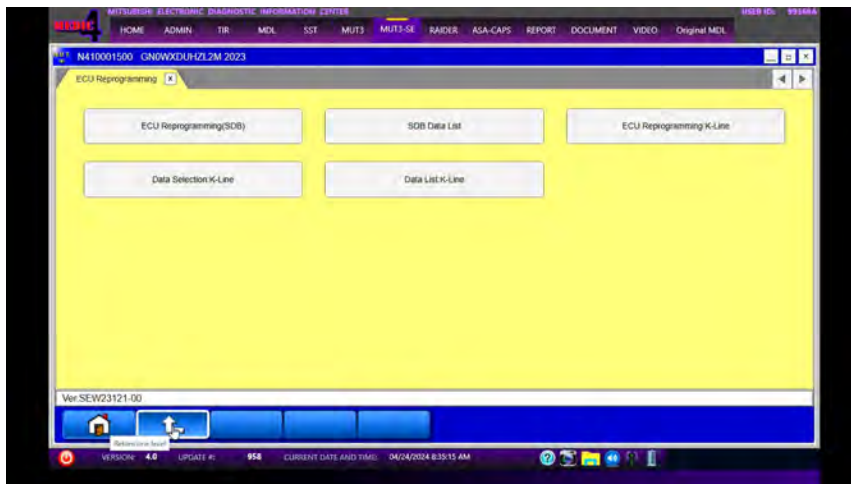
15. Return up one level.

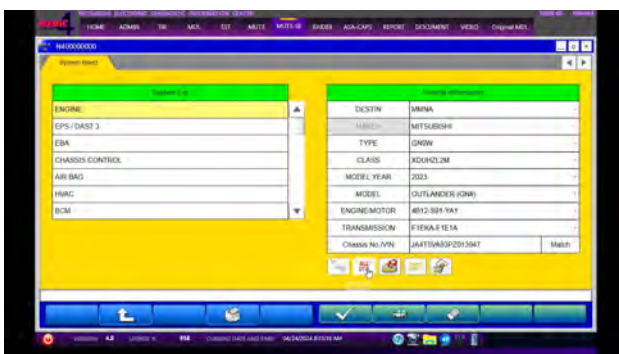
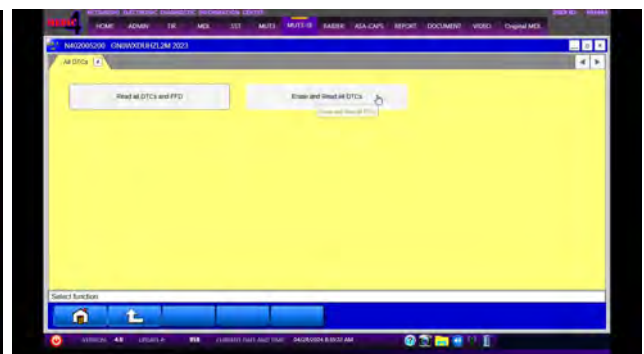
Press "ALL DTC" button to initiate the "Erase and Read all DTCs". Return to the System Select screen to select Erase and Read all DTCs . Select all systems from the list and press OK.

**IMPORTANT:** The "Erase and Read all DTCs" must be performed since DTCs may be generated and stored.

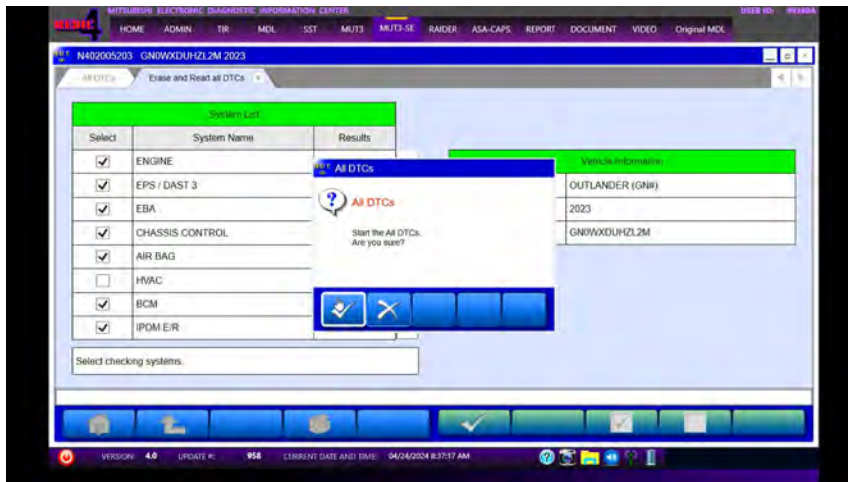
17. Press OK to start checking All DTCs.

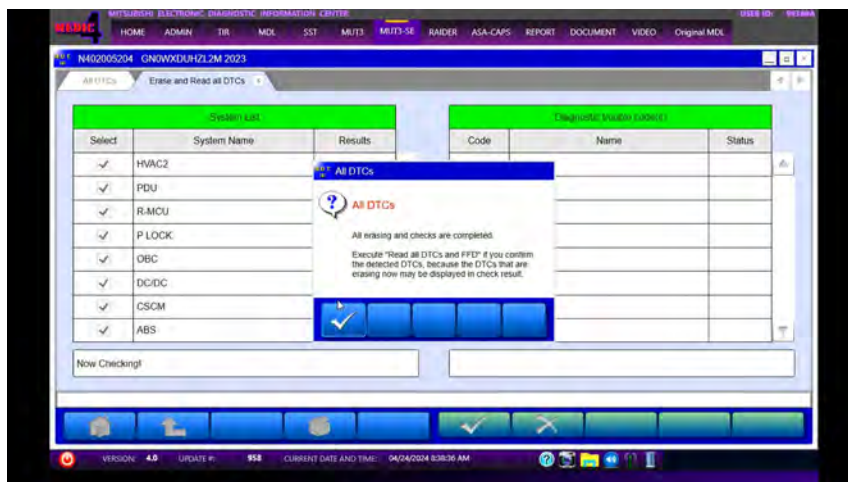
18. When all erasing and checks are completed, press OK.

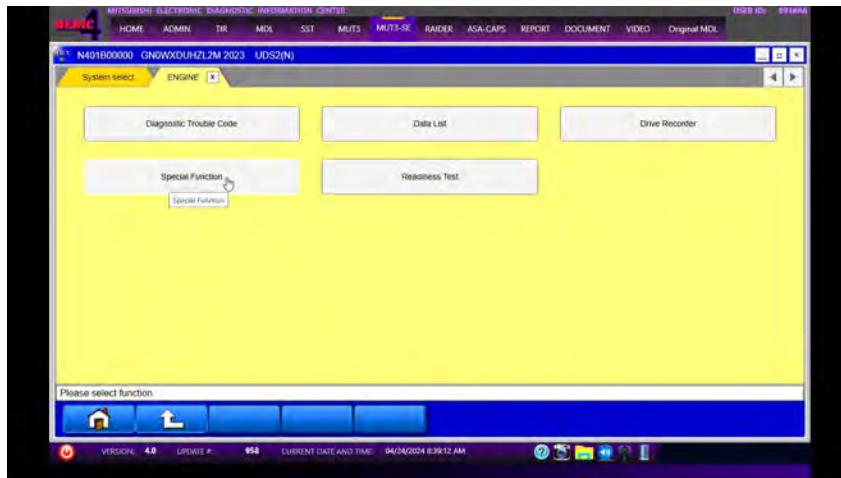
19. From the ENGINE tab, select Special Function.

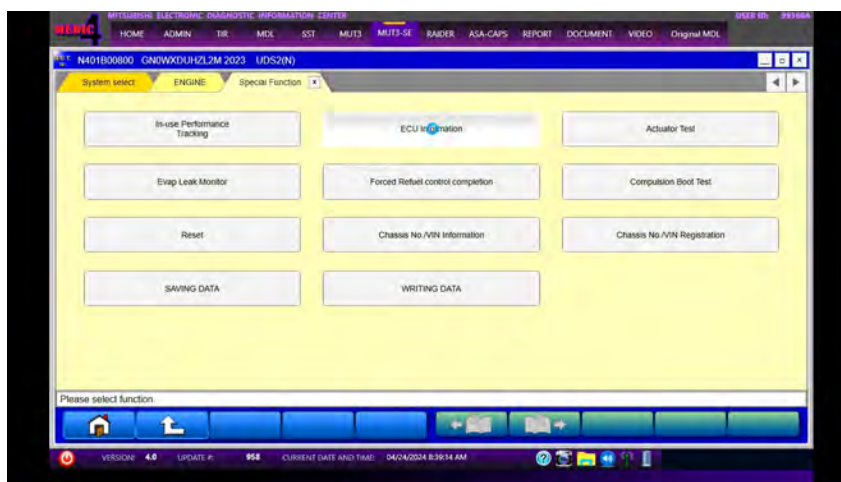
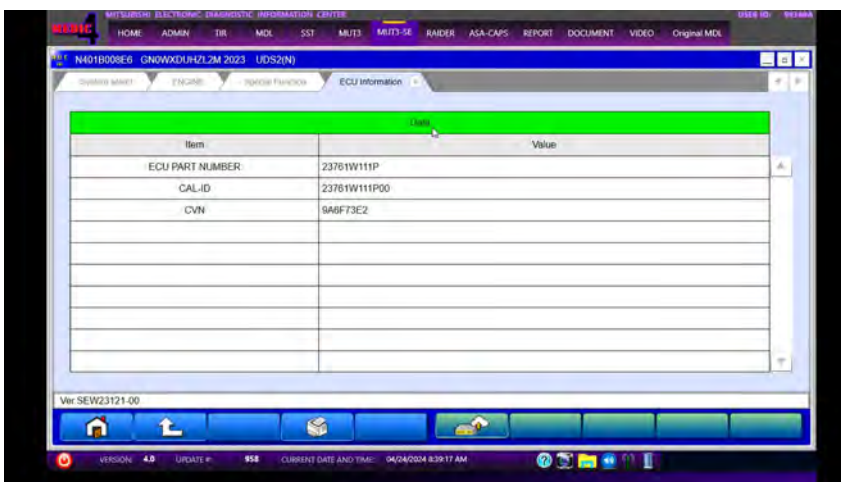
20. From the SPECIAL FUNCTION tab, select ECU Information and verify the ECU Part Number.
