Technical Service Bulletin (TSB)
Global Telematics Box Module (TBM) Firmware Over The Air (FOTA) Software Update from 5.15 to 5.43

REFERENCE:	TSB: 08-138-24 GROUP: 08 - Electrical	Date:	June 6, 2024	REVISION:	–
VEHICLES AFFECTED:	2023 - 2024 (JL) Jeep Wrangler This bulletin applies to vehicles equipped with an Instrumental Panel Parts Module (Sales Code X81) with Connectivity - US/CANADA (Sales Code RTM) with Global Telematics Box Module (Sales Code RDG).	MARKET APPLICABILITY:			
		<input checked="" type="checkbox"/> NA <input type="checkbox"/> MEA <input type="checkbox"/> SA <input type="checkbox"/> IAP <input type="checkbox"/> EE <input type="checkbox"/> CH			
CUSTOMER SYMPTOM:	Customers may experience one or more of the following: <ul style="list-style-type: none"> • Remote door lock and unlock commands sent from the Jeep mobile app fail. • After saving the edited charge or climate schedule in the radio, the mobile app reverts it back to the schedule set on the Jeep mobile app. • Remote operation ignition on remote start not working. • Customer not receiving a monthly email containing the VHR (Vehicle Health Report).

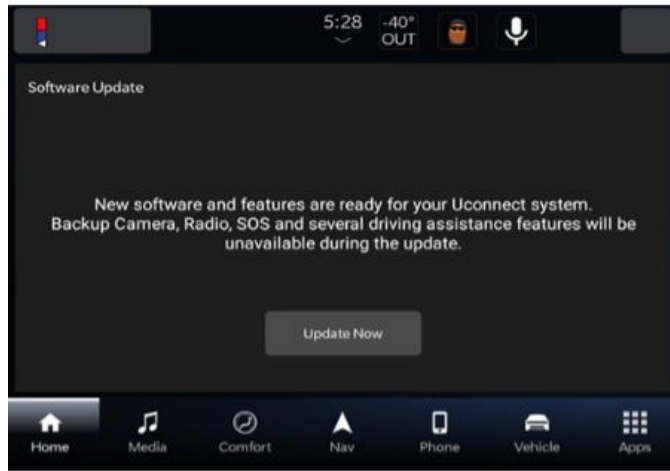
Fig. 1
Software Acceptance Screen

1. The vehicle needs to be in 'Park'. The ignition needs to be in the off position.
2. If the customer selects "Update Now" they can shut off the vehicle and leave. The update will be completed automatically.

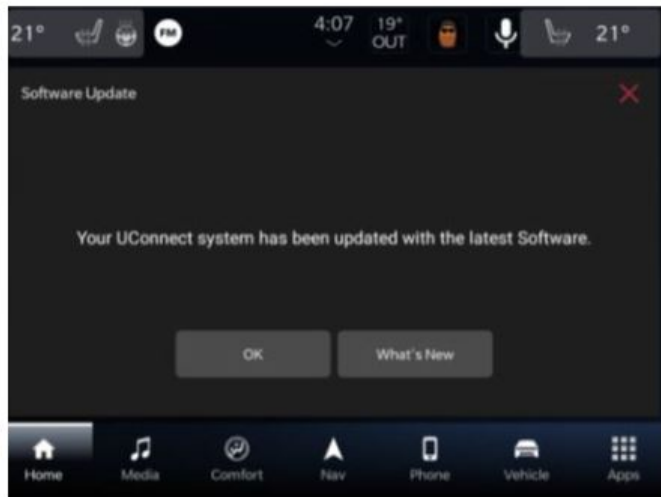
Fig. 2
Software Update Confirmation Screen

3. Upon completion of update, the radio will display a confirmation message [Fig. 2](#).
