GROUP	MODEL
ELE	2024MY EV9 (MV)
NUMBER	DATE
327	June 2024

TECHNICAL SERVICE BULLETIN

SUBJECT: **SERVICE ACTION: RSPA LOGIC IMPROVEMENT (SA558)**

This bulletin provides the procedure to update the software logic of the Advanced Drivers Assistance System Parking (ADAS_PRK) system on certain 2024MY EV9 (MV) vehicles produced from September 24, 2023 through November 30, 2023, to restore Remote Start Parking Assist (RSPA) operation following incorrect software version installation, which may have resulted in RSPA becoming inoperative. Follow the procedure outlined in this publication to apply the improved logic to the 'ADAS_PRK' system using the KDS ECU Upgrade function in Manual Mode only as described in this bulletin. For confirmation that the latest reflash has been applied to a vehicle you are working on, verify the ROM ID using the table on page 6 of this bulletin.

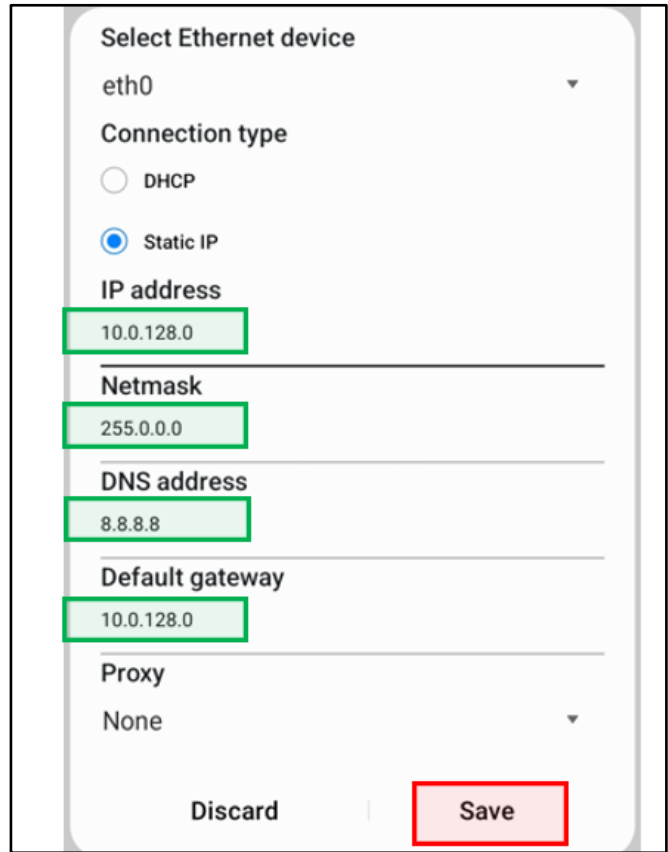
- 7a. Input 10.0.128.0 under 'IP address'.
- 7b. Input 255.0.0.0 under 'Netmask'.
- 7c. Input 8.8.8.8 under 'DNS address'.
- 7d. Input 10.0.128.0 under 'Default gateway'.
- 8. Select 'Save'.

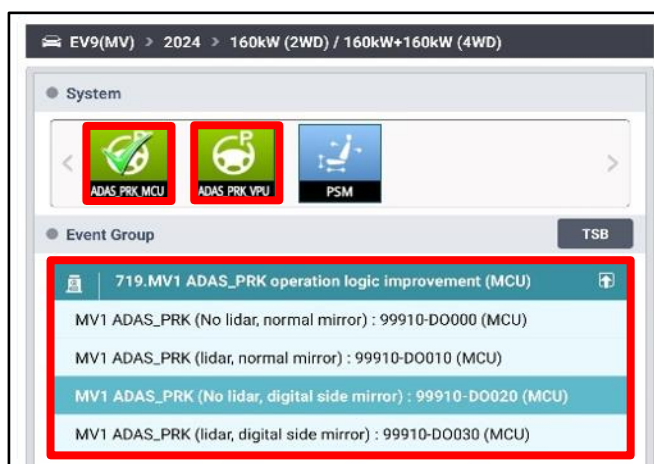
UPGRADE EVENT:

719.MV1 ADAS_PRK Operation Logic Improvement (MCU)

AND

720.MV1 ADAS_PRK Operation Logic Improvement (VPU)
