GENERAL MOTORS
DCS6931
URGENT - DISTRIBUTE IMMEDIATELY

Subject: N242443001 - Service Update
High Voltage Battery Software Update

Models: 2017 – 2022 Chevrolet Bolt EV
2022 Chevrolet Bolt EUV

N242443001 High Voltage Battery Software Update

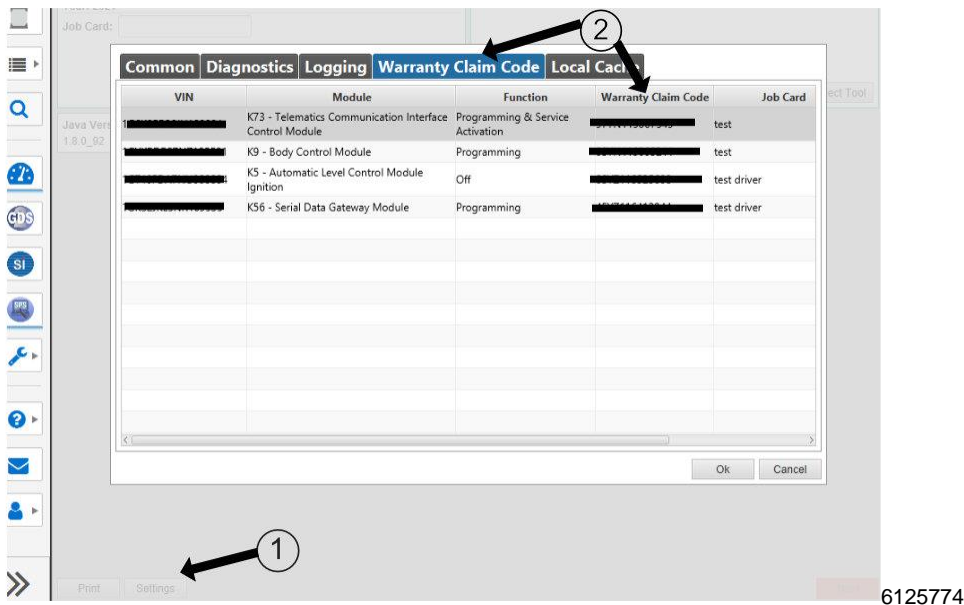
If the Warranty Claim Code was not recorded on the Job Card, the code can be retrieved in the SPS2 system as follows:

1. Open TLC on the computer used to program the vehicle.
2. Select and start SPS2.
3. Select Settings (1).
4. Select the Warranty Claim Code tab (2).

The VIN, Warranty Claim Code and Date/Time will be listed on a roster of recent programming events. If the code is retrievable, dealers should resubmit the transaction making sure to include the code in the SPS Warranty Claim Code field.

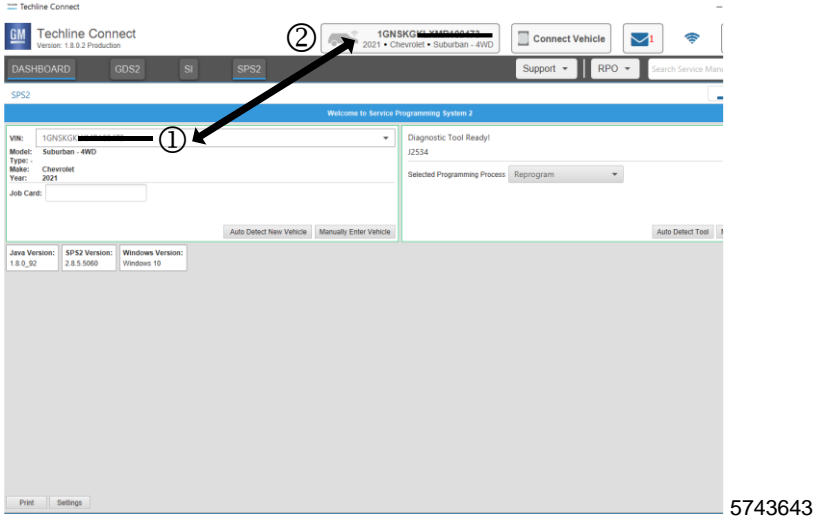
Caution: Be sure the VIN selected in the drop-down menu (1) is the same as the vehicle connected (2) before beginning programming.

Important: The service technician always needs to verify that the VIN displayed in the TLC left side drop down menu and the top center window match the VIN plate of the vehicle to be programmed prior to using Service Programming System 2 (SPS2) for programming or reprogramming a module.

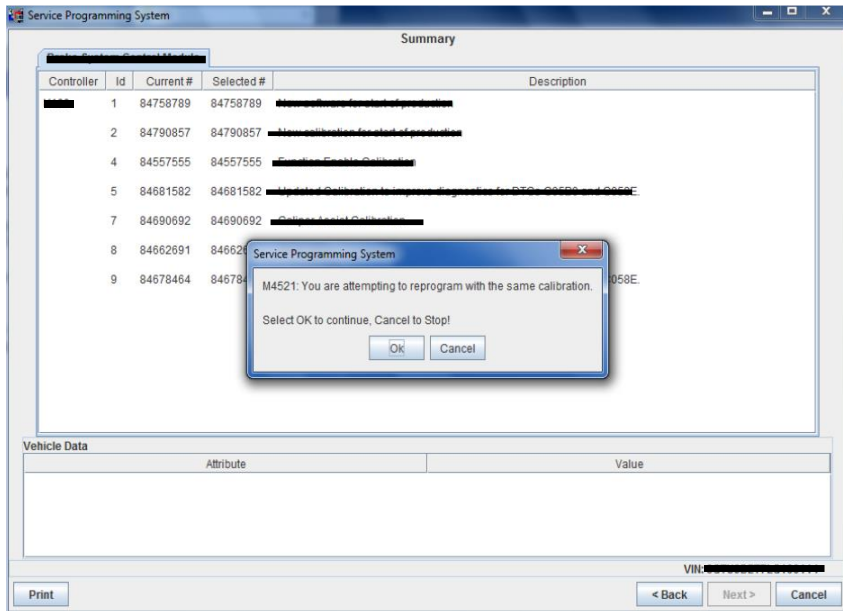
5431207

Important: Techline Connect and TIS2WEB screens shown above.

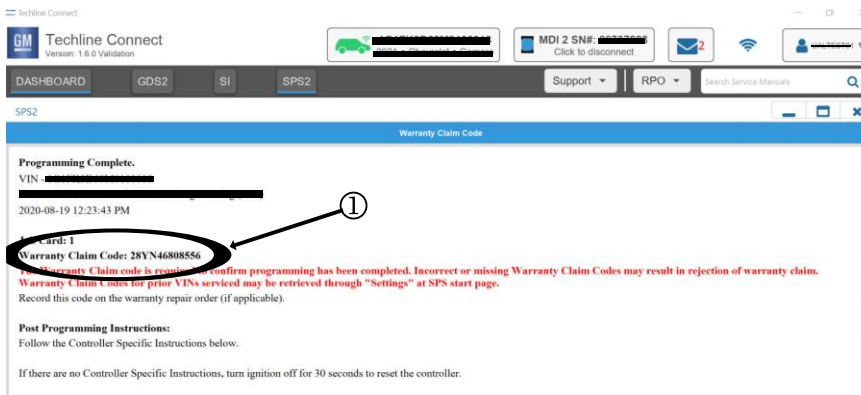
5644478

Important: If the same calibration/software warning is noted on the TLC or SPS Summary screen, select OK and follow screen instructions. After a successful programming event, the WCC is located in the Service Programming System dialogue box of the SPS Summary screen. No further action is required. Refer to the Warranty section of the bulletin.

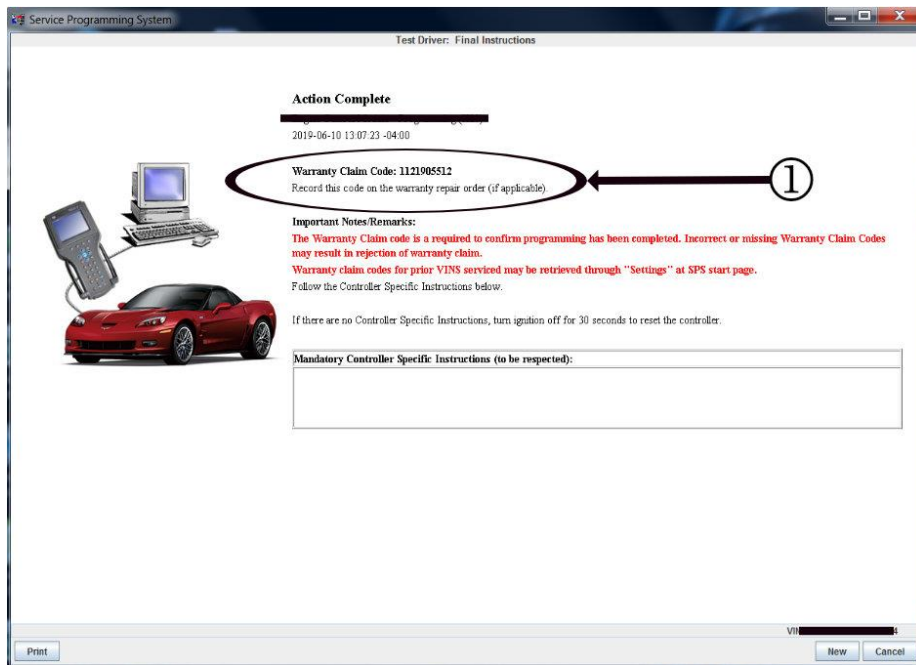
5431209

Note: The screenshots above are an example of module programming and may not be indicative of the specific module that is being programmed. Module selection and VIN information have been blacked out.
