March 2024  
SF681 A-C  
(Revised June 2024)

## **Subject: eCascadia Software Package Update**

**Models Affected:** Specific model years 2023-2024 Freightliner eCascadia vehicles, manufactured May 16, 2022, through September 19, 2023.

Certain eCascadia vehicles require eCPC (Electric Common Powertrain Controller) and BMS (Battery Monitoring System) software updates to resolve multiple issues.

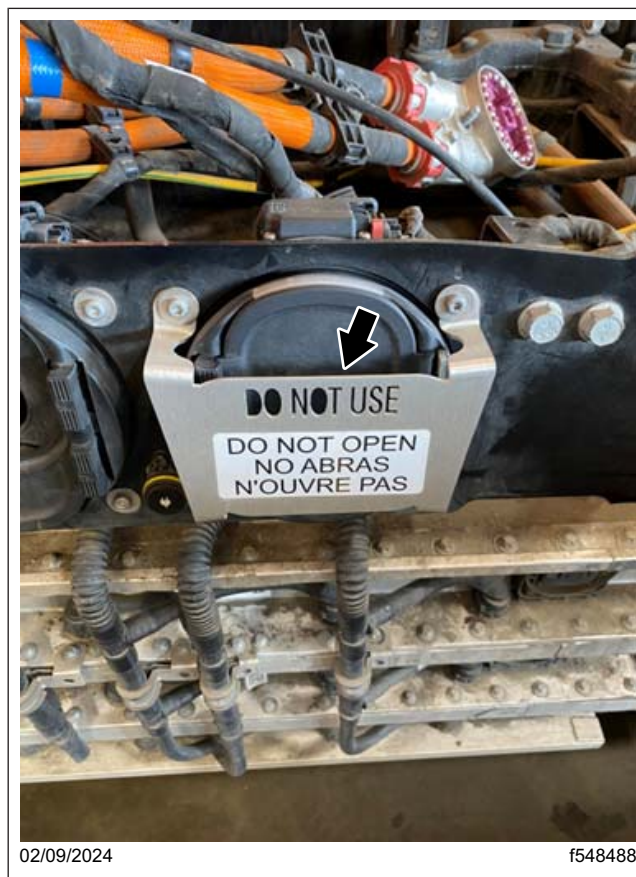
50. To ensure the high voltage connectors are installed vertically during installation, use the tool (DSNEMG022008) to connect the three high voltage connectors.
51. Remove the alignment pin, and install the high voltage connector mounting fasteners.
52. Install the high voltage cable clamps, and tighten the fasteners.
53. Tighten the high voltage connector fasteners 14 lbf·ft (19 N·m).
54. Secure the low voltage harnesses and the ground cables with cable ties.
55. Install the side impact protection. For instructions, see **Section 31.03, Subject 100** of the *eCascadia Workshop Manual*.
56. Remove the block off plate of the dual port charger. See **Fig. 16**.

**Fig. 16, Location of the Block Off Plate**

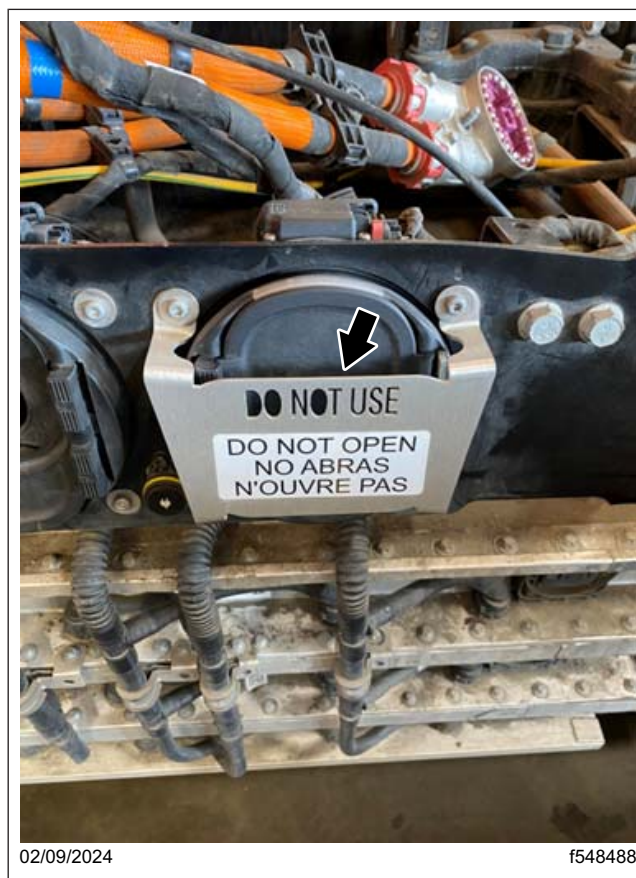
27. To ensure the high voltage connectors are installed vertically during installation, use the tool (DSNEMG022008) to connect the three high voltage connectors.
28. Remove the alignment pin, and install the high voltage connector mounting fasteners.
29. Install the high voltage cable clamps, and tighten the fasteners.
30. Tighten the high voltage connector fasteners 14 lbf·ft (19 N·m).
31. Secure the low voltage harnesses and the ground cables with cable ties.
32. Install the side impact protection. For instructions, see **Section 31.03, Subject 100** of the *eCascadia Workshop Manual*.
33. Remove the block off plate of the dual port charger. See **Fig. 20**.

**Fig. 20, Location of the Block Off Plate**
