D24M2

**Subject: Field Service Campaign D24M2
DETROIT® ePowertrain™ eCPC Reprogramming**

Models Affected					
Make	Model	Model Yr. Start	Model Yr. End	Prod. Start Date	Prod. End Date
Detroit Diesel Corporation	400.EM2 400.EP4 410.EM2 410.EP4	2023	2024	August 26, 2020	April 26, 2024
Freightliner	eCascadia eM2	2023	2024	August 26, 2020	April 26, 2024
Identifying Feature	Detroit ePowertrain eCPC Software Reprogramming

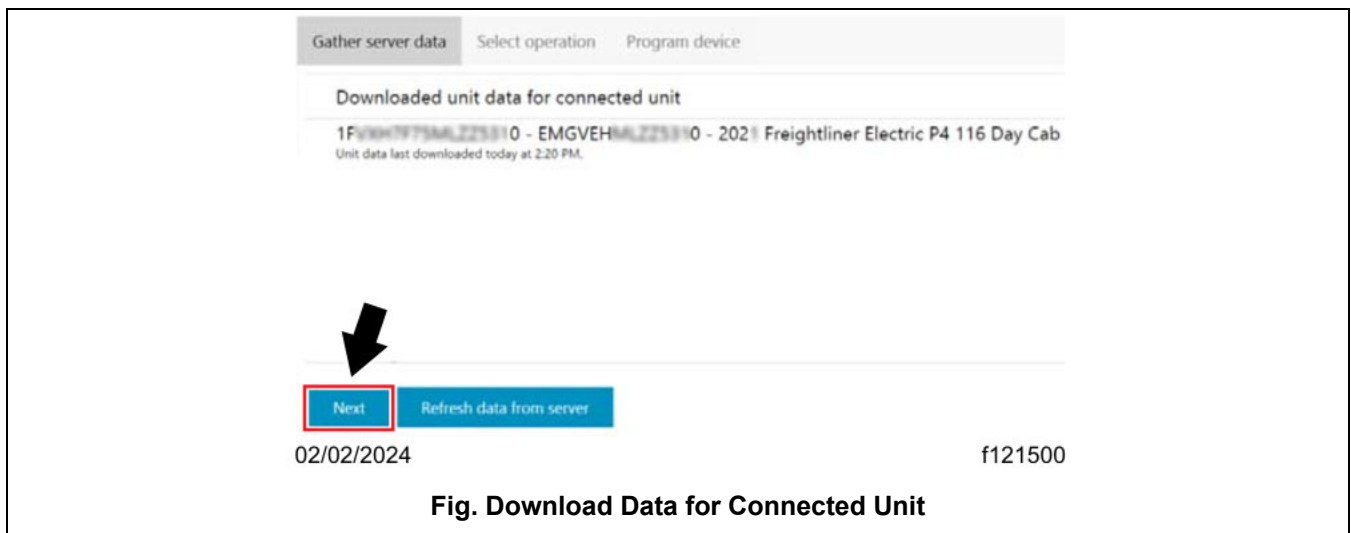
- Once the data download is complete, select 'Next.' See Figure 'Download Data for Connected Unit'. Devices with available software are listed.

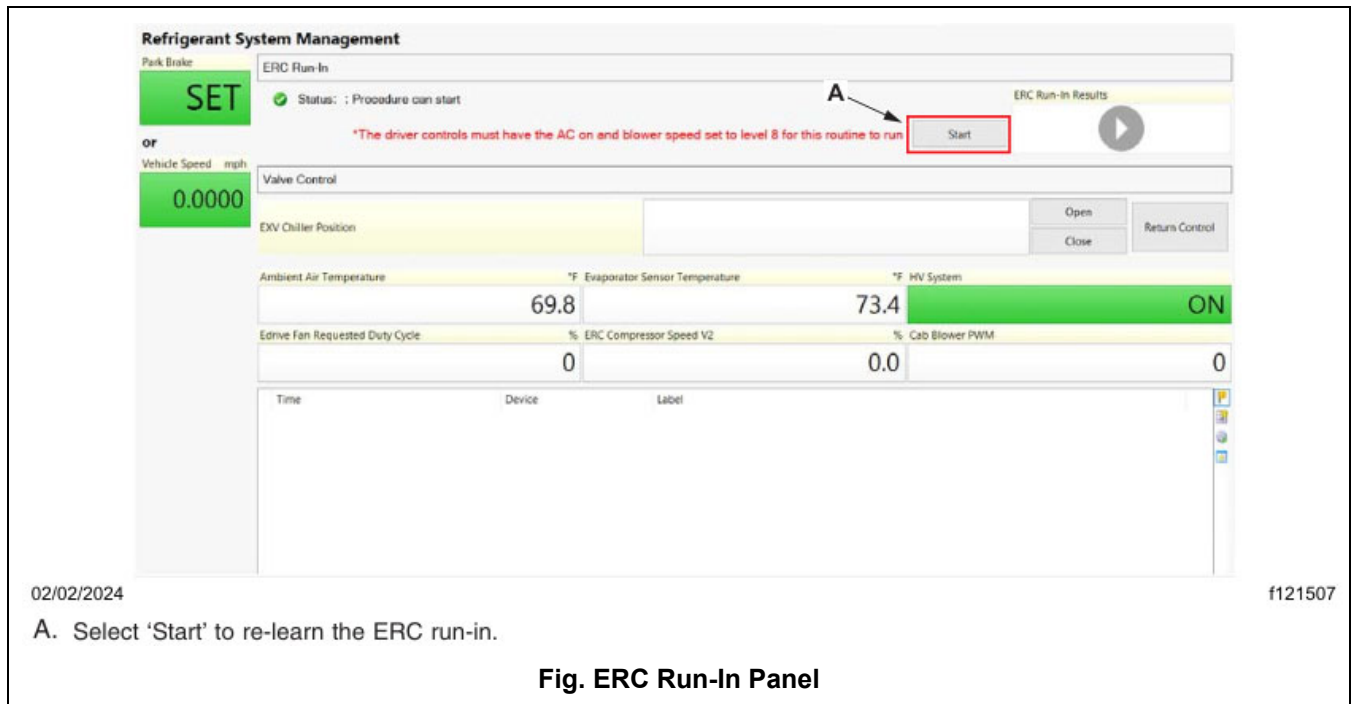
23. Perform the ERC run-in procedure by opening the 'Refrigerant System Management' panel. This panel is located on the 'Service Routines' tab in DL version 8.19 SP1 and later. In DL versions 8.19 and earlier, it is under the 'I/O Controls' tab.
24. Set the blower fan speed to a minimum of level 8.
25. Select 'Start' to re-learn the ERC run-in. See Figure 'ERC Run-In Panel'.
