## SERVICE BULLETIN

**NUMBER:** 15-305-22R  
**DATE:** 11/15/22  
**REVISED:** 06/28/24

**SUBJECT:** Reprogramming File Availability for Optimization of Gen 4.5 Denso CP1.5 Infotainment Systems

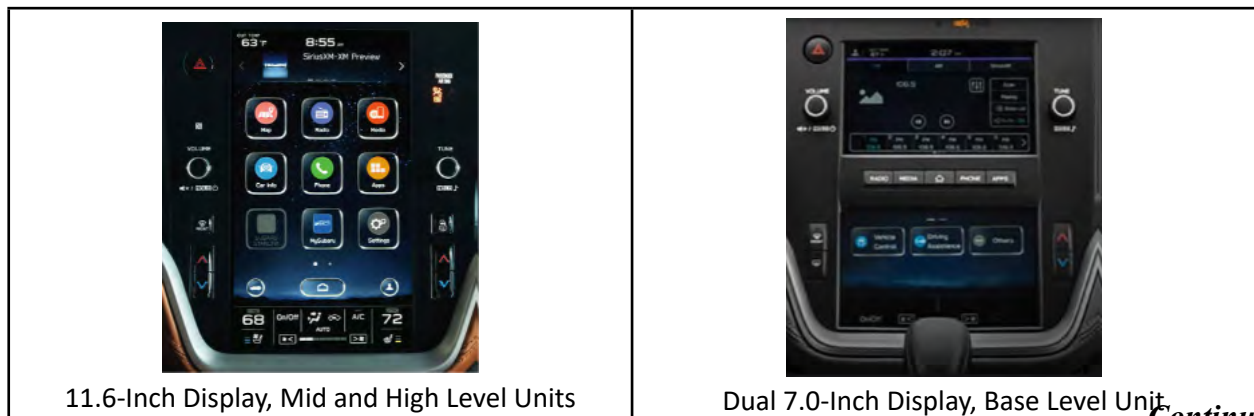
**NOTE:** High Level unit is equipped with Navigation option (Map icon on Home screen)

11.6-Inch Display, Mid and High Level Units

Dual 7.0-Inch Display, Base Level Unit

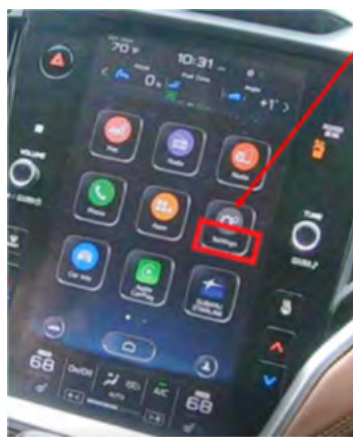
1a) After starting the engine and system boot-up completes, from the HOME screen, touch the **Settings** button.

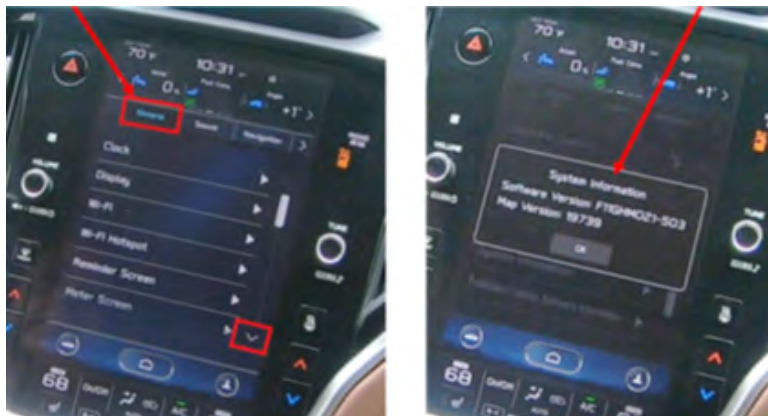
1b) Press the **General** button. Use the down arrow to scroll to **System Information** then press to display the System Information / Version information.

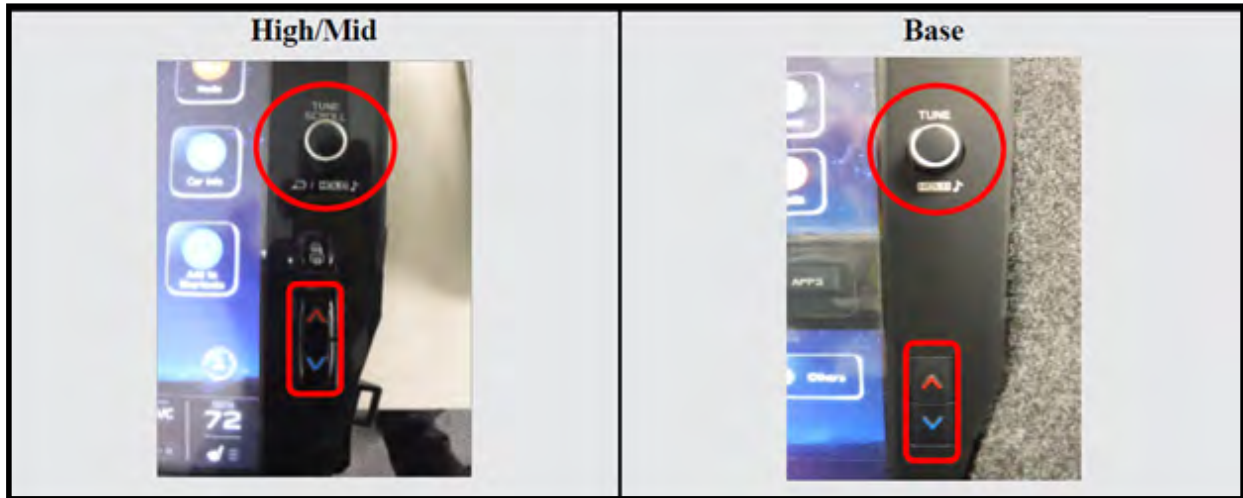
4a) PRESS and HOLD the RIGHT-side temperature control buttons (both up and down) and press the Tune / Scroll knob 6 times then release all to display the Dealership Mode Menu.

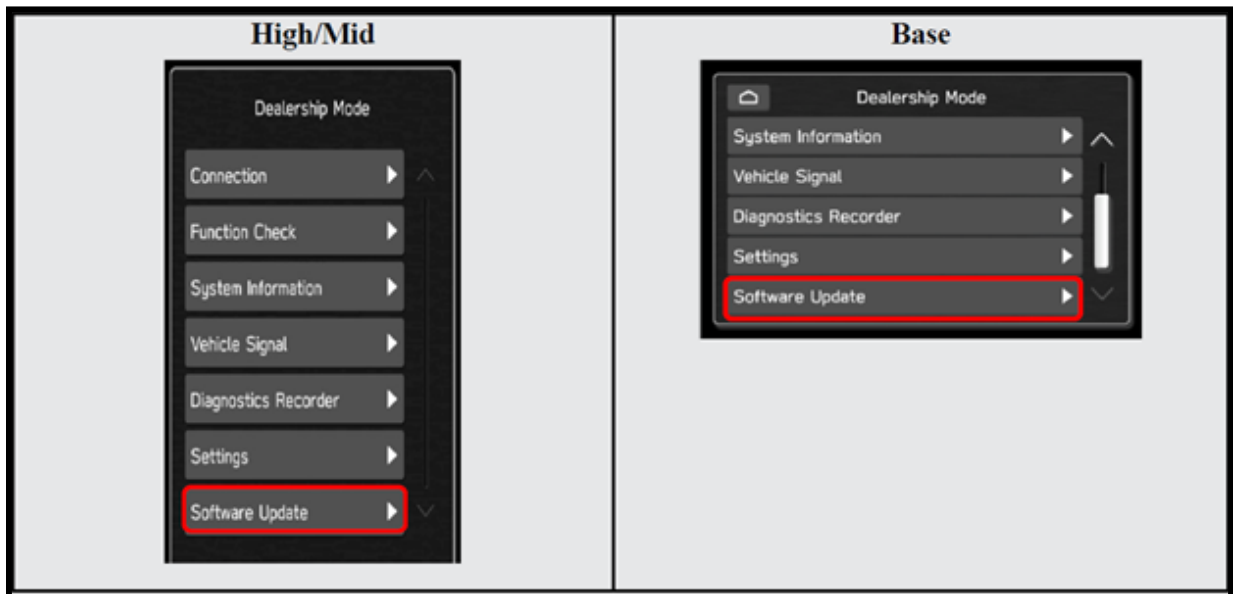
4b) Select **Software Update** from the Dealership Mode menu.

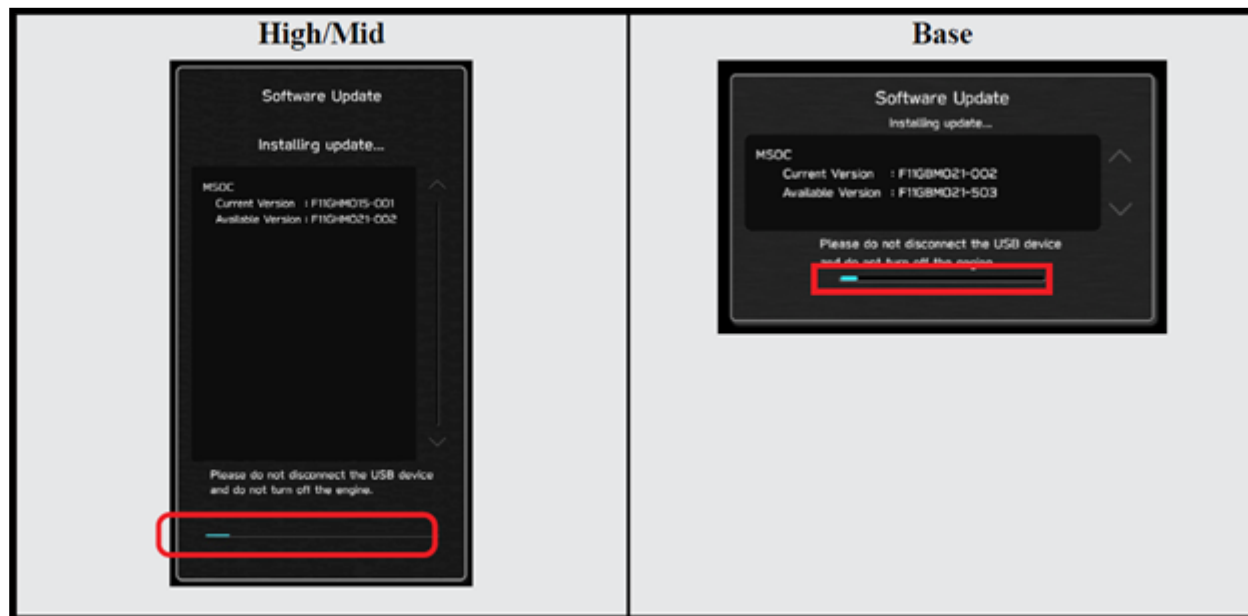
4f) Once the update begins, the screen below will be displayed with a progress bar. It takes about 15 to 20 minutes for the update to complete.

**VERY IMPORTANT:** NEVER turn off the ignition while the software update is in process.

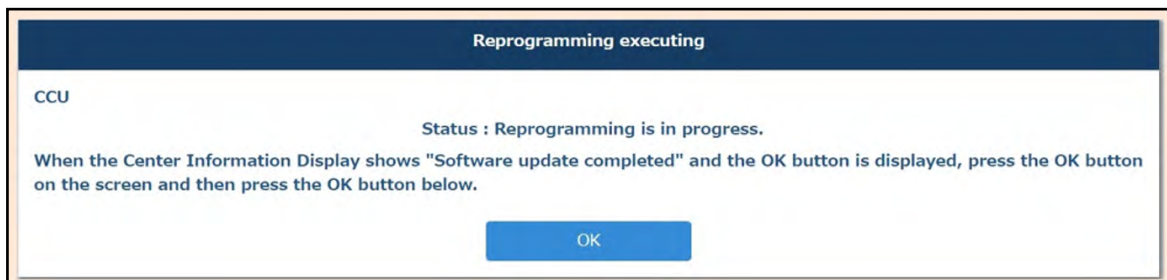
When the following screen is displayed, the software update starts within the CCU.

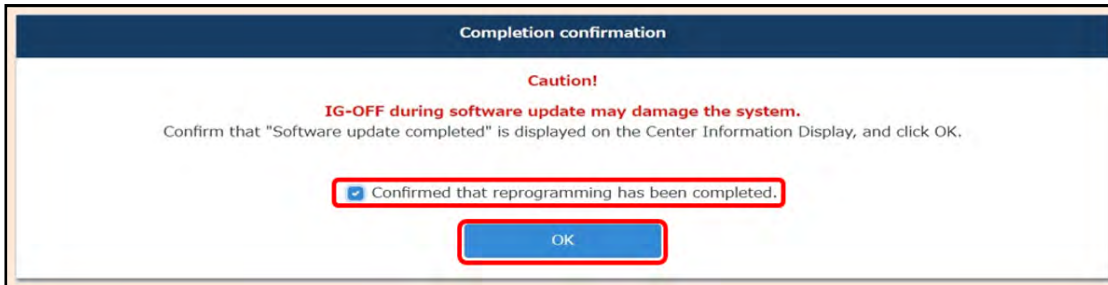
- vi. Confirmation screen will be displayed as shown below. Check the box and click [OK].

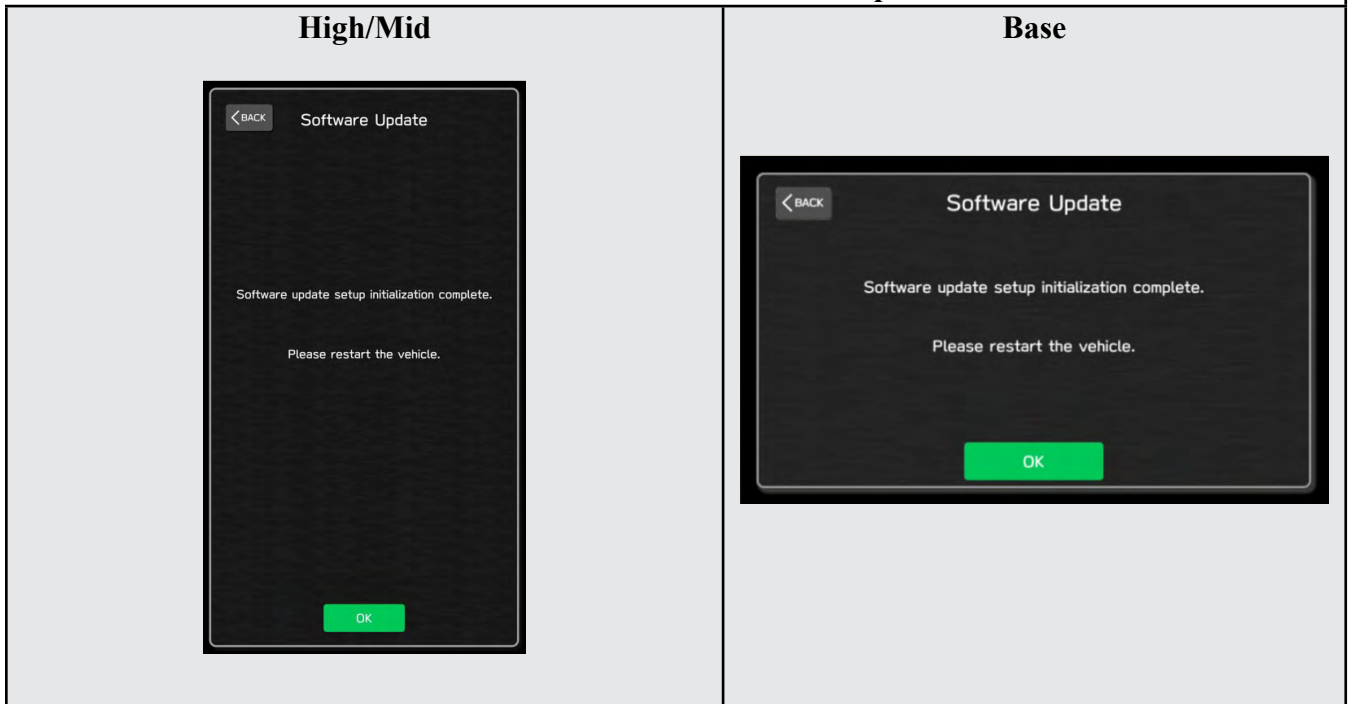
2-8. You will see the screen below when the initialization is complete.

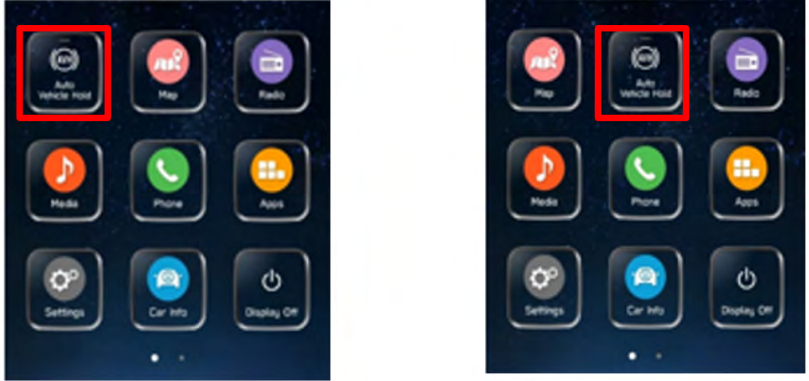
Number	Category	Symptoms to be Improved:
6	Display	<p>The AVH icons on the HOME screen are initially lined up next to the Valet-Mode icon. However, in some cases they are placed at the top (upper left corner of the first page) or next to the MAP icon. (only applicable to HIGH and MID trim)</p>

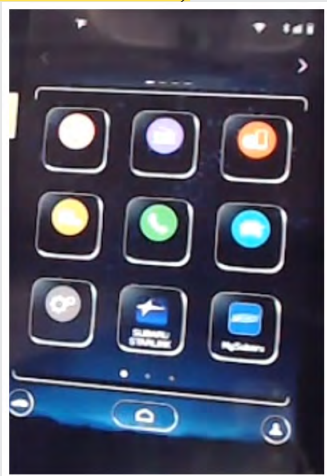
<p>After switching the clock function to AUTO, the CID screen display may become distorted. (only applicable to HIGH and MID trim)</p>

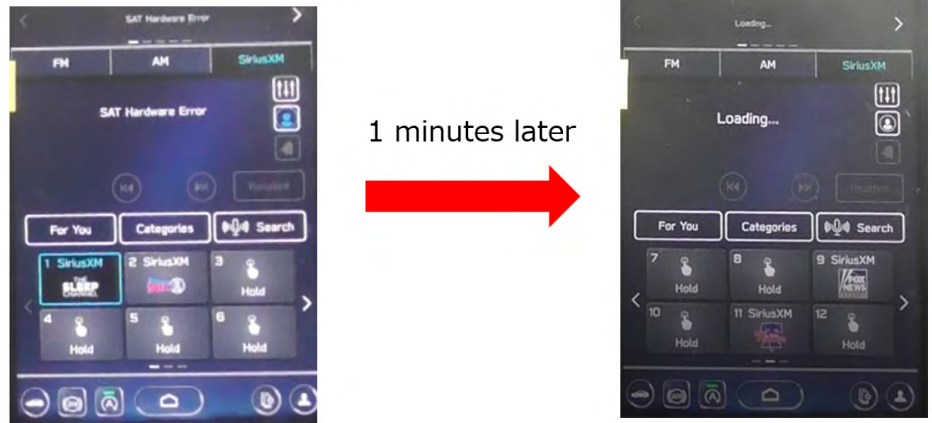
<p>It may take accessive time to start the CID screen after ignition on.</p>
7	SXM	<p>The first time ignition on after the CCU software update added the SXM360 functionality, the SXM playback screen may remain at “Loading...” after the CCU software update.</p>

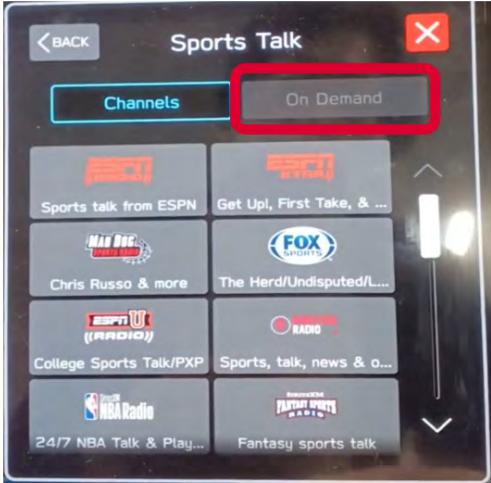
Number	Category	Symptoms to be Improved:
7	SXM	<p>In the SXM screen, the On Demand button in the upper right corner is grayed out and cannot be operated in the Sports→ Sports Talk screen. (only applicable to HIGH and MID trim)</p>

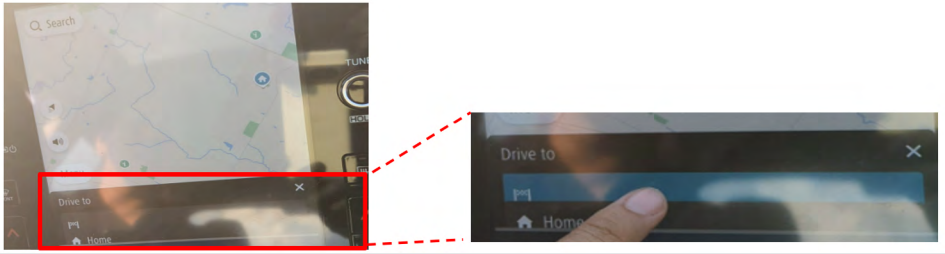
8	Navi	<p>After booting, the Map screen may not appear even if the Map icon on the Home screen is pressed. (only applicable to HIGH trim)</p> <p>Three destination suggestion displays in the navigation system are sometimes displayed overlapping each other. Originally, up to three destination suggestions are displayed at the bottom of the screen when the navigation system is started. (only applicable to HIGH trim)</p>

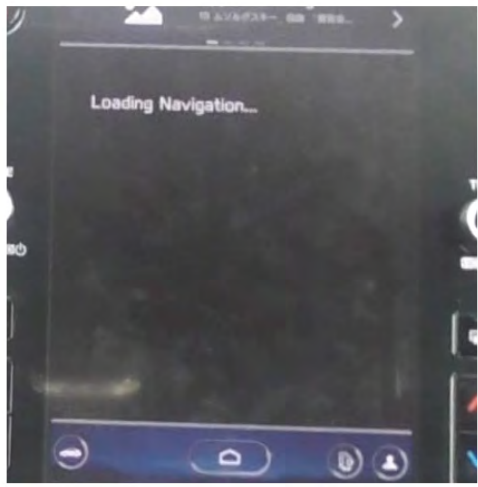
Number	Category	Symptoms to be Improved:
8	Navi	<p>When turning ignition off and on while the Map screen is displayed, the message ""Loading Navigation..." may remain on the screen, and the Map screen may not be displayed. (only applicable to HIGH trim)</p>

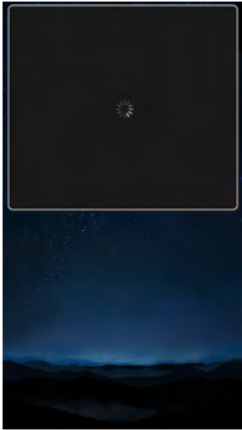
<p>After engine starts, only the black frame of the Caution screen display may remain on the CID screen. The rear view camera can be displayed by shifting to shift R.</p>

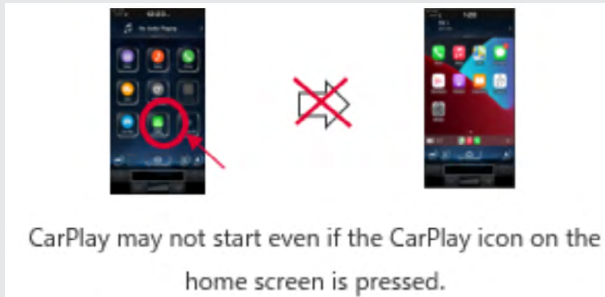
<ul style="list-style-type: none"> <li>- When starting the engine with the iPhone connected via USB, CarPlay may not start even if the CarPlay icon on the home screen is pressed. (This can be resolved by reinserting the USB cable.)</li> </ul> <div data-bbox="696 1482 1297 1776" data-label="Image">

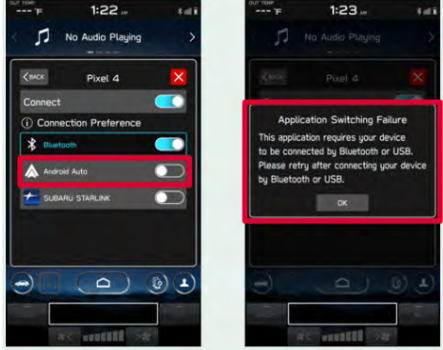
<p>- When you toggle on Android Auto from the Manage Device screen in CID while the Android device is not connected via USB, there may be a failure to start Wireless Android Auto (not applicable to BASE trim)</p>

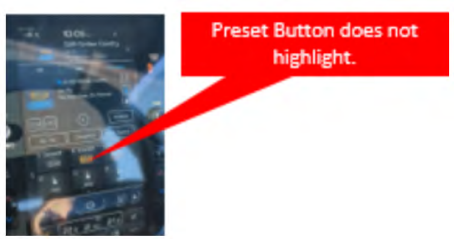
Number	Category	Symptoms to be Improved:
7	Bluetooth	<ul style="list-style-type: none"> <li>- Address vulnerabilities in the Bluetooth encryption mechanism (only applicable to BASE trim)</li> <li>- If the Bluetooth connection fails due to the loss of the link key in the phone, the following message should be changed to be displayed. Before: Connection unsuccessful Please try again later After: Connection unsuccessful Please try deleting and then re-pairing your device</li> </ul>
8	Radio	<ul style="list-style-type: none"> <li>- When pressing a preset button for a registered radio channel, you can play the channel. But the button you pressed does not highlight, and you cannot operate through presets using the steering wheel controls (not applicable to WRX)</li> </ul>

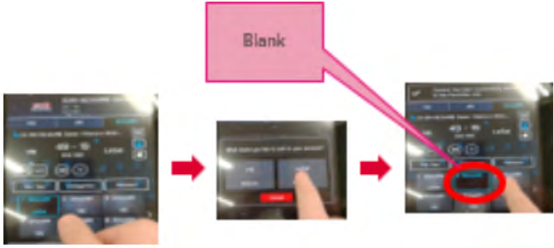
<p data-bbox="500 663 1497 814">- When registering SXM sports team channels to the radio preset buttons if a team for which logo image cannot be captured is registered, the channel short name will not be displayed on the registered button and the button will be blank (not applicable to BASE trim)</p>

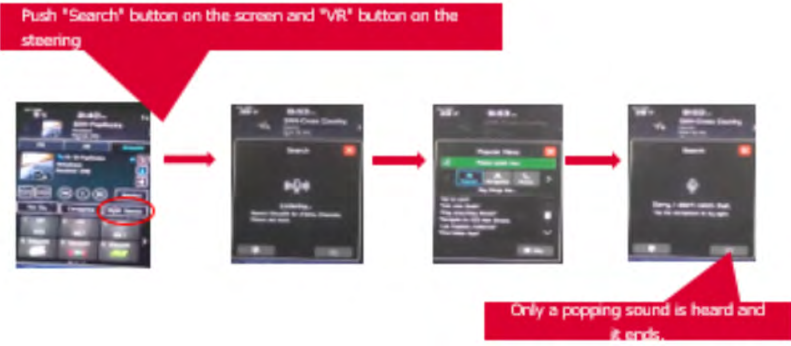
<p data-bbox="500 1430 1497 1539">- The voice recognition function encounters an error and ends, when initiating the SXM Search feature simultaneously with the activation of the CCU unit's voice recognition</p>

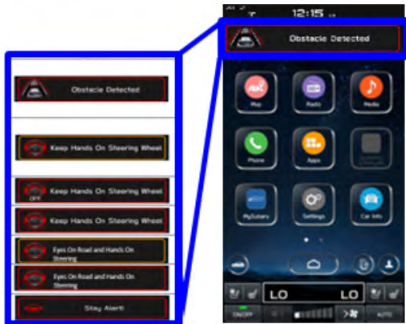
<p>Even after starting AndroidAuto, small screen is not disappearing.</p>
<p>- If the language setting of the CID is changed while an alarm message by the Driver Monitoring System(DMS) is displayed on the CID, the alarm will be hidden (not applicable to BASE trim)</p>

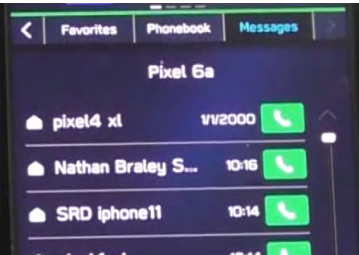
</div> </div> <p>- The date for the message is displayed as 1/1/2000 instead of the correct date. This occurs on some models of phones with Android OS 13 or later.</p> <div style="text-align: center;">

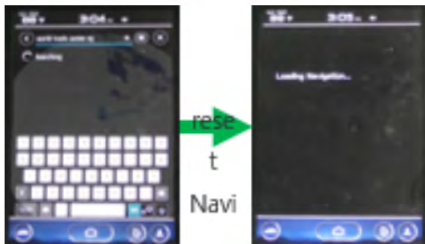
12	Touch Operation	<p>- Suddenly, the touch screen on the CID (Central Information Display) becomes unresponsive, even though the screen display remains normal. (not applicable to WRX)</p> <p>- CID doesn't respond to touch (The screen is displayed and sound is played, but only the operations are not available)</p>
13	Navi Operation	<p>- When repeatedly entering text on the destination search screen, the screen may freeze, and the navigation application restarts (only applicable to HIGH trim)</p> <div style="text-align: center;">

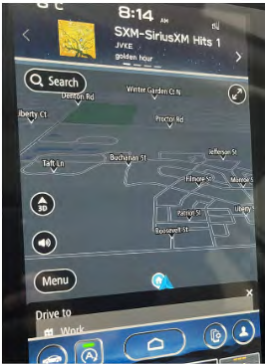
<p>- In the navigation screen, the bottom of the destination suggestion list's popup screen is cut off and not fully displayed (only applicable to HIGH trim)</p>

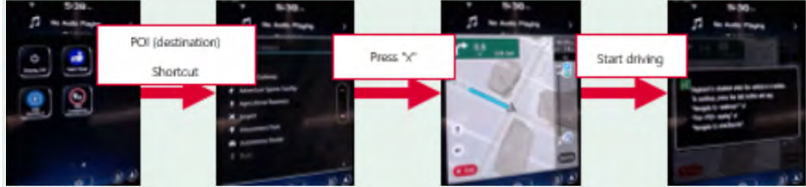
Number	Category	Symptoms to be Improved:
13	Navi Operation	<p>- "Keyboard is disable while the vehile is in motion"" is displayed on the screen when performing the steps below (only applicable to HIGH trim) :</p> <ol style="list-style-type: none"> <li>1. Press the POI (destination) Shortcut on the home screen to display the list of destinations.</li> <li>2. Press "x" to clear the list.</li> <li>3. Start driving with the Map screen displayed.</li> </ol>

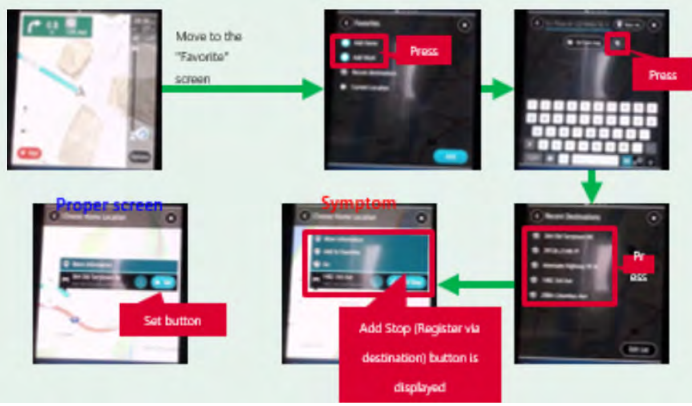
<p>- Add Stop (Register via destination) button is displayed instead of Set button and Favoirte registration for Home/Work cannot be done after performig the steps below moving to the ""Favorite"" screen with the navigation destination set (only applicable to HIGH trim) :</p> <ol style="list-style-type: none"> <li>1. Press Add Home/Work</li> <li>2. Select a location from the Destination History screen</li> </ol>

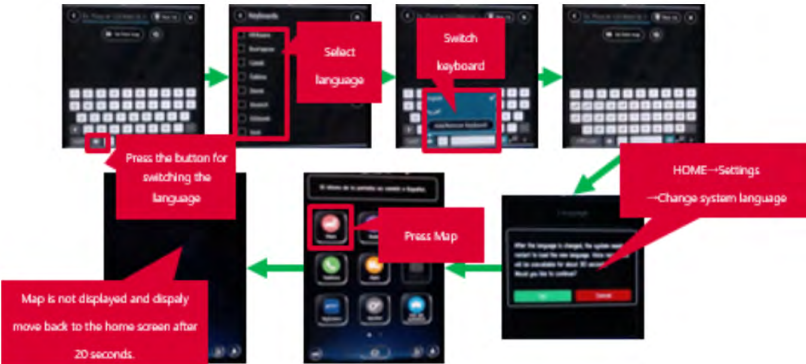
<p>- Map is not displayed when Map is pressed from the home screen if switch- ing the language used for the text input keyboard on the search screen of the navigation application (only applicable to HIGH trim)</p>

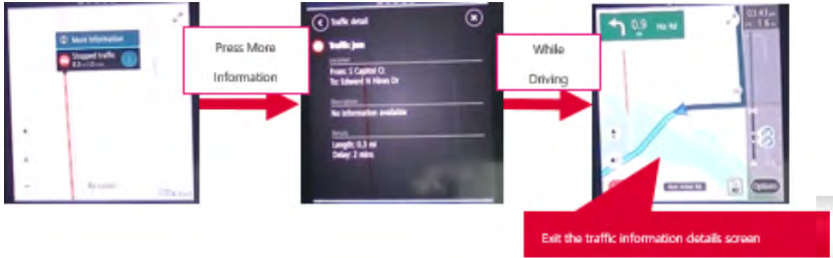
</div> </div> <p>- When using voice recognition to search for a destination based on a Point of Interest (POI) category name (such as "gas station"), the search results may display facilities that have names partially matching the POI category name in addition to the facilities within that specific category (only applicable to HIGH trim)</p> <p>- While parked or driving, touch the traffic information icon on the map or the traffic information icon on the route bar and display the traffic information details screen. If you start driving with this screen displayed, it will exit the traffic information details screen and transitions back to the map screen (only applicable to HIGH trim)</p> <div style="text-align: center;">

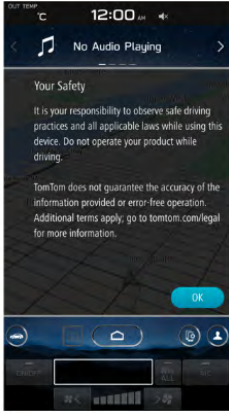
Number	Category	Symptoms to be Improved:
13	<b>Navi Operation</b>	<p>- The requirement to press ""OK"" on the Your Safety screen during the initial navigation launch sometimes wasn't displayed (only applicable to HIGH trim).</p> <p>Before the change: If the navigation app was launched for the first time from any icon other than the Map icon on the Home screen (e.g., through a rest suggestion feature) the Your Safety screen would not appear and navigation functionality could not be initiated.</p> <p>After the change: Even if the navigation app is launched for the first time from an icon other than the Map icon on the Home screen, the Your Safety screen will be displayed.</p>

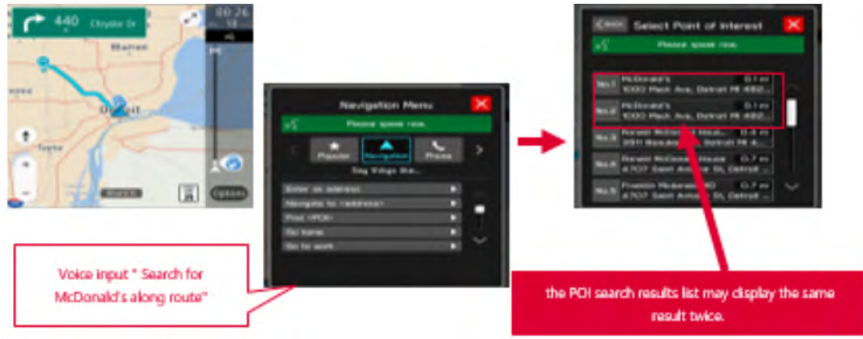
Number	Category	Symptoms to be Improved:
13	Navi Operation	<p>- When using voice recognition during navigation to say 'Search for **** along route,' the POI search results list may display the same result twice (only applicable to HIGH trim)</p>

<p>Voice input " Search for McDonald's along route"</p> <p>the POI search results list may display the same result twice.</p>
14	Audio/Voice Recognition	<p>- USB audio is activated by voice recognition command ""play artist xxx"" or ""play album xxx"". The last song played by USB audio is played, not the song commanded by voice. (only if the same USB is used) (not applicable to WRX)</p>
15	Voice Guidance	<p>- While driving with a navigation route set, there are instances where the voice guidance may not correctly pronounce "mile." It mispronounces "mile" as "me" (only applicable to HIGH trim)</p>
16	Voice Recognition	<p>- After setting a route in the navigation system and activating voice recognition function, the route guidance is not canceled even "Cancel Route" or "Delete Destination" is completed (only applicable to HIGH trim)</p> <p>- When you say ""Call *****"" using voice recognition, the meter display shows "Please wait a moment," but the call cannot be made (not applicable to WRX) (Note: ""*****" indicates an actual phone number or contact name you are trying to call)</p> <p>- Starting the CCU (Cockpit Control Unit) voice recognition while using the SXM Voice Search function results in an error and ends the voice recognition (not applicable to BASE trim)</p>

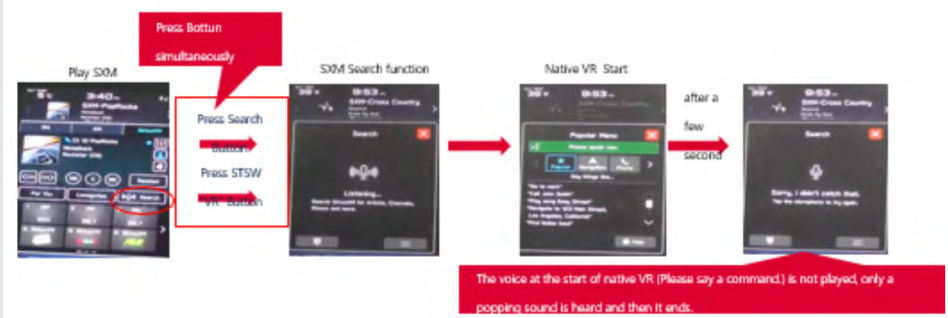
<p>Press Bottom simultaneously</p> <p>Press Search</p> <p>Press STSW</p> <p>Press VR</p> <p>The voice at the start of native VR (Please say a command) is not played, only a popping sound is heard and then it ends.</p> <p>- When operating the navigation system via voice recognition, certain regional place names (states, cities, etc.) are not recognized (only applicable to HIGH trim)</p>

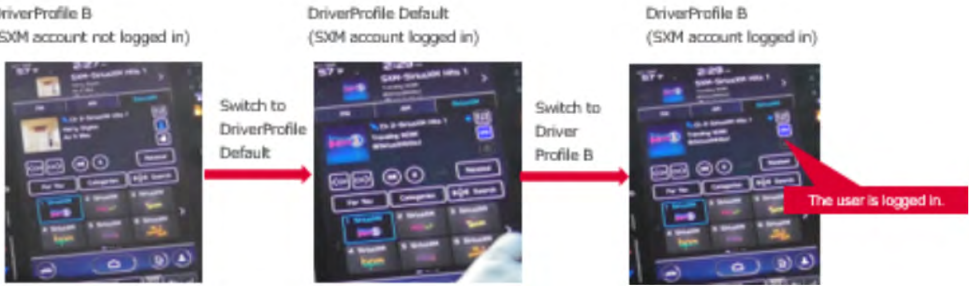
<ul style="list-style-type: none"> <li>- Switching the Driver Profile user causes the user to be logged into SXM even though he/she was not logged into the SXM account as the user after the switch</li> </ul>

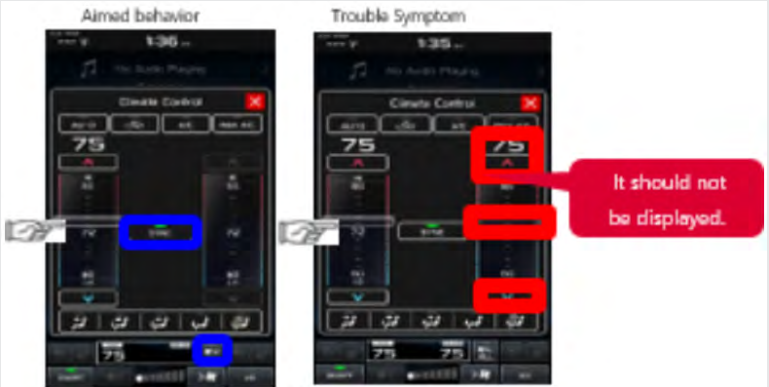
<p>- In the maintenance schedule settings screen despite setting a date the configured date is not displayed and is replaced with hyphens (not applicable to WRX)</p>
24	Air Conditioner	<p>- With the air conditioning SYNC enabled and the single-seat focus set to the driver's seat tapping the temperature adjustment bar on the driver's side unexpectedly displays the temperature adjustment bar for the passenger's side, which should not be displayed (only applicable to BASE trim)</p>

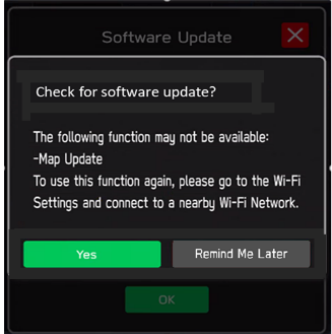
Number	Category	Symptoms to be Improved:
26	Software Update	<p>- To use FOTA (Firmware update Over The Air) for CCU software update via DCM (Data Communication Module) it is necessary to switch from the Wi-Fi communication settings for MapUpdate to the DCM communication settings. To notify the customer about this switching, the below message screen pops up a new CCU software becomes available from the server. (not applicable to BASE trim)</p>

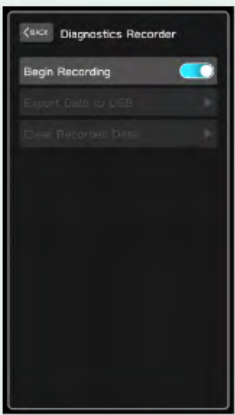
10	<p>Update against vulnerability in security of Bluetooth connection.</p>
11	<p>When getting CCU USB logs at the Diagnostics Recorder screen in the Dealership Mode, it was necessary to turn off "Begin Recording" to "Export Data to USB." And after the log acquisition, it was necessary to turn "Begin Recording" ON again. The system interface is improved so that "Begin Recording" is automatically switched ON after log acquisition has been accomplished.</p> <div data-bbox="786 1522 1019 1934" style="text-align: center;">

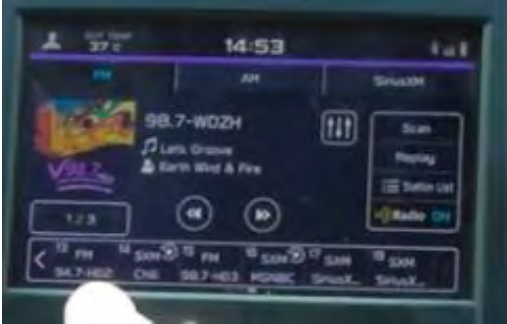
Number	Symptoms to be Improved:
8	Android Auto Wireless (AAW) cannot be connected.
9	Android Auto Wireless (AAW) cannot be started from “Manage Devices” Screen.
10	Sound volume control does not work while using Android Auto. It is caused by data communication error between Android device and CCU.
11	Cyclic short noise like a drilling or vibration is heard from speakers.
12	<p>Sound is lost when changed to Subchannel 2 right after a preset HD radio channel has been selected.</p>

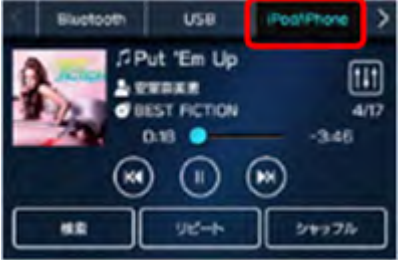
Number	Symptoms to be Improved:
1	<p>iPod/iPhone tab in Media screen cannot be selected, when connected by USB.</p> <p>The symptom occurs when the iPhone is connected to CP1.5 via Bluetooth in parallel to USB connection by error. (It is supposed to be connected either via Bluetooth or by USB.)</p>

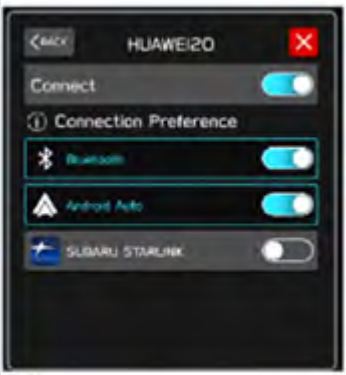
2	<p>On the “Manage Devices” screen Bluetooth cannot be selected as connection preference.</p>

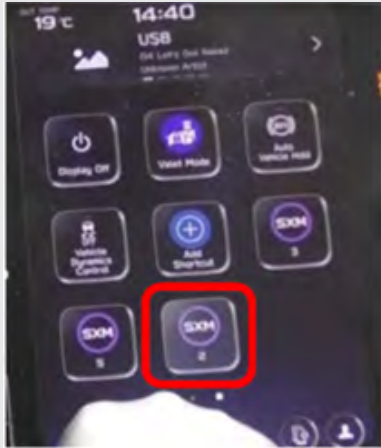
Number	Symptoms to be Improved:
6	<p>SXM station shortcut created by the customer does not work when the SXM has not been used as audio source after the Ignition Switch was turned on in the ignition cycle.</p>

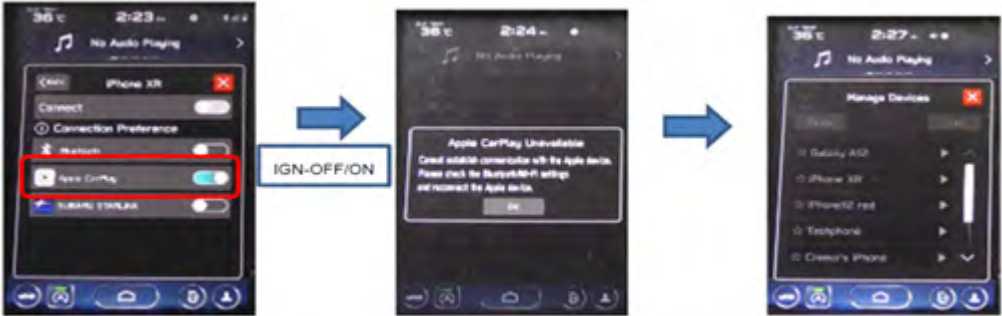
7	<p>Manage Device Screen becomes dark and inoperative when Ignition Switch is turned Off and On while starting CarPlay by CID operation.</p>

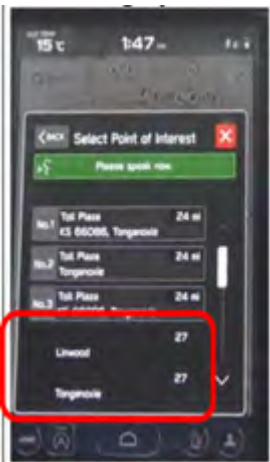
8	<p>Cannot connect to CarPlay via wireless connection. This symptom possibly occurs after the Ignition Switch was turned Off and On abruptly.</p>
9	<p>POI Search Result shows only city names and distances (without unit) when voice recognition POI search with Category name like “Find toll gate” is used.</p>

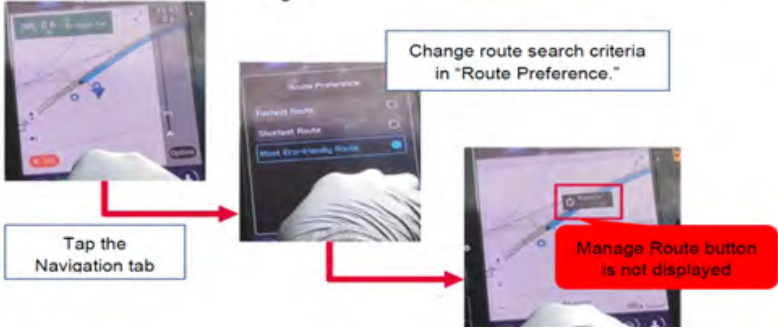
Number	Symptoms to be Improved:
10	Navigation restarts itself, when the letters are rashly entered or deleted using keyboard function to search destination.
11	<p>“Manage Route” button is not displayed when touching the route line on Navigation system, when the route search criteria got changed in the Route Preference Screen after a route had been searched.</p>

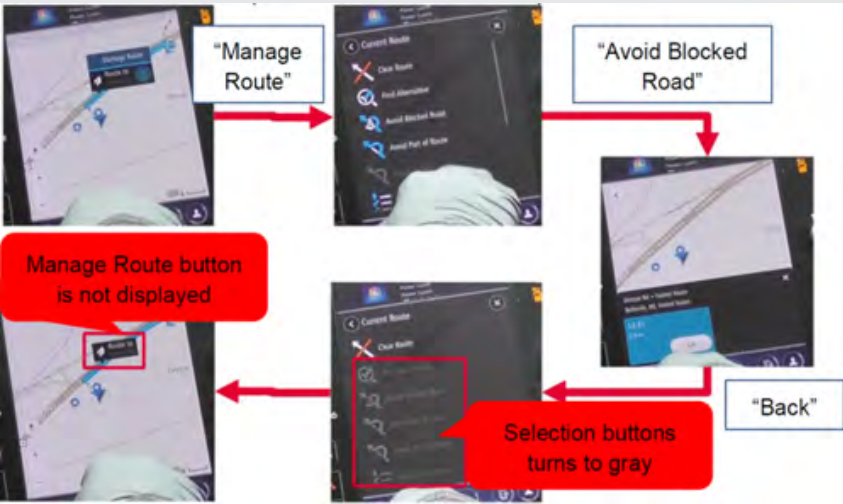
12	<p>“Manage Route” button is not displayed and buttons on the Current Route Screen become unselectable (turns to grayish fill) when the Navigation system is operated in the sequence of “Manage Route” &gt; “Avoid Blocked Road” (in the Current Route Screen) &gt; “Back.”</p>

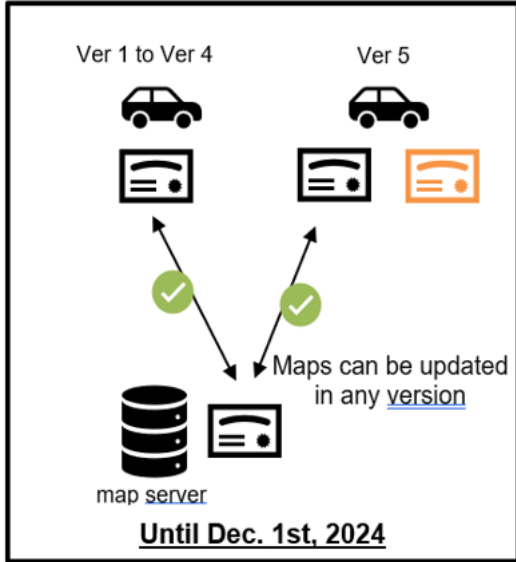
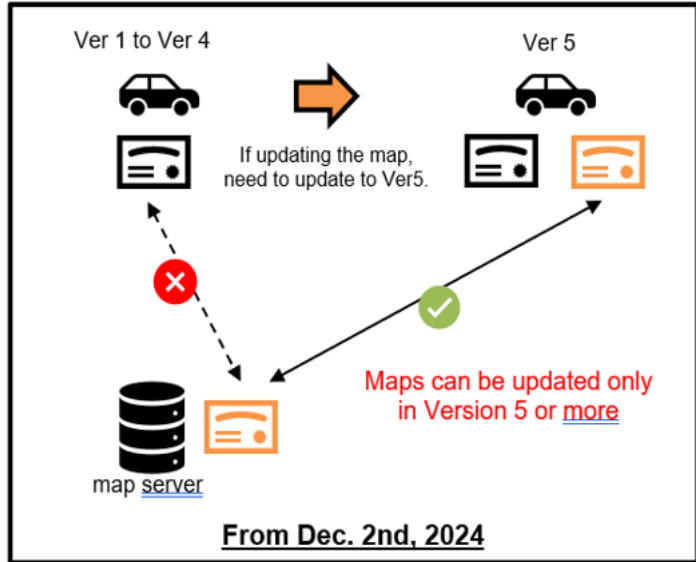
Current Certificate

**IMPORTANT NOTE:** The certificate of the data distribution server for the map update service by Map OTA (MOTA) will be changed **from Dec 1<sup>st</sup>, 2024**, and the previous server certificate will no longer be eligible after **2<sup>nd</sup> December, 2024**. To get the MOTA service on and **after Dec 2<sup>nd</sup>, 2024, Ver. 5 software that includes new server certificate should be installed in advance.**
