Technical Service Bulletin

GROUP CAMPAIGN	NUMBER 24-01-050H
DATE JUNE 2024	MODEL(S) SEE BELOW

SUBJECT: 4TH GEN AVN SOFTWARE UPDATE(SERVICE CAMPAIGN TBV)

Description: This bulletin provides instructions to update the 4th generation AVN head unit software to ensure the SIM Over The Air function for the Bluelink service is operating properly.

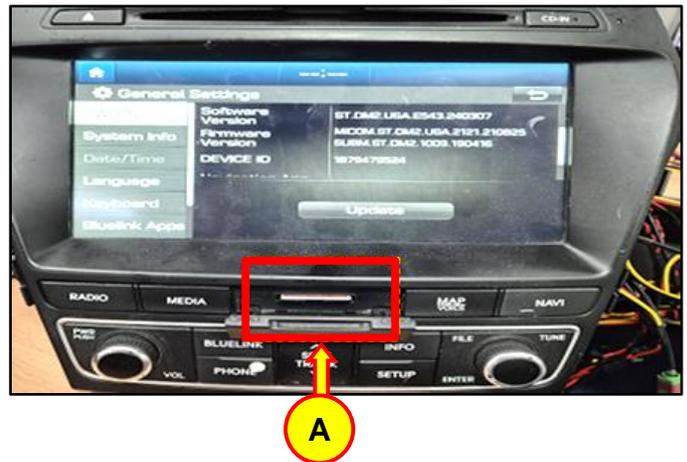
2. Remove the customer's SD card from the vehicle and update the software version from the supplied SD card to the customer's SD card.

Reinsert the customer's SD card into the vehicle's head unit (A).

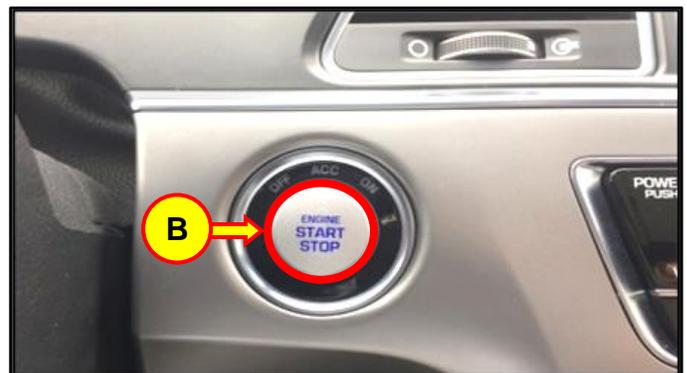
3. Turn **ON** the ignition switch (B).

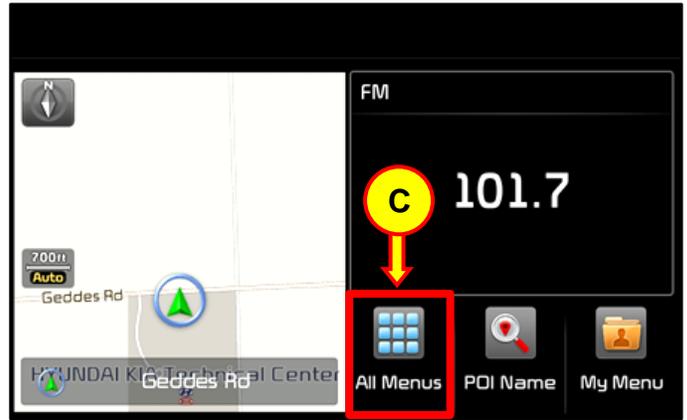
4. Select **All Menu** (C).

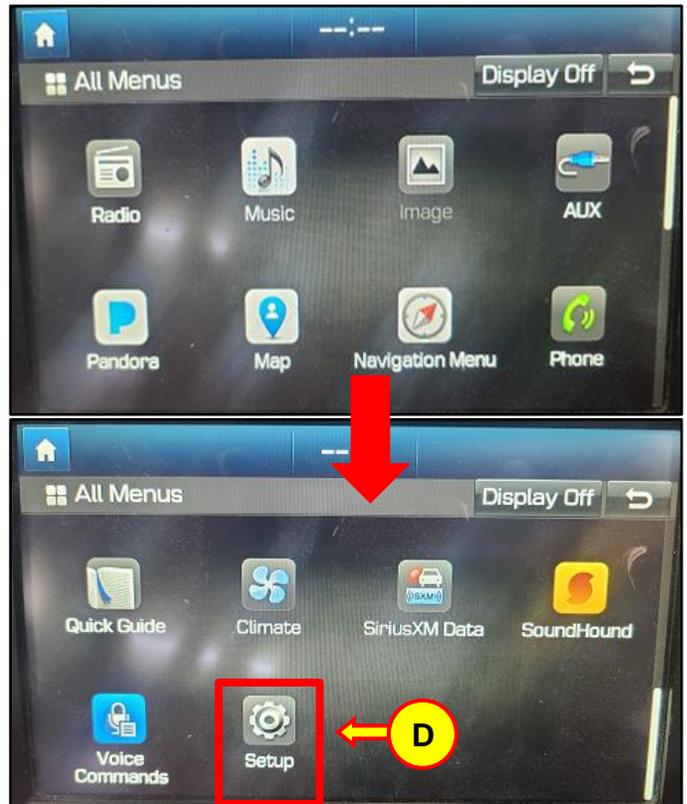
5. Scroll down the screen and select **Setup** (D).

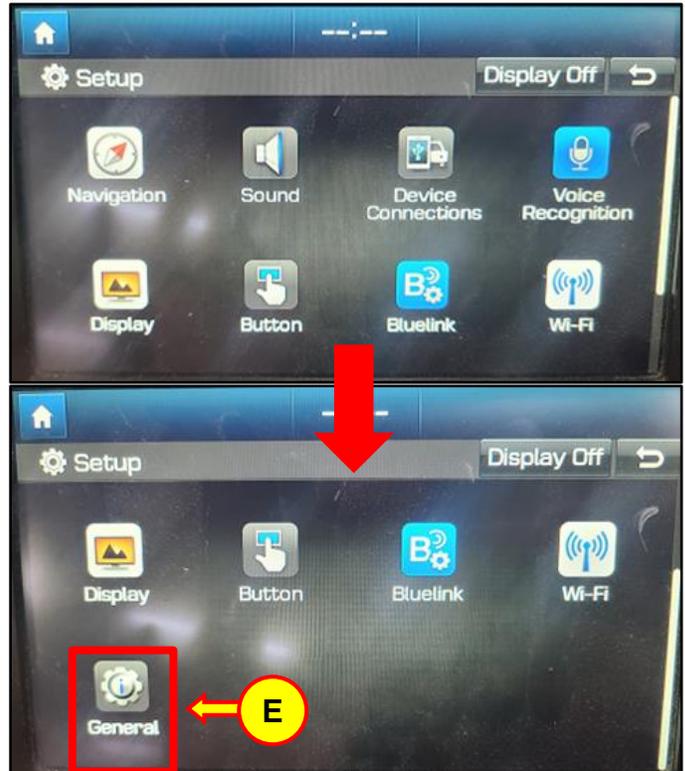
6. Scroll down the screen and select **General (E)**.

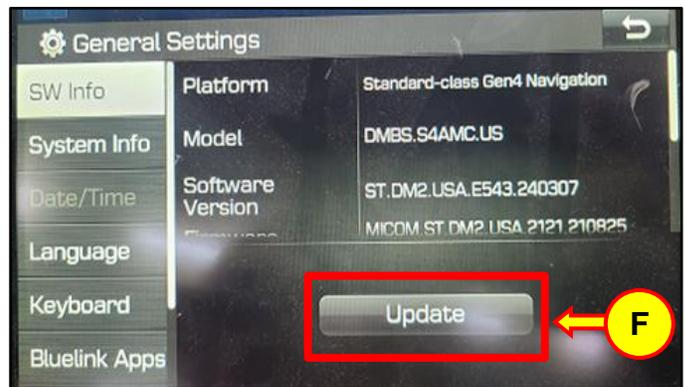
7. Select **Update (F)**.

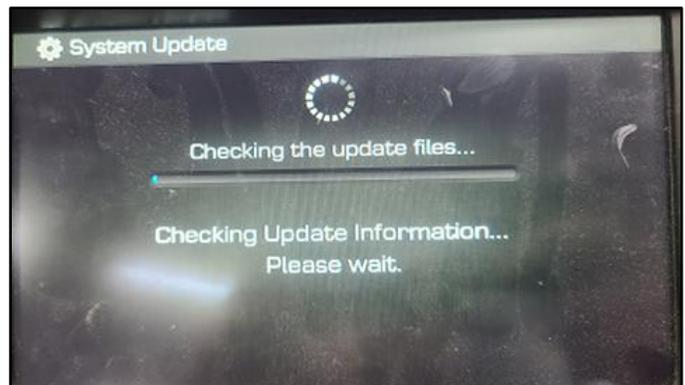
8. Wait for approximately **40 minutes** until the update is completed.

Do **NOT** remove the SD card or turn **OFF** the ignition during the update to prevent an improper installation.

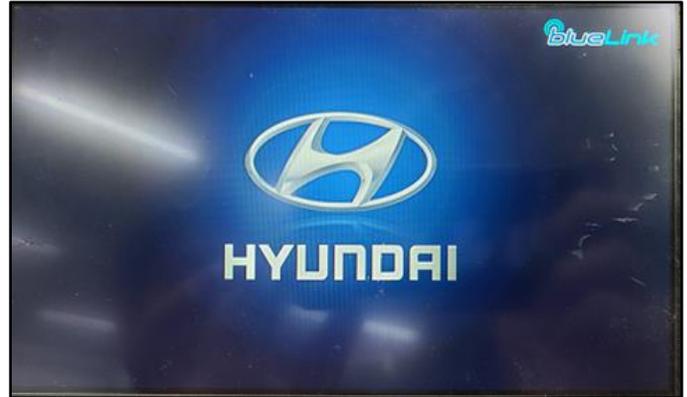
9. Once the update is completed, the screen will display the Hyundai logo.

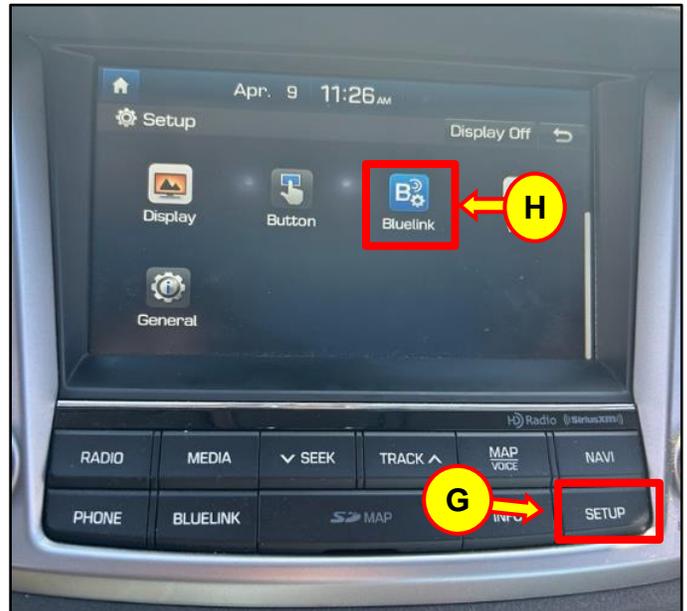
10. After Update is complete, Select **Setup** (G) then **Bluelink** (H).

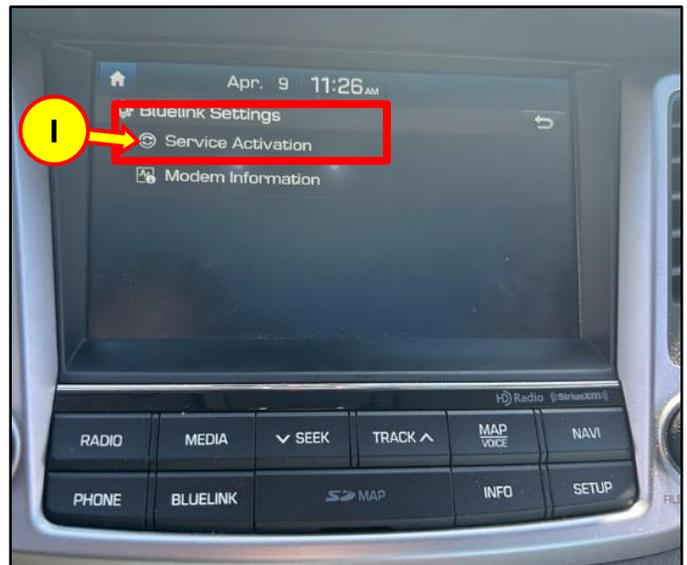
11. Select **Service Activation** (I).

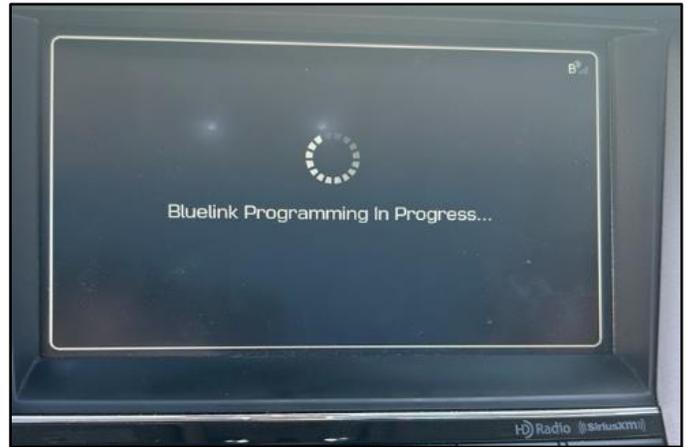
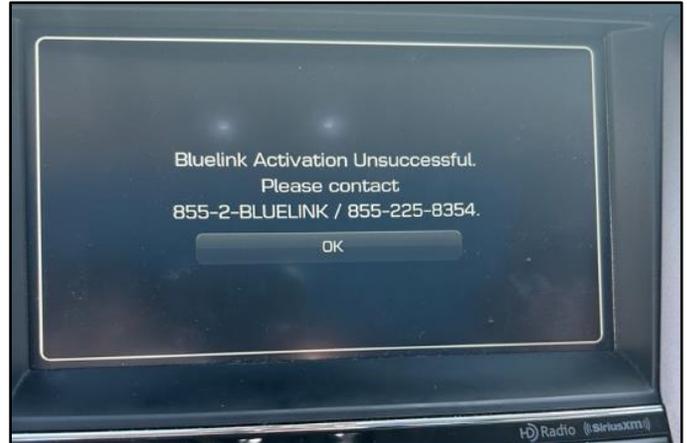
12. Please note Bluelink Activation will be Unsuccessful on the first attempt. This is expected.

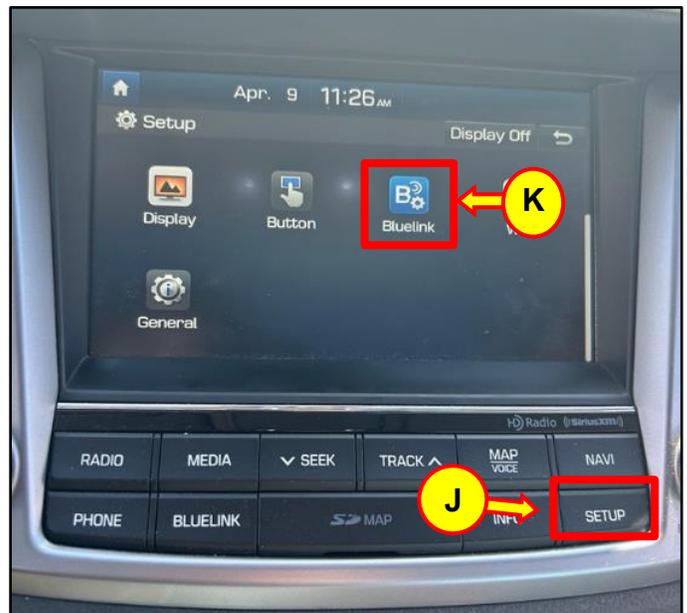
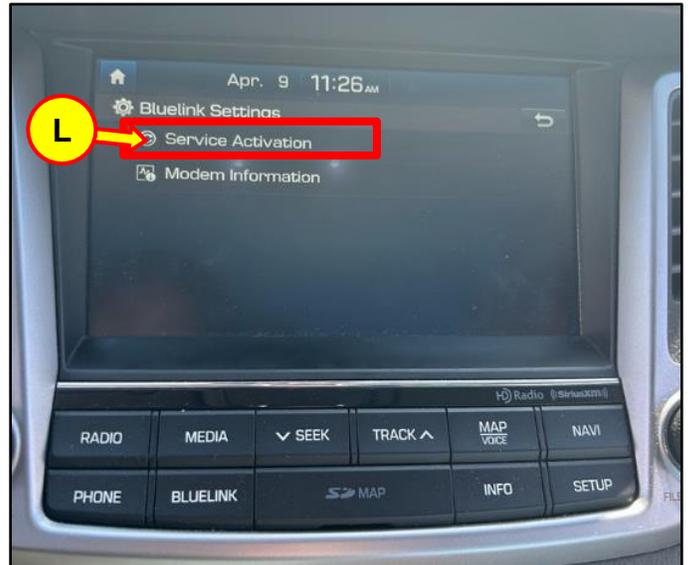
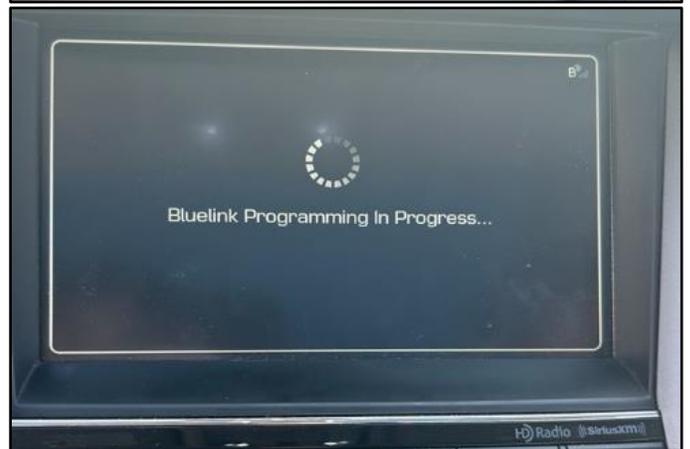
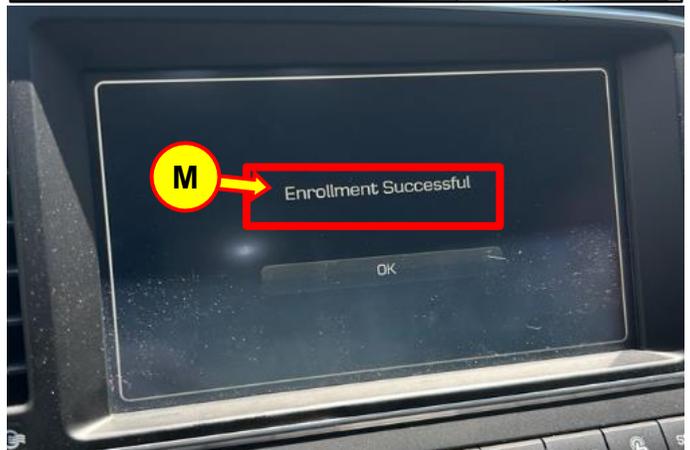
13. Repeat Steps 10 and 11.

Select **Setup** (J), **Bluelink** (K), and **Service Activation** (L). Confirm Bluelink Activation is successful now (M).

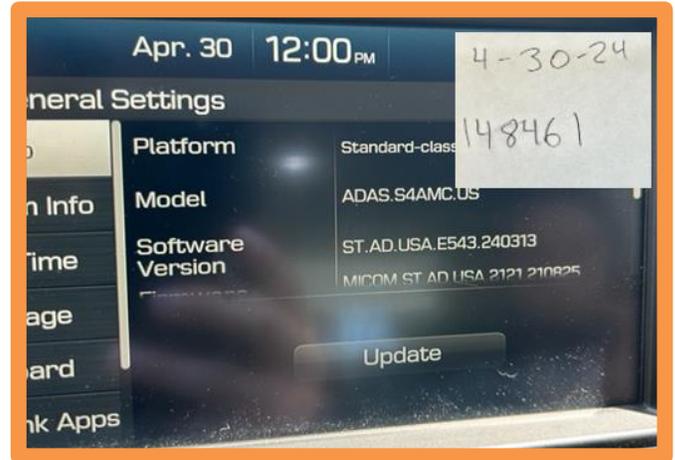
Take a photo of the 'SW Info/Update' screen showing the updated S/W version with the last 6 digits of the VIN and date of repair on a piece of paper. Put post-it/piece of paper in top right-hand corner for photo.

Upload the photo to STUI.

This TSB includes Repair validation photos. Refer to the latest Warranty Digital Documentation Policy for requirements.
