Battery Electric Vehicle (BEV) Post Programming Faults

Valid for Mack LRe and Volvo VNRe, model years 2021 to current

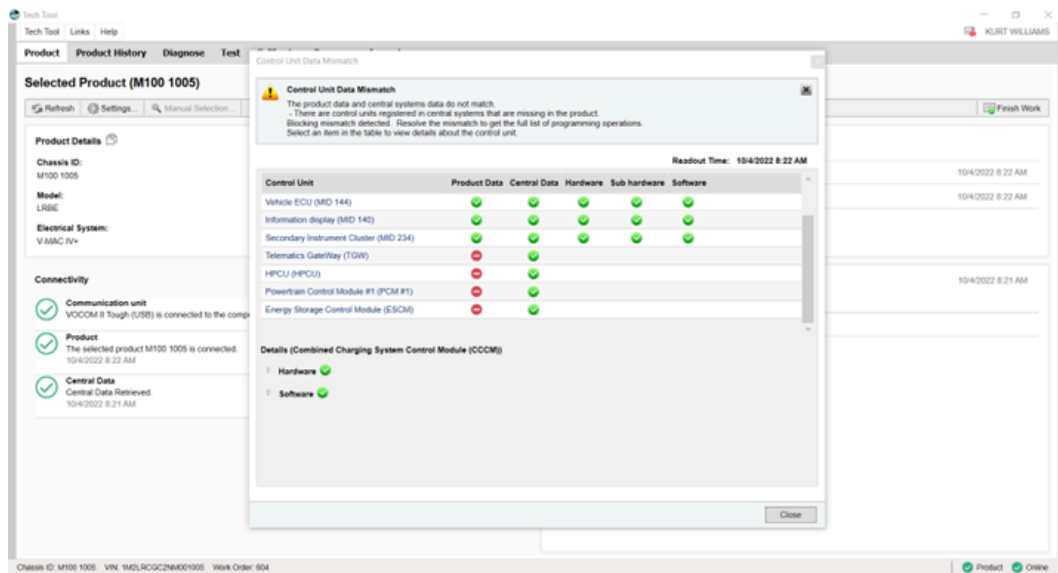
- a.** This can be corrected if hooking TT to the truck follows the below process:
 - i.** Turn truck ON and let everything power up
 - ii.** Start TT on PC, Login and get to home screen
 - iii.** Connect communication box to computer
 - iv.** Connect to truck
 - v.** TT should then identify product and mis-matches like shown below should not happen.
- b.** If there are still issue they may have to disconnect from product
 - i.** Clear the chassis from their recent selections and try again.

We see a lot of data mismatches, and this has to do with the TEA2+ ECU's not reporting to the tool.
