Service Bulletin

Bulletin No.: 24-NA-105

Subject: Inability to create user profile on the infotainment system

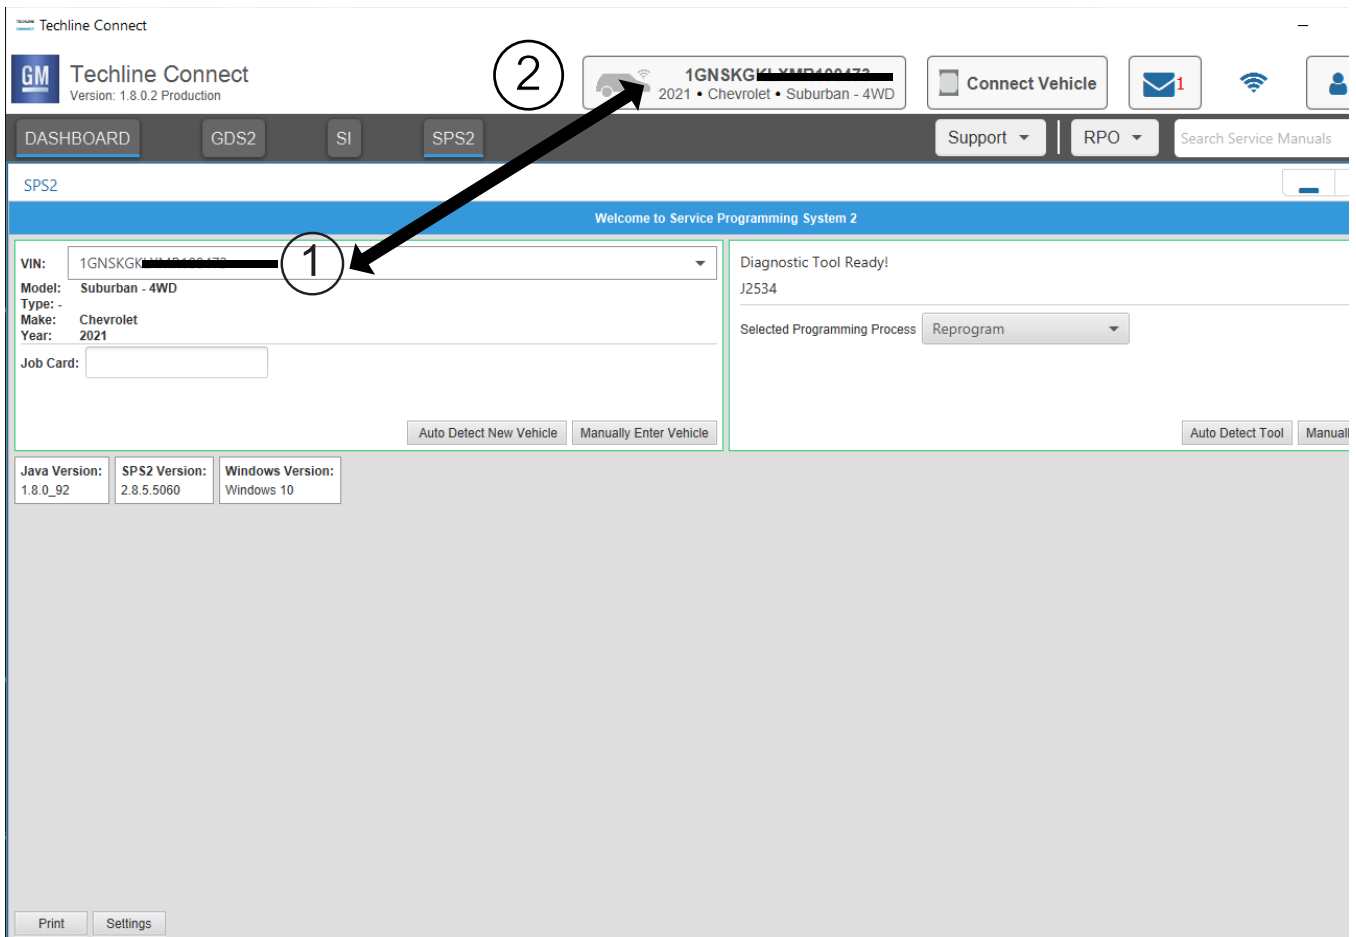
5743643

Caution: Be sure the VIN selected in the drop down menu (1) is the same as the vehicle connected (2) before beginning programming.
