GROUP	MODEL
ELE	2024MY EV9 (MV)
NUMBER	DATE
327 (Rev 1, 7/10/2024)	June 2024

## TECHNICAL SERVICE BULLETIN

### SERVICE ACTION: RSPA LOGIC IMPROVEMENT (SA558)

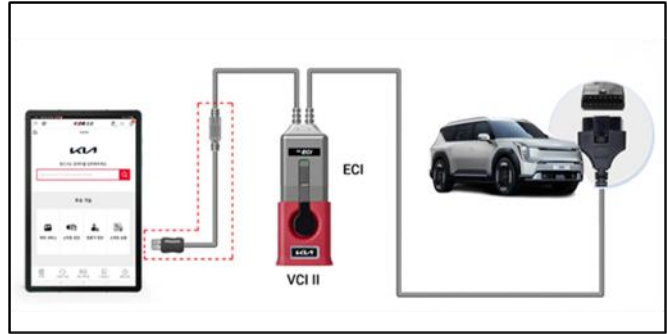
- 1a. Connect the ECI DLC connector to the OBD-II connector, located under the driver's side of the instrument panel.
- 1b. Connect the ECI USB -C connector to the KDS tablet.
- 1c. Connect the VCI II to the ECI OBD-II connector

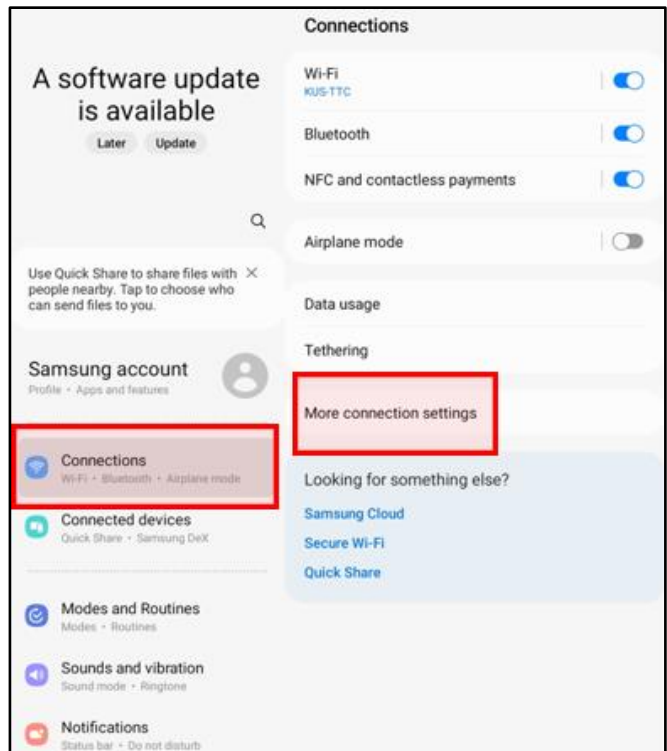
- 3a. Select 'Settings' on the KDS tablet.
- 3b. Select 'Connections'.
- 3c. Select 'More connection settings'.

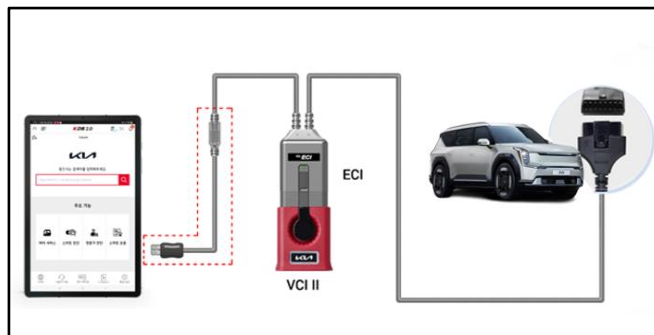
- 1a. Connect the ECI DLC connector to the OBD-II connector, located under the driver's side of the instrument panel.
- 1b. Connect the ECI USB -C connector to the KDS tablet.
- 1c. Connect the VCI II to the ECI OBD-II connector

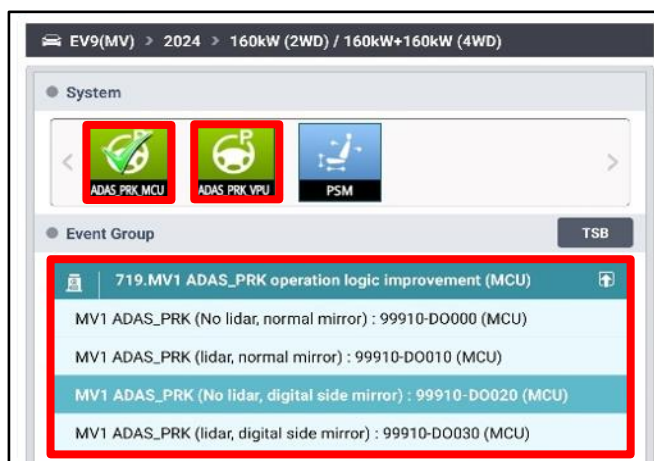
**UPGRADE EVENT:**

719.MV1 ADAS\_PRK Operation Logic Improvement (MCU)

**AND**

720.MV1 ADAS\_PRK Operation Logic Improvement (VPU)

**BOTH** Upgrade Event #719 **AND** Upgrade Event #720 need to be installed.
