GROUP	MODEL
ELE	2024MY EV9 (MV)
NUMBER	DATE
336 (Rev 1, 7/10/2024)	April 2024

TECHNICAL SERVICE BULLETIN

SERVICE ACTION: INTEGRATED LED HEADLAMP CONTROL UNIT OPERATION LOGIC IMPROVEMENT (SA567)

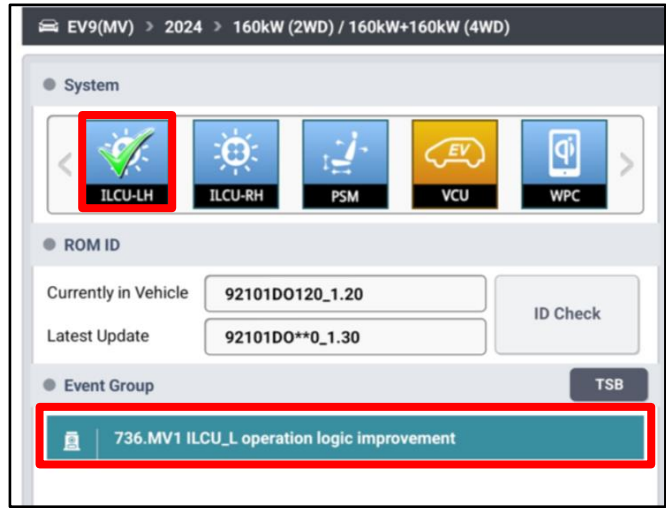
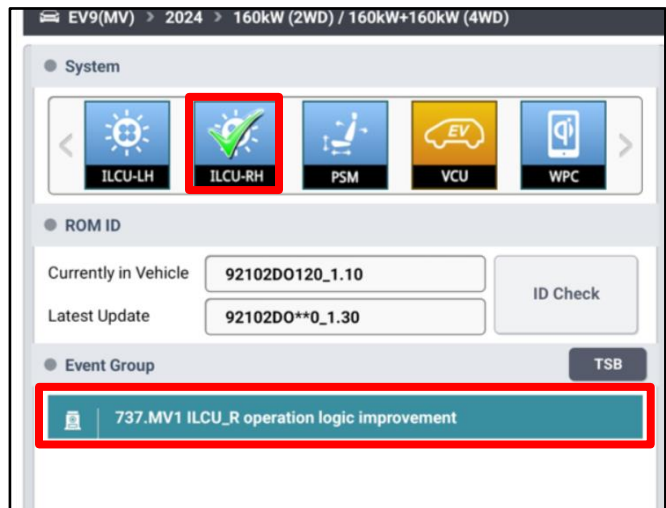
NOTICE

Prior to performing the ECU upgrade, be sure to check that the KDS is fully charged.
