GROUP	MODEL
ELE	2024MY EV9 (MV)
NUMBER	DATE
346 (Rev 1, 7/10/2024)	June 2024

TECHNICAL SERVICE BULLETIN

SERVICE ACTION: VCMS RESERVED BATTERY CHARGING LOGIC IMPROVEMENT (SA577)

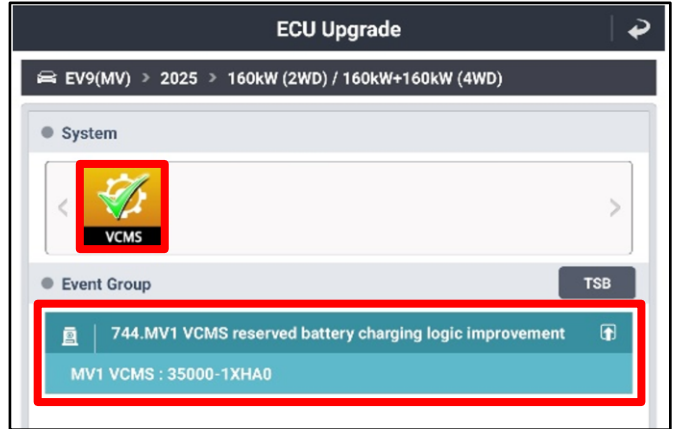
Refer to [TSB SST081](#) for instructions to upgrade the 'VCMS' system:

UPGRADE EVENT:

744.MV1 VCMS Reserved Battery Charging Logic Improvement
