# Service Bulletin

Bulletin No.: 24-NA-111

**Subject: MIL Set P0606: Control Module Processor Performance**

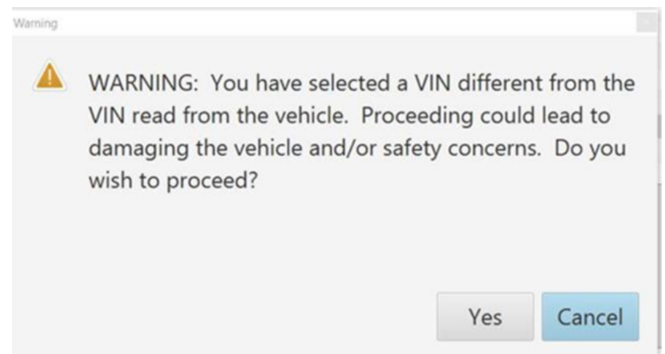
5877000

**Important:** If the vehicle VIN DOES NOT match, the message below will be shown

The screenshot shows the Techline Connect software interface. At the top, there is a navigation bar with 'DASHBOARD', 'GDS2', 'SI', and 'SPS2' tabs. The 'SPS2' tab is active. A warning dialog box is displayed in the center, with the text: 'M4521: You are attempting to reprogram with the same calibration. Select OK to continue, Cancel to Stop!'. Below the dialog is a table with columns: Controller, ID, Current #, and Description. The table contains seven rows of data for K17 controllers. At the bottom of the screen, there are buttons for 'Print', 'Save to PDF', 'ECU Data', 'Back', 'Start Programming', and 'Cancel'. A VIN field is visible at the bottom right.

**Important:** Techline Connect screens shown above.  
**Important:** If the same calibration/software warning is noted on the TLC Summary screen, select OK and follow screen instructions. After a successful programming event, the WCC is located in the Service Programming System dialogue box of the SPS
