# Service Bulletin

Bulletin No.: 24-NA-050

**Subject: Silverado and Sierra Setting DTC P0606 and either DTC P0562 or P0563**

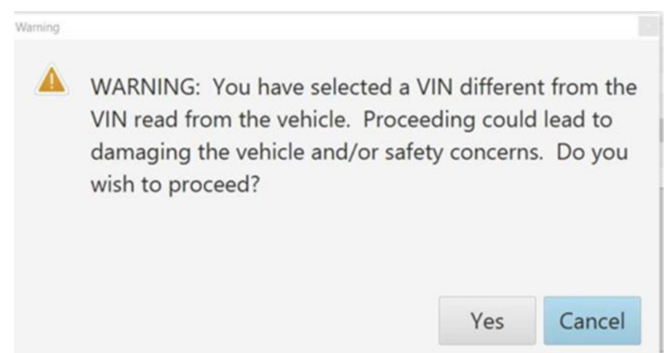
5743643

**Important:** If the vehicle VIN DOES NOT match, the message below will be shown
