Service Bulletin

Bulletin No.: 24-NA-092

Subject: Radio Software Version is W38E-174.4.1-M170-SQBR5-180.3

Brand:	Model:	Model Year:		VIN:		Engine:	Transmission:
		from	to	from	to		
Chevrolet	Blazer EV	2024	2024

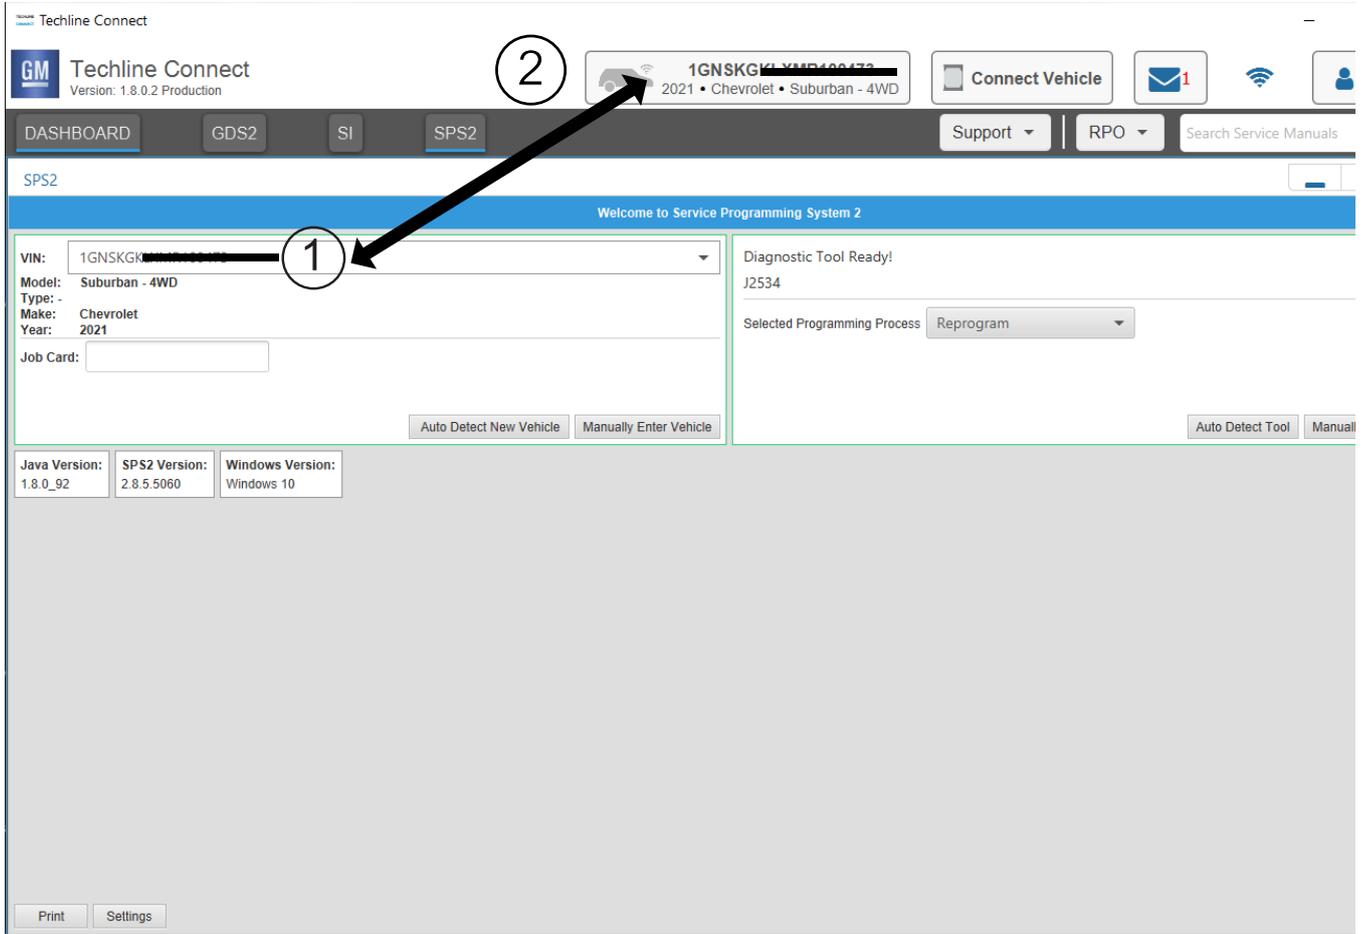
5743643

Caution: Be sure the VIN selected in the drop down menu (1) is the same as the vehicle connected (2) before beginning programming.

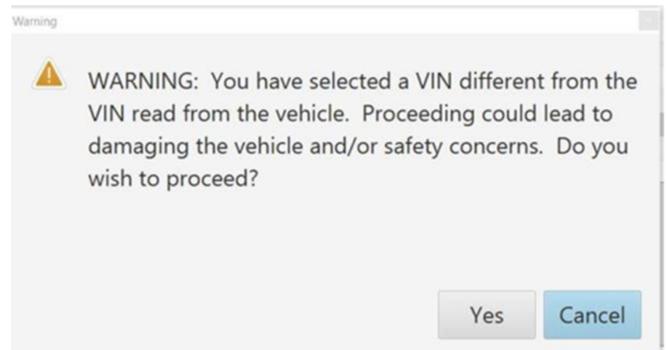
5877000

Important: If the vehicle VIN DOES NOT match, the message below will be shown

The screenshot shows the Techline Connect software interface. At the top, there is a navigation bar with 'DASHBOARD', 'GDS2', 'SI', and 'SPS2' tabs. The 'SPS2' tab is active. A warning dialog box is displayed in the center, with the text: 'M4521: You are attempting to reprogram with the same calibration. Select OK to continue, Cancel to Stop!'. Below the dialog is a table with columns: Controller, ID, Current #, and Description. The table contains 7 rows of data for K17 controllers. At the bottom of the interface, there are buttons for 'Print', 'Save to PDF', 'ECU Data', 'Back', 'Start Programming', and 'Cancel'. A VIN field is visible at the bottom right.

Important: Techline Connect screens shown above.
Important: If the same calibration/software warning is noted on the TLC Summary screen, select OK and follow screen instructions. After a successful programming event, the WCC is located in the Service Programming System dialogue box of the SPS Summary screen. No further action is required. Refer to the Warranty section of the bulletin.

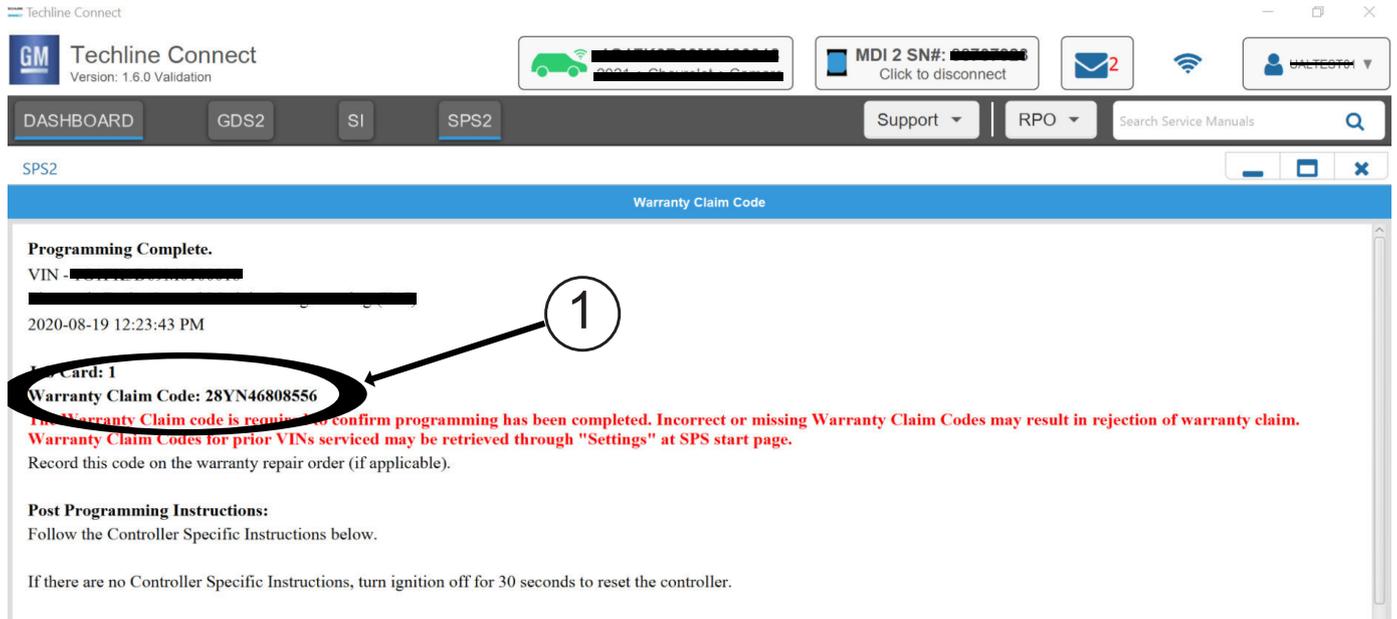
5644478

Note: The screenshot above is an example of module programming and may not be indicative of the specific module that is being programmed. Module selection and VIN information have been blacked out.
