GROUP	MODEL
ELE	2024MY EV9 (MV)
NUMBER	DATE
348 (Rev 1, 7/10/2024)	June 2024

TECHNICAL SERVICE BULLETIN

SUBJECT: **SERVICE ACTION: BDC-BCM LOGIC IMPROVEMENT
FOR DTC C1126 (SA579)**

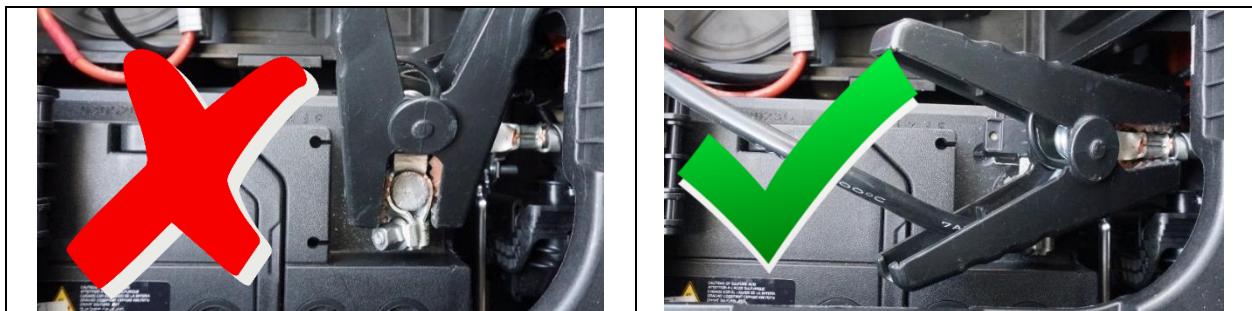
Note: When connecting the external battery pack, in-vehicle operation built-in CAM might be issued by impossible charging amount sensing of the battery sensor.

[Connect the negative \(-\) terminal to the battery as shown below.](#)
