Service Bulletin

Bulletin No.: 24-NA-114

Subject: Check Engine Lamp Illuminated with DTC P026D Set, Engine LWN Controller E98 Update

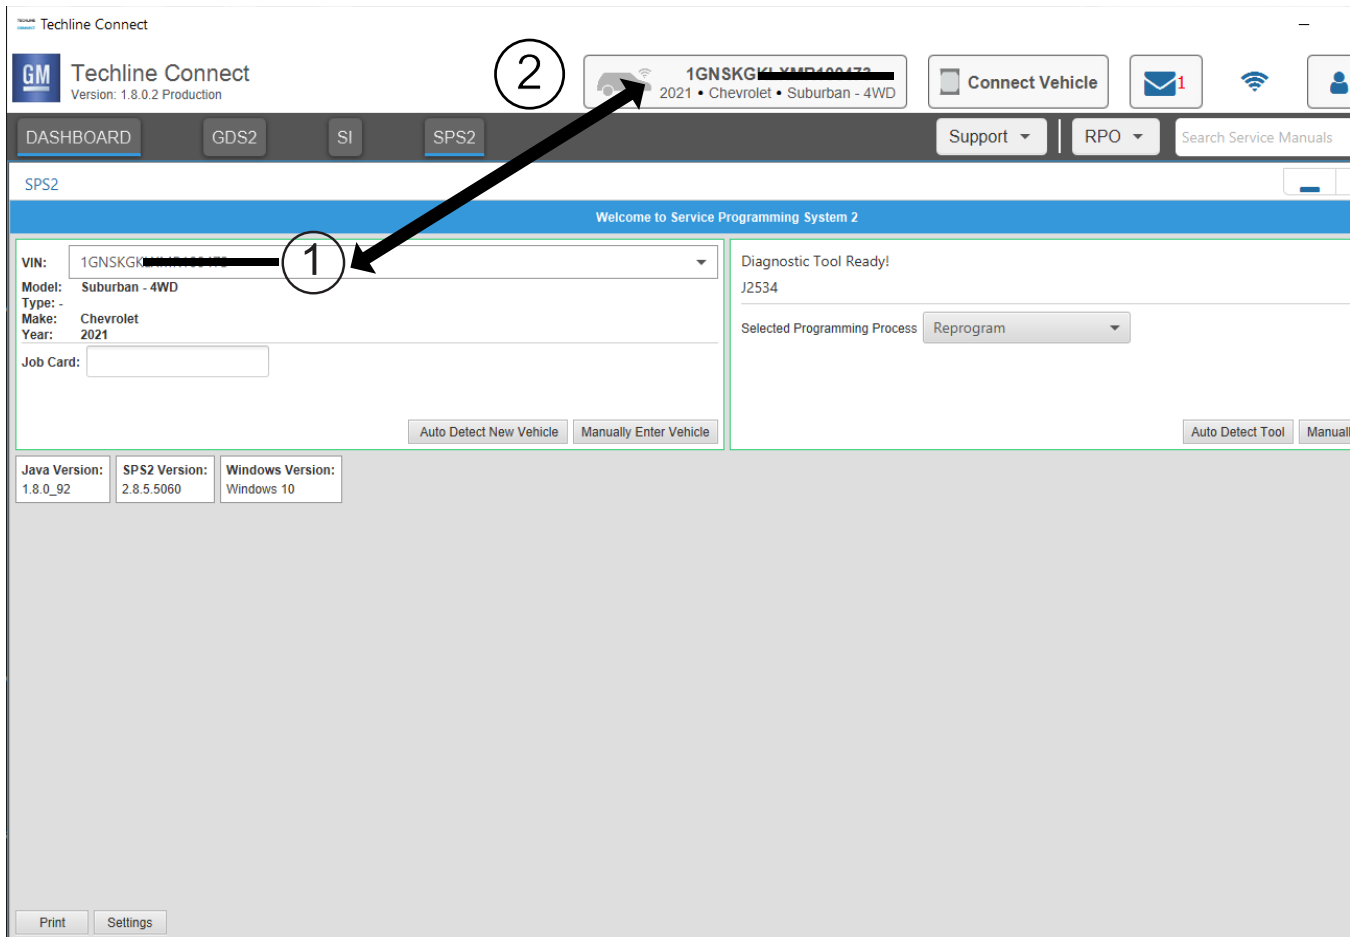
5743643

Caution: Be sure the VIN selected in the drop down menu (1) is the same as the vehicle connected (2) before beginning programming.

Note: The screenshot above is an example of module programming and may not be indicative of the specific module that is being programmed. Module selection and VIN information have been blacked out.
