TECHNICAL SERVICE BULLETIN

Classification: DA23-001A	Reference: NTB23-044A	Date: May 10, 2024
------------------------------	--------------------------	-----------------------

FALSE ACTIVATION OF AEB OR FCW

APPLIED VEHICLES: 2020-2024 Titan/Titan XD (A61)
APPLIED DATES: Built on or before December 1, 2023
APPLIED SYSTEMS: Automatic Emergency Braking/Forward Collision Warning

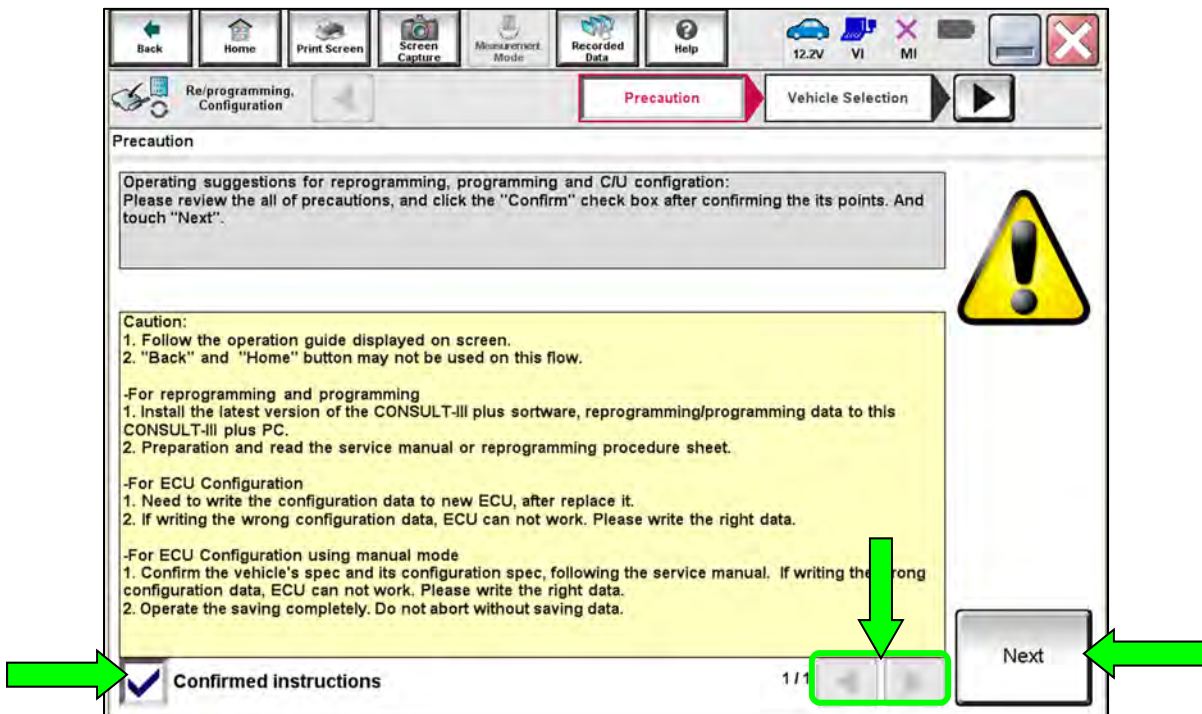
Figure 3

13. Use the arrows (if needed) to view and read all precautions.

14. Check the box confirming the precautions have been read.

15. Select **Next**.

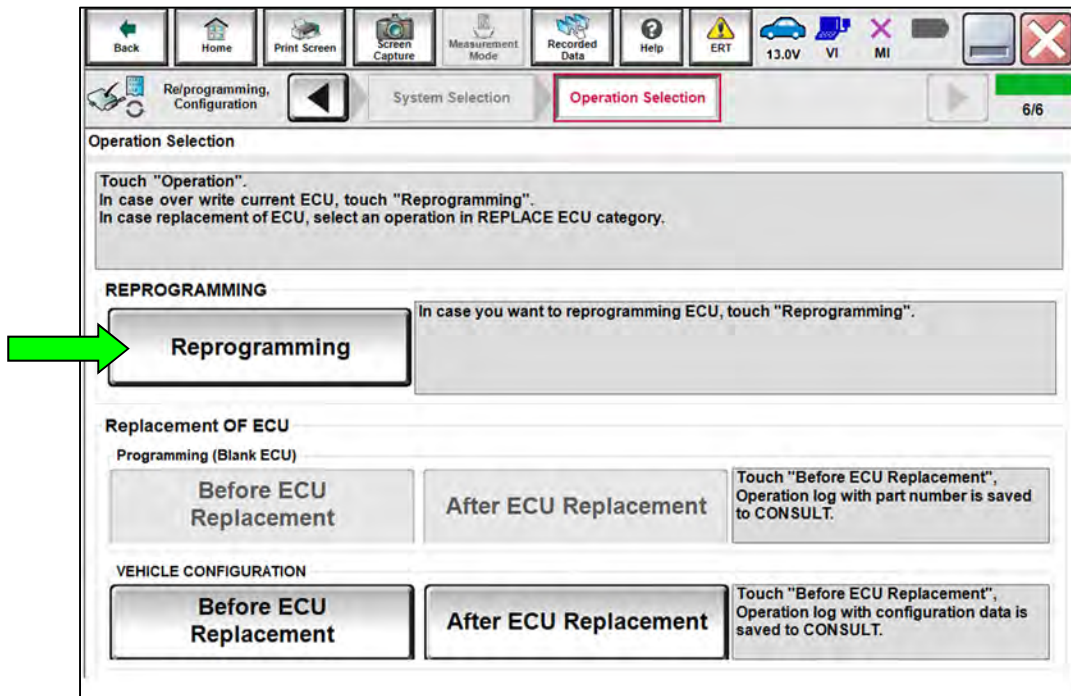
Figure 8

21. Select **Reprogramming**.

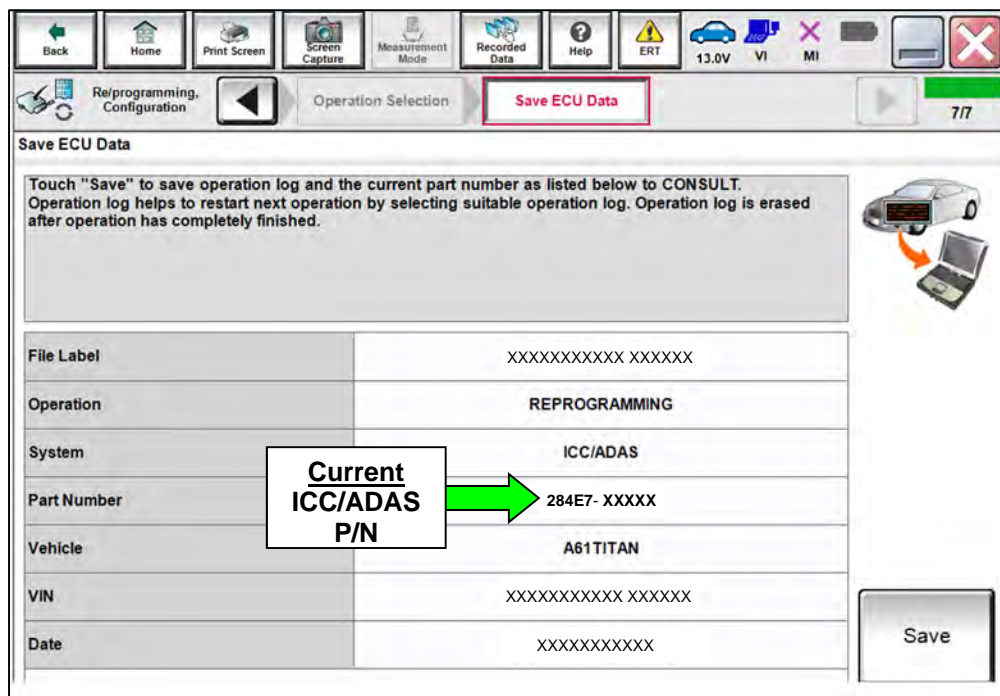
Figure 9

22. When you get to the screen shown in Figure 9, confirm that a reprogram is available as follows:

- a. Find the ICC/ADAS **Part Number** and write it on the repair order.

HINT: This is the current ICC/ADAS part number (P/N).

- b. Compare the P/N you wrote down to the numbers in the **CURRENT ICC/ADAS PART NUMBER** column in **Table A**.
 - o If there is a match in **Table A**, continue with the reprogramming procedure.
 - o If there is not a match, in **Table A**, this bulletin does not apply. See the ESM (Electronic Service Manual) for further diagnostic information.

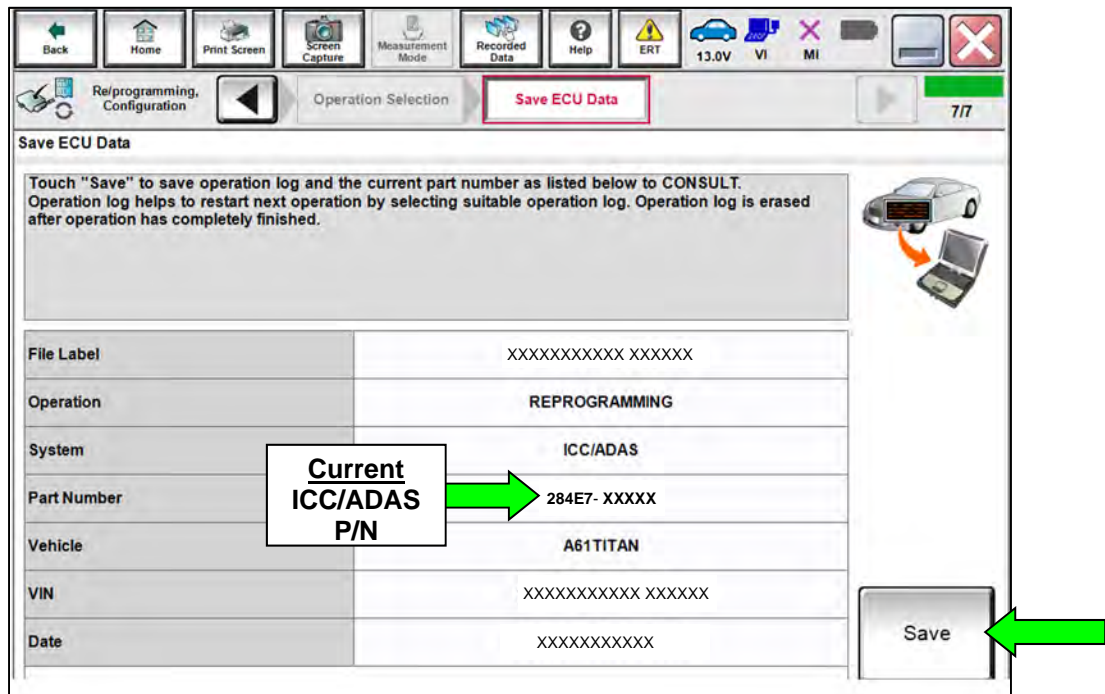
Figure 10

24. Select **Save**.

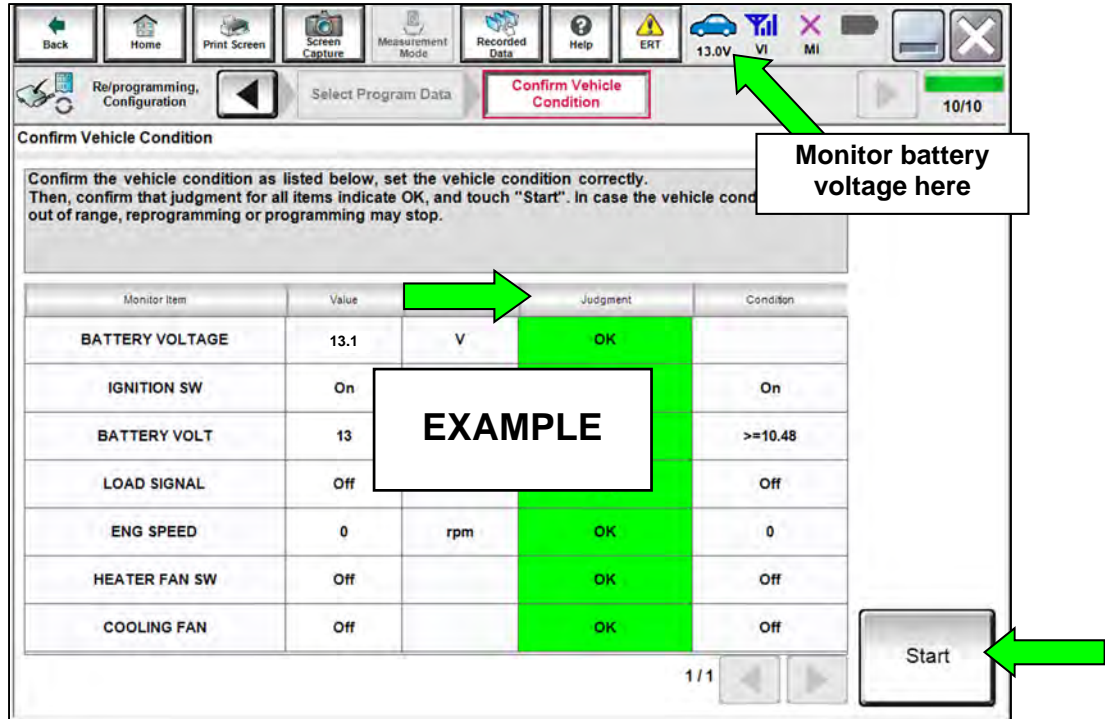
Figure 15

32. Confirm all **Judgment** items are “OK”, and then select **Start**.

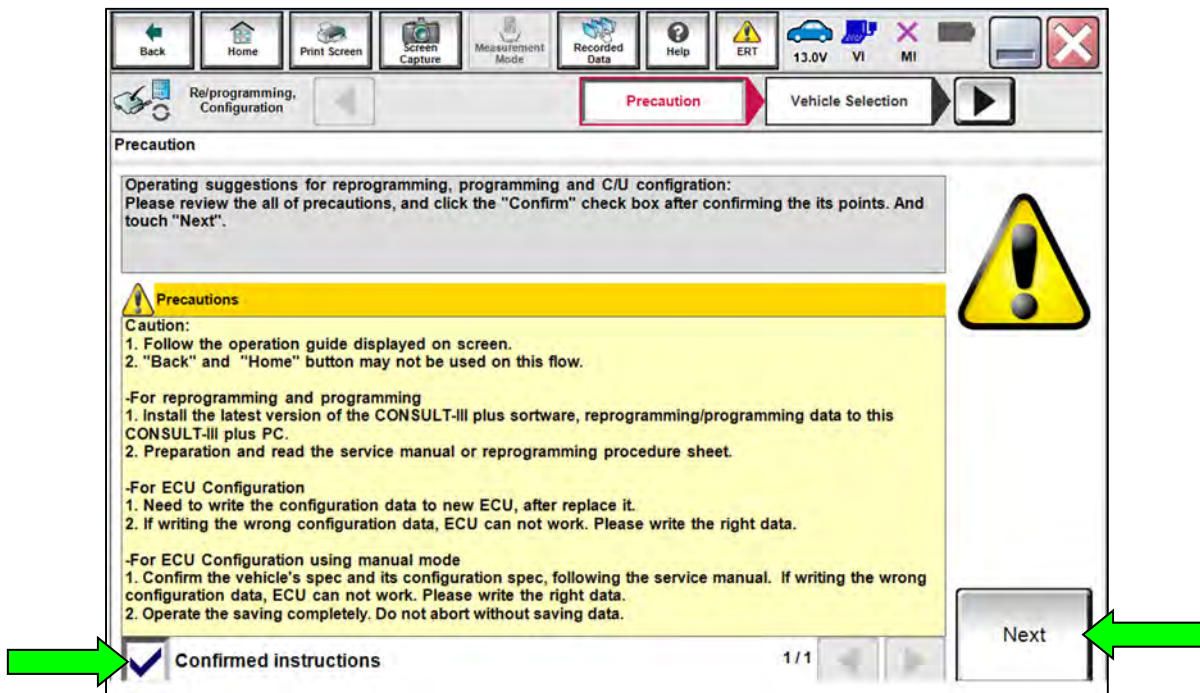
Figure 23

40. Read the precautions on the C-III plus screen, check the box for **Confirmed Instructions**, and then select **Next**.

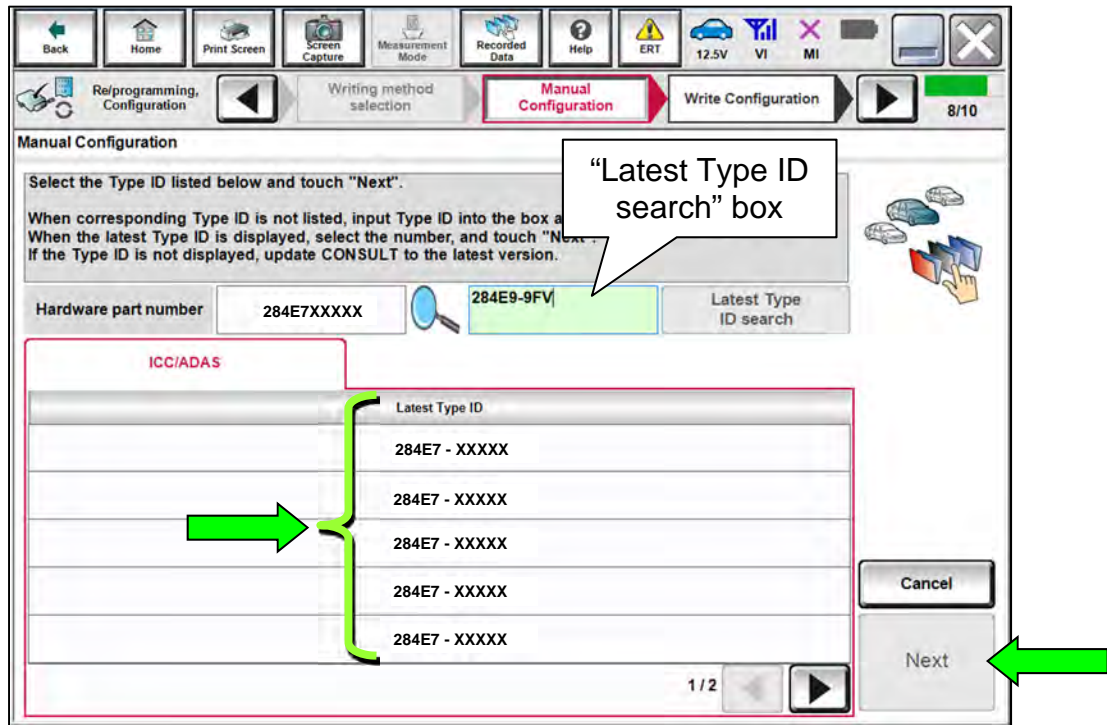
Figure 30

50. Either enter the last two (2) characters of the **NEW (Latest Type ID)** into the **Latest Type ID search** box (Figure 30) or manually select the correct **Latest Type ID** that was found in **Table B** (page 22).
51. Select **Next**.

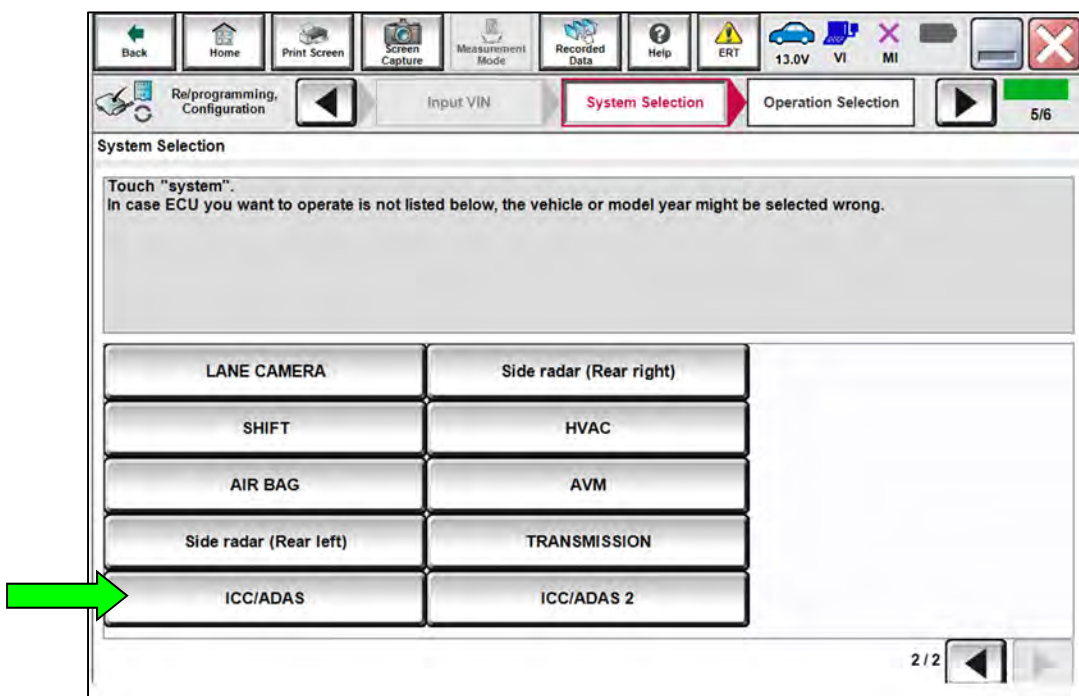
Figure 36

61. Select **ICC/ADAS**.
