# Head Unit Software Update Version 2170 (Panasonic)

**Service Category** Audio/Visual/Telematics

YEAR(S)	MODEL(S)	ADDITIONAL INFORMATION
2023 - 2024	Sequoia HV	
2022 - 2024	Tundra, Tundra HV

A head unit software update is now available for 2022 model year Tundra and Tundra Hybrid vehicles equipped with Toyota Multimedia (version 1020 or earlier). This software update provides improved performance and capability for the following:

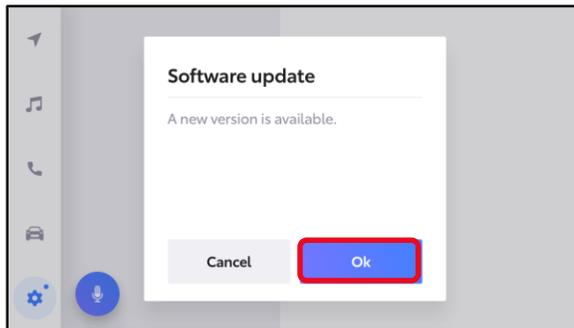
**Figure 1.**

Vehicle operators can perform this update directly by accepting the on-screen notification (see Figure 1), advising the software update is available, or by locating the software update from the Settings menu and initiating the available update (see Figure 2). The release notes text below will be displayed to the customer:

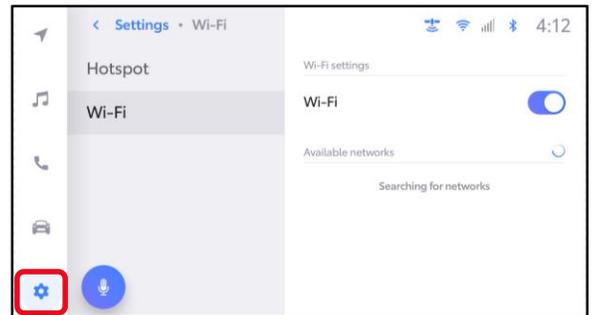
Figure 3.

1. Turn ON the ignition.
2. Select the gear icon in the lower left corner of the radio screen.

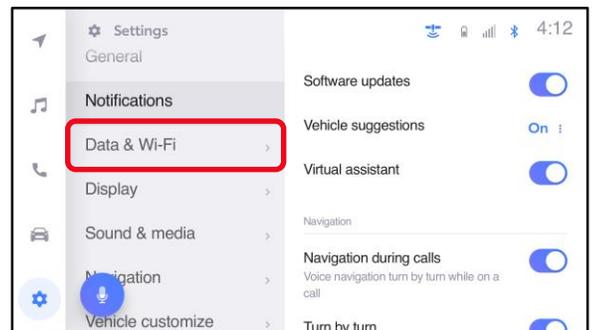
Figure 4.

3. Select Data & Wi-Fi.

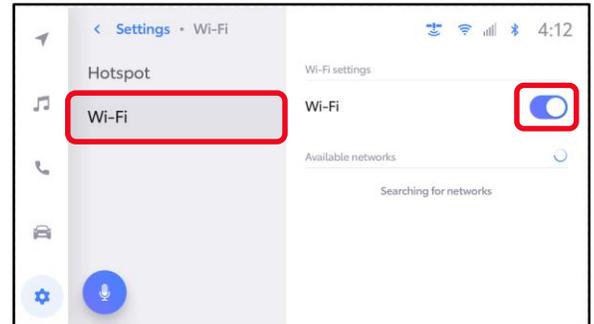
**Figure 5.**

- This step is used to connect the vehicle to an EXTERNAL Wi-Fi source.
- Wi-Fi connection is NOT required for updates that are delivered through DCM data.

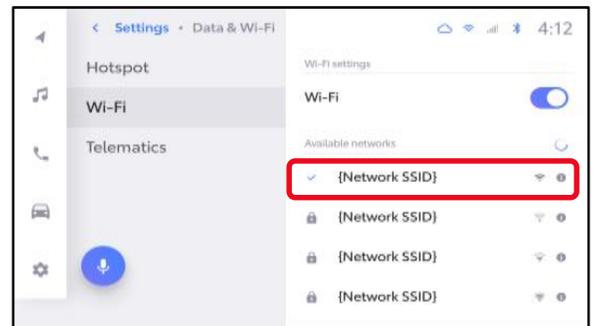
**Figure 6.**

- Select the Wi-Fi network desired to connect.

It is NOT possible to connect to a Wi-Fi source that requires a username and password to be entered in a browser.

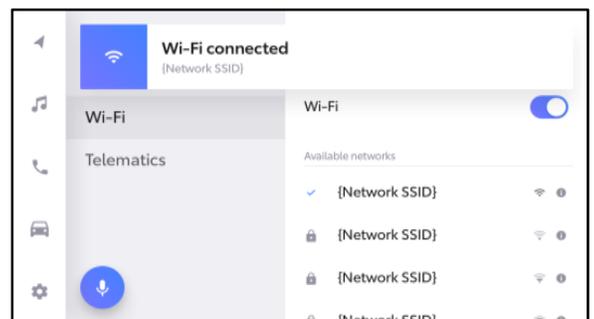
**Figure 7.**

- Follow the on-screen instructions. A message will appear confirming that the vehicle is successfully connected to the network.

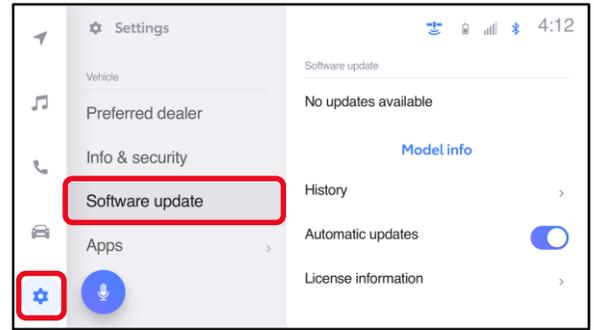
**Figure 8.**

1. Select the gear icon, scroll down, and select Software update.

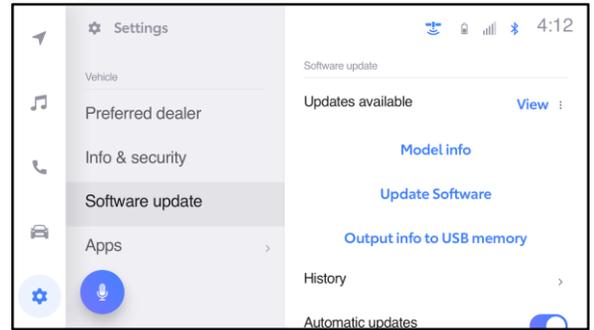
**Figure 11.**

3. Select Model info.

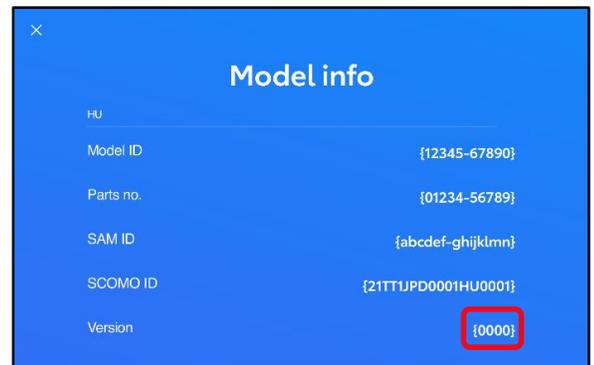
**Figure 12.**

4. Is the software up to date?  
(Refer to Table 1 below.)
- **YES** — This bulletin does NOT apply. Continue diagnosis using the applicable Repair Manual.
  - **NO** — Continue to step 5.

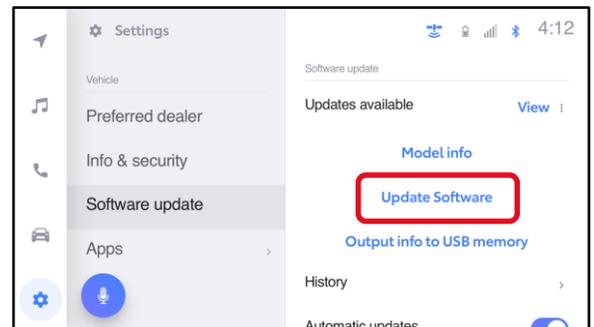
**Figure 13.**

5. Select Update Software.

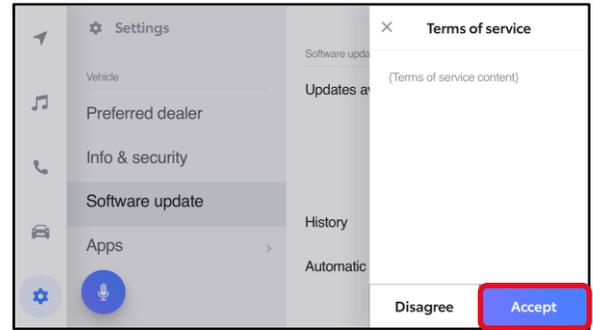
Figure 14.

6. Select Accept on the Terms of service screen.

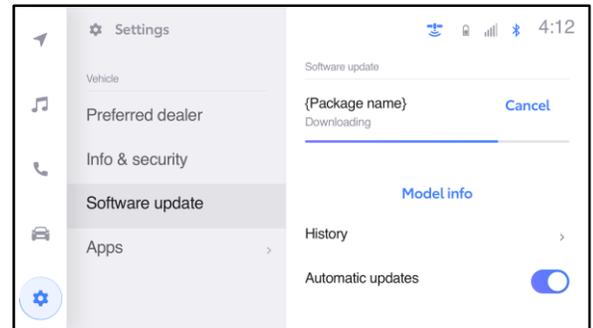
Figure 15.

7. Wait for the update to download.

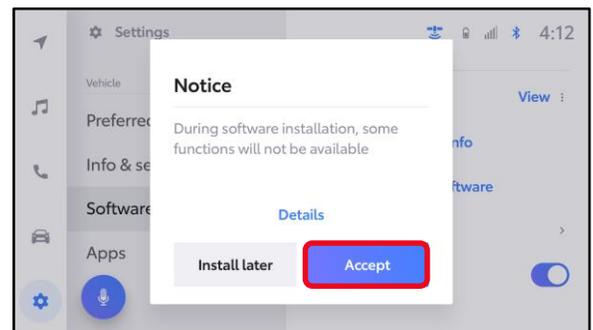
Figure 16.

8. Select Accept on the Notice pop-up message if it appears.

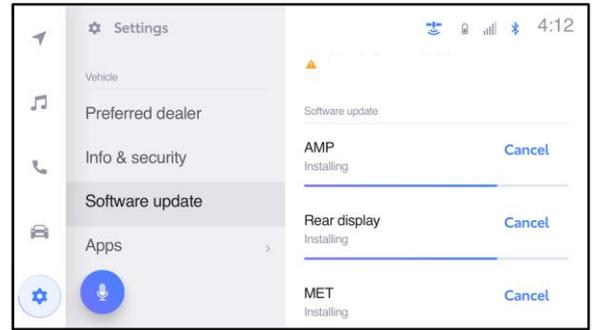
**Figure 17.**

- Do NOT turn OFF the engine or ACC BEFORE the software is ready for updating.
- Selecting Cancel will cancel the installation of the specific component, but it can be installed manually later.

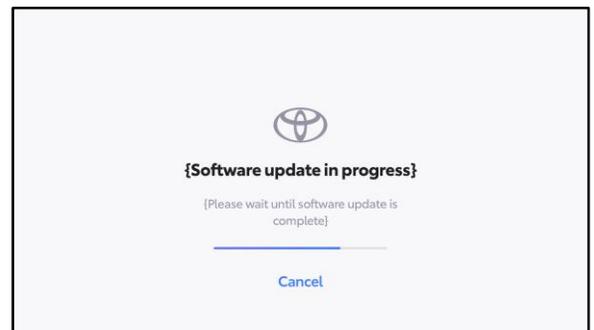
**Figure 18.**

10. If a major update is being installed the message "Software update in progress" will be displayed.

- Do NOT turn OFF the engine or ACC BEFORE the software has updated successfully.
- Selecting Cancel will cancel the installation of the specific component, but it can be installed manually later.

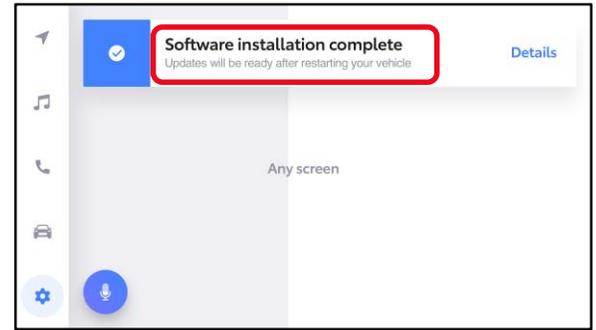
**Figure 19.**

- The software installation is complete when either a “Software installation complete” banner (Figure 19) or the “Software update complete” screen (Figure 20) is displayed.

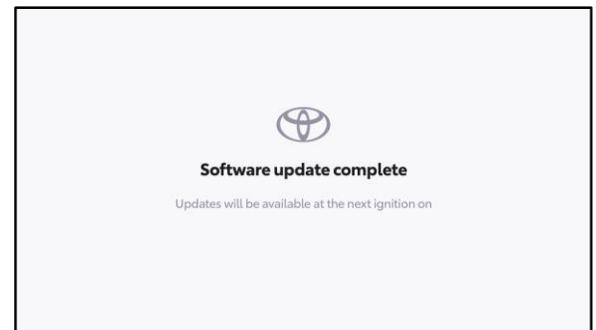
**Figure 20.**

If the vehicle has installed a major update, and the “Software update complete” screen is displayed, then an IG-OFF/ON will need to be performed prior to attempting to operate any of the multimedia functions.

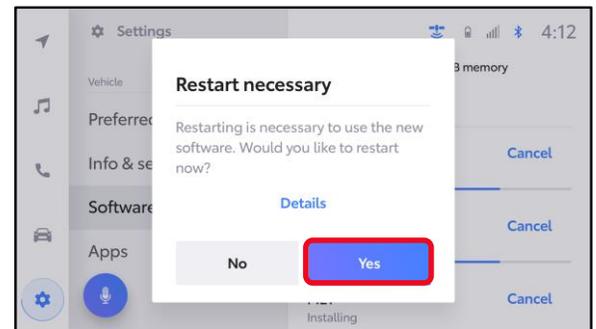
**Figure 21.**

- If a restart is necessary, select Yes to restart the head unit.

If No is selected or the vehicle is switched to IG-OFF, the installation will occur at the next IG-ON.

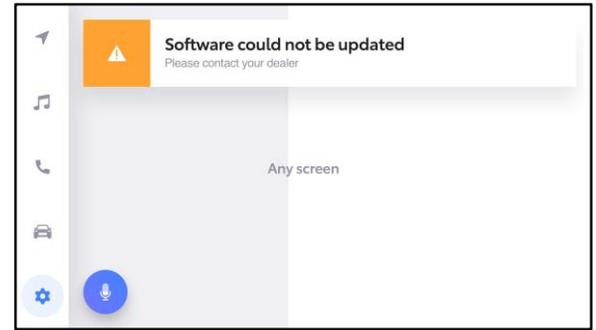
Figure 22.

- If after IG-OFF/ON a “Software could not be updated” banner appears, continue to the [USB Update Procedure](#) subsection.

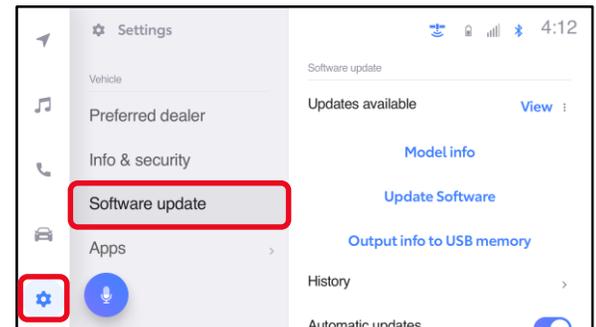
Figure 23.

- Select the gear icon and scroll down to select Software update.

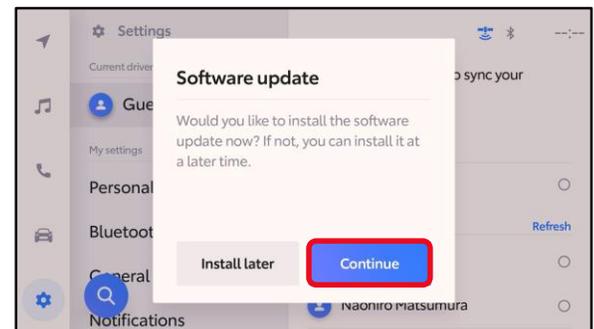
**Figure 26.**

4. Select Continue when the message in Figure 26 appears.

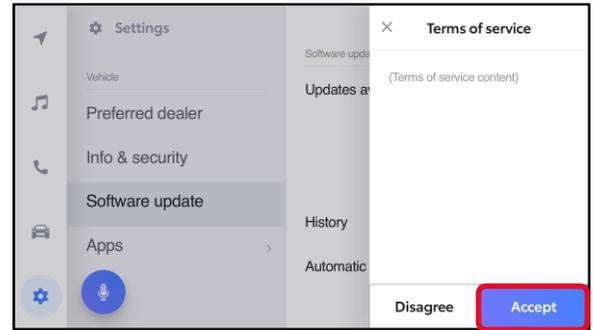
**Figure 27.**

5. Select Accept on the Terms of service screen.

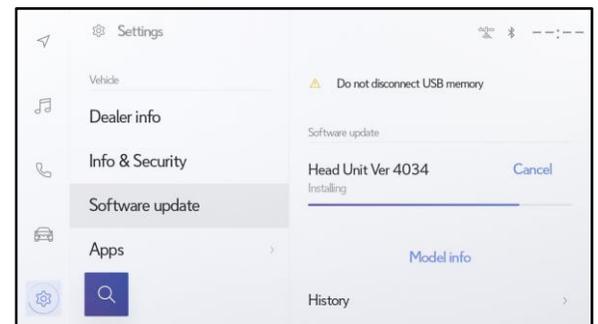
**Figure 28.**

6. Wait for the update to download. Once the head unit software begins installation, the update will take up to 15 minutes per update file.

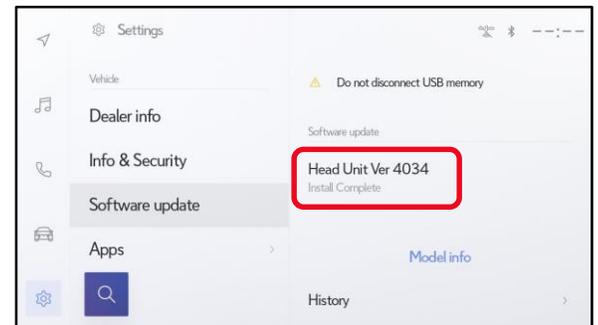
**Figure 29.**

- A. When the update is complete, "Install Complete" will show on the head unit, as shown in Figure 29.

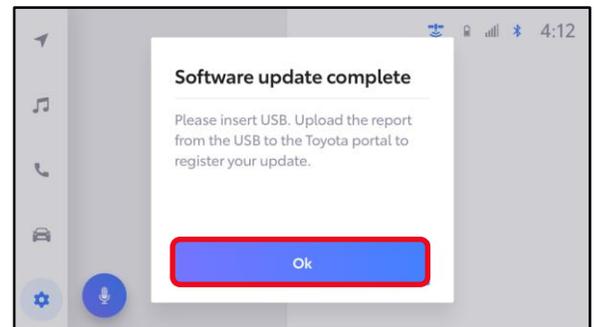
**Figure 31.**

If you are prompted to upload a report as shown in Figure 31, insert a blank USB to remove the .JSON files. These files are NOT needed.
